Resilient Repair Guide Source Report: Case Study Annex

APPLIED TECHNOLOGY COUNCIL
201 Redwood Shores Parkway, Suite 240
Redwood City, California 94065
www.ATCouncil.org

FEDERAL EMERGENCY MANAGEMENT AGENCY
Michael Mahoney, Project Officer
William T. Holmes, Technical Monitor
Washington, D.C.

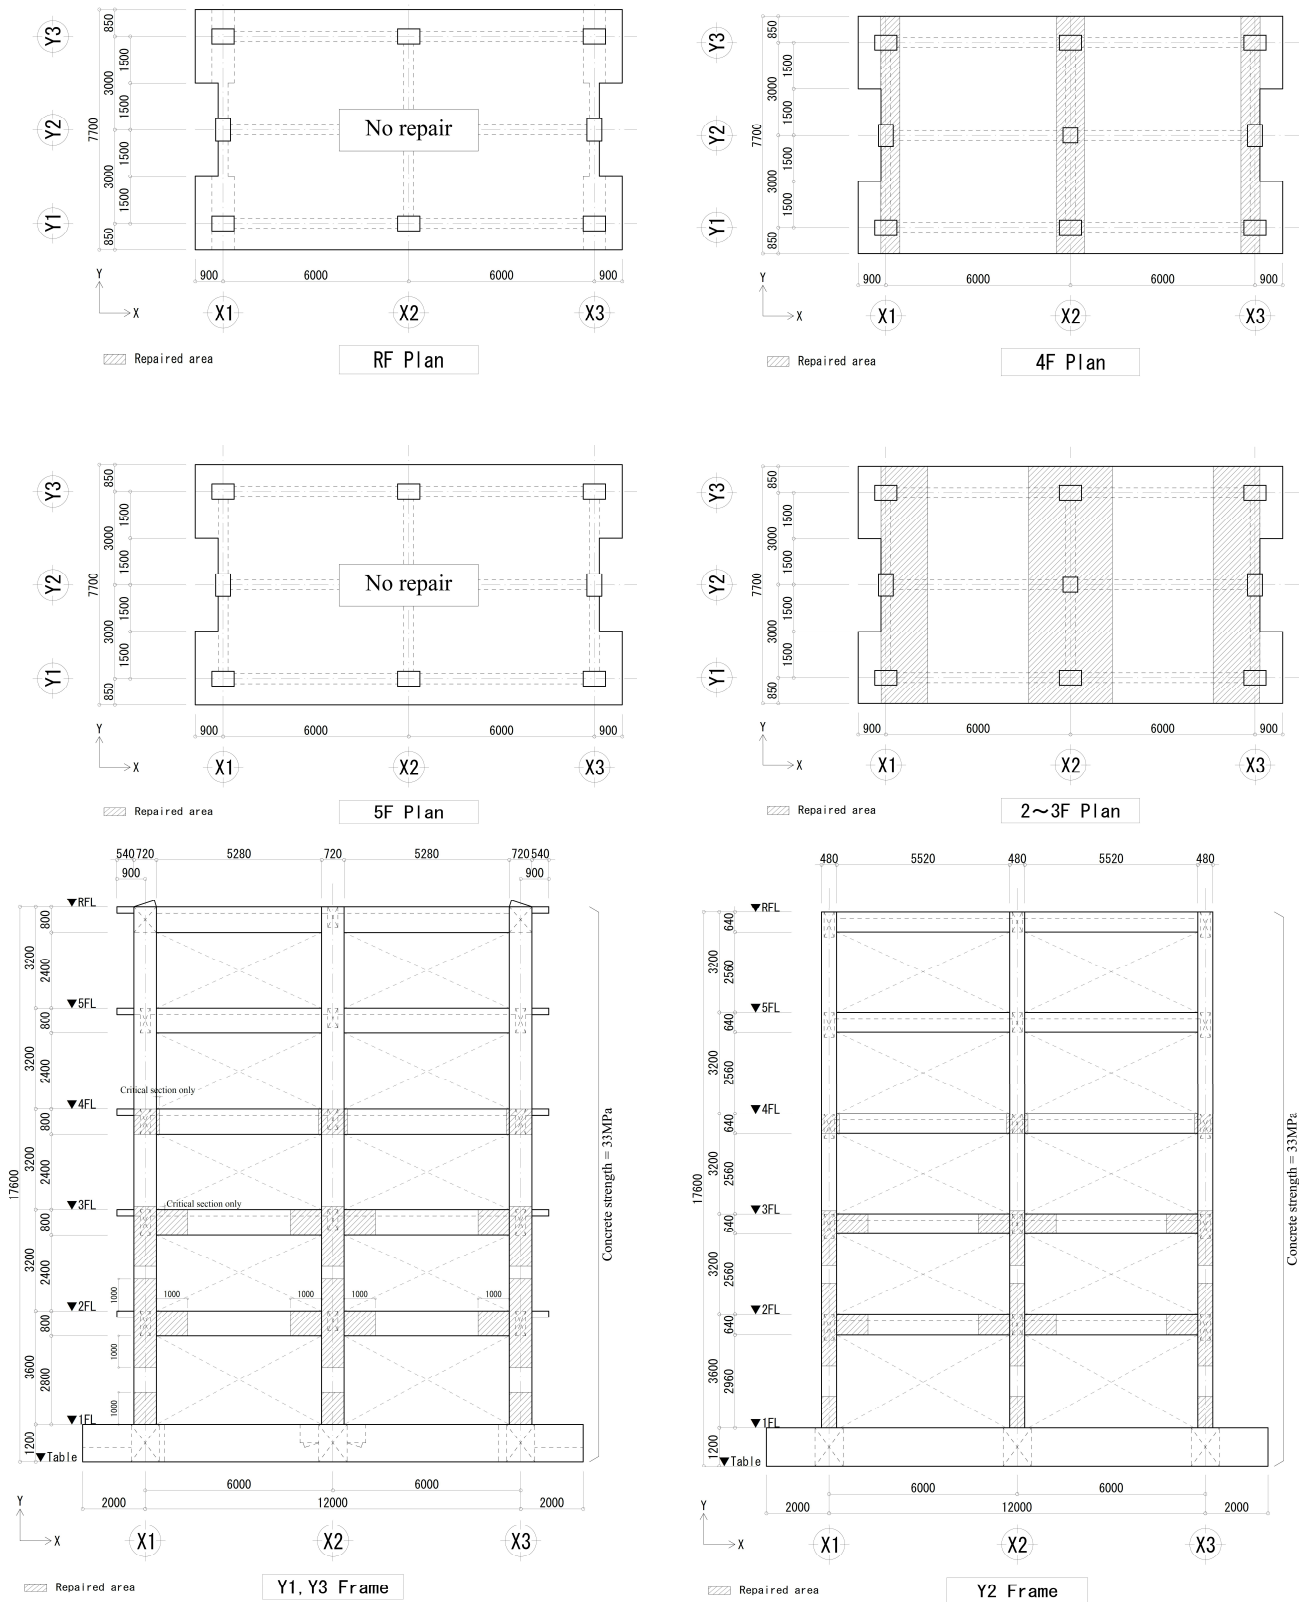
Figure 3-4 Repaired area in test building.

Figure 3-4 illustrates the areas where the repair was applied. Each beam, column and beam-column joint was repaired up to the third floor level. On the fourth floor level, beams were repaired only at the critical section, and beam-column joints were repaired in the same way as the lower floors. Due to the time restriction between tests, the fourth and fifth stories were not repaired. As the drift demands in these stories were less 1.0% during the previous Runs, it was deemed acceptable to leave these stories un-repaired.

The concept of the repair was to determine the ability of a simple repair methodology to recover the original structural capacity. In this test, the specimen was repaired with epoxy injection and mortar patching. The scope of the repair was the plastic hinge zone of each component and beam-column joints. In order to simplify the repair work, the plastic hinge length of each member was defined as 1.0 m from the face of the beam-column joint. However, repair was not always contained to this 1.0 m distance because if the cracks straddle the plastic hinge region, the epoxy resin also penetrated into the cracks out of this range.

The repair technique was able to inject down to 0.05 mm cracks. Therefore, basically all the cracks in the plastic hinge zone and the beam-column joint were repaired.

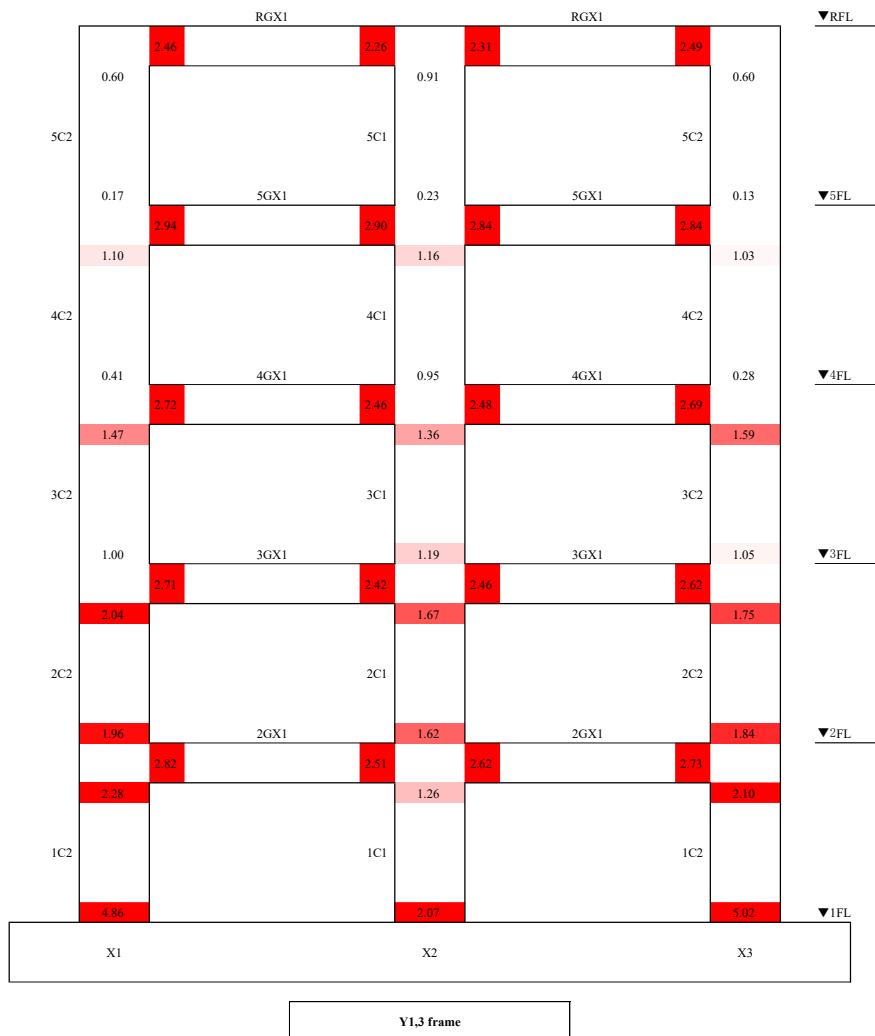
Figure 4-18 DCR with the modified linear model (Run 3).

Figure 4-18 shows DCR of each component with the modified linear model on the exterior and interior frame. As can be seen, most of the beams show DCRs of nearly 2.0 – 3.0, which implies these beams are subjected to moderate ductility demand compared to prior ductility demand. In the columns, DCRs are nearly 2.0 other than the bottom of columns in the first story. These outputs indicate that most of beams and columns were likely to experience inelastic response and be severely damaged. However, in the visual inspection, no severe damage was observed. This discrepancy might lead to significantly conservative estimation on ductility demand and damage level.

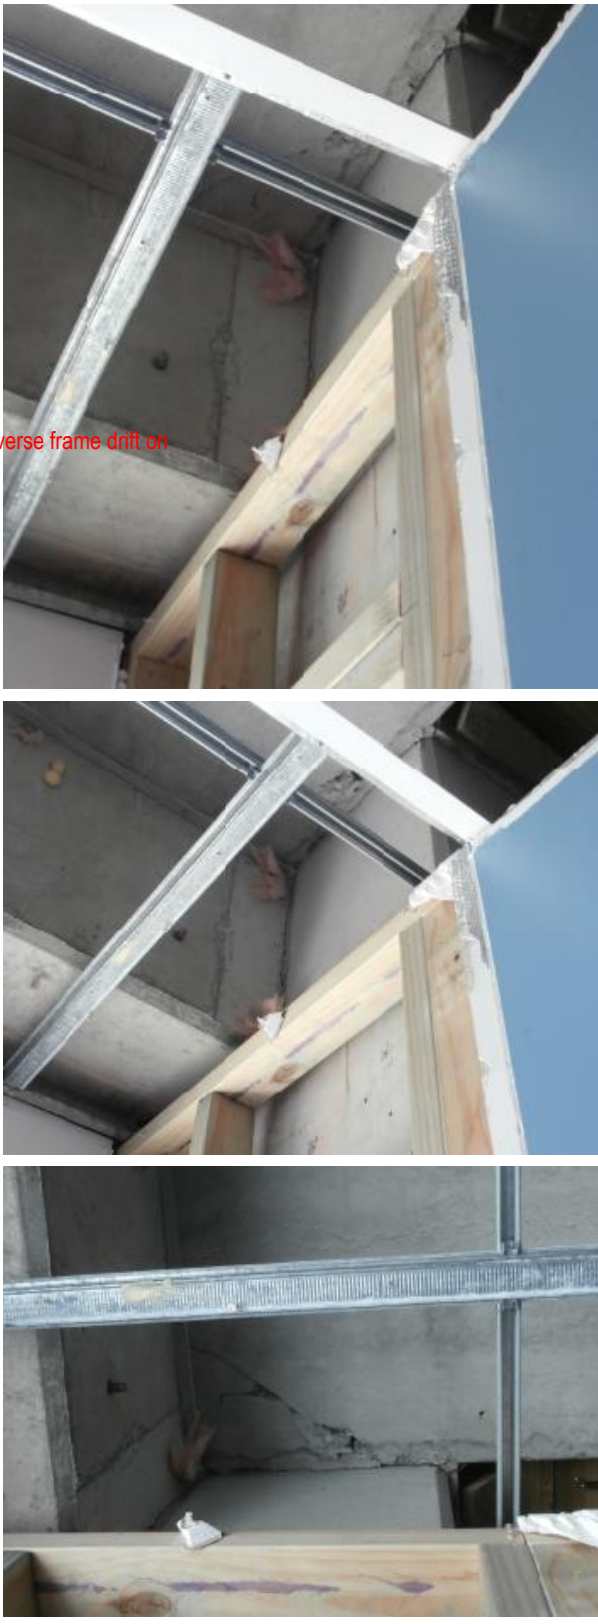
16	Elevation 8A- Grid HA. Beam column joint underside of level 3 DS 2 2.75% DS 1 2.0%	Approximately 2.5 mm wide vertical crack on the face of the beam column joint. Diagonal crack underside of the Dycore unit. Concrete crushed and loss of support.

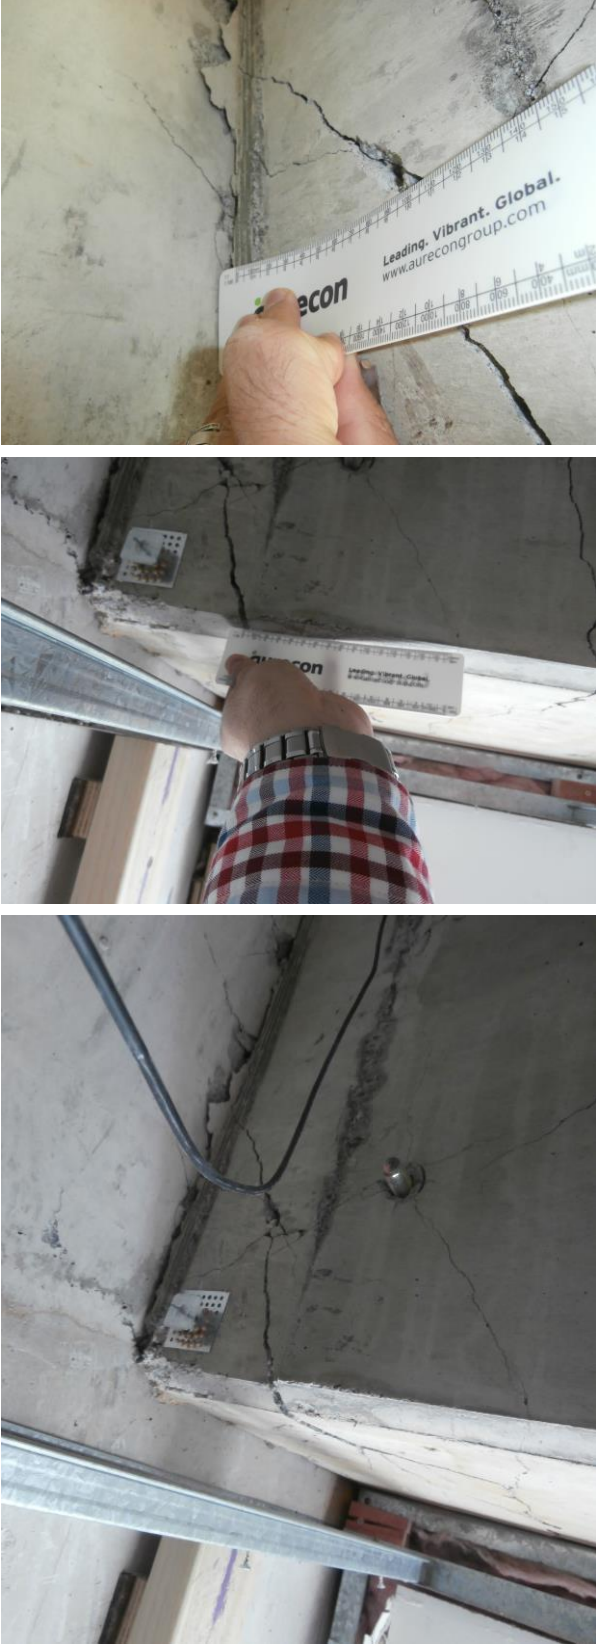
17	Elevation 1- Grid HA. Beam Column joint underside of level 3 DS 2 2.75%	Three diagonal cracks of width ~7 mm. Vertical crack at the column face. Spalling of concrete in both the column and beam. Cracks along the beam.

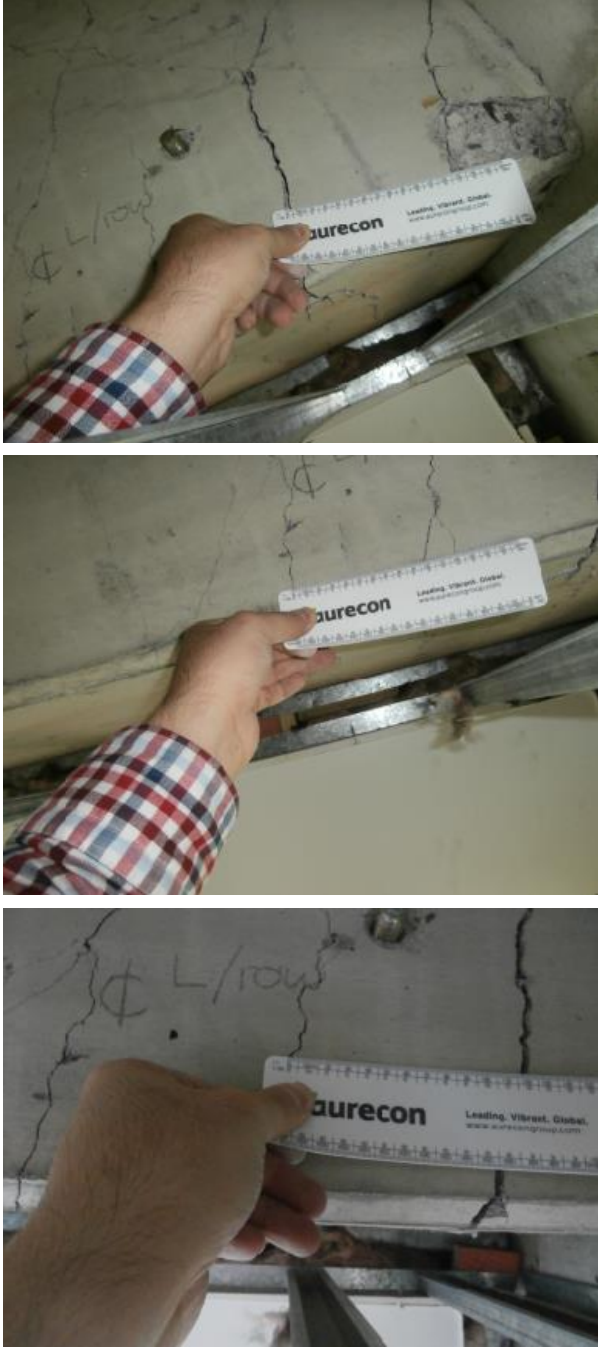
<p>24</p>	<p>Elevation 1- Grid N. Beam Column joint underside of level 3.</p> <p>DS 2 2.75%</p>	<p>Width of diagonal cracks approximately 1 mm.</p> <p>Width of verical cracks range from 3-5 mm.</p> <p>Loss of concrete in the beam, and concrete crushed in the column</p>

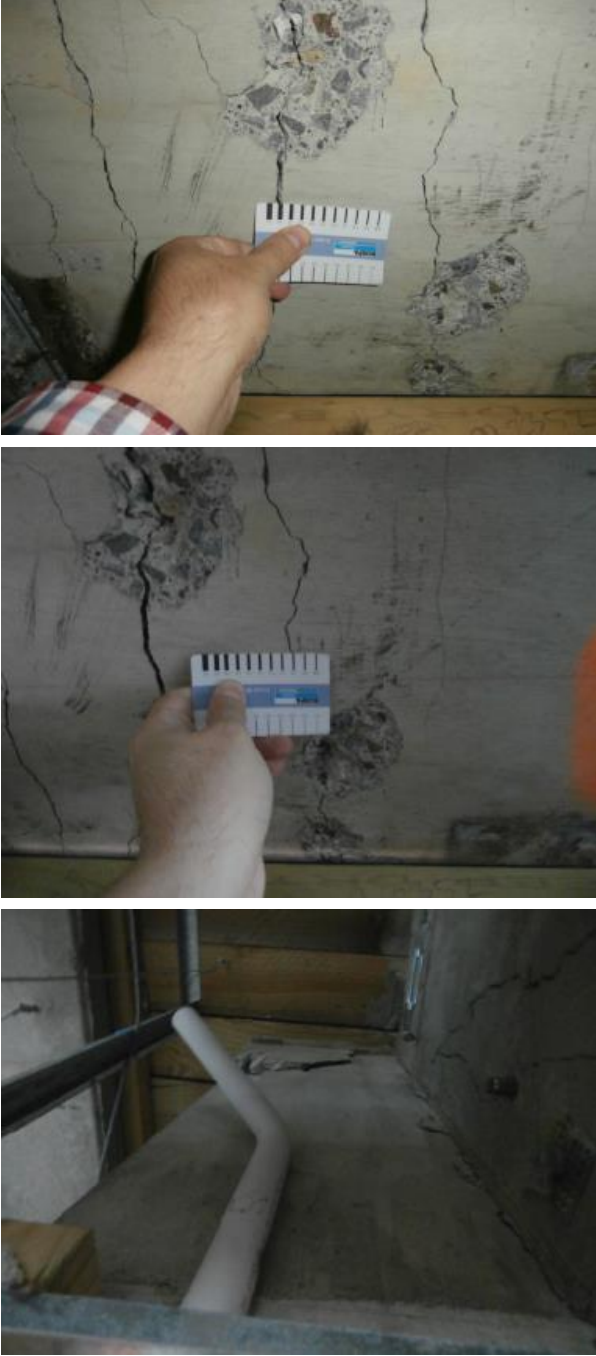
<p>25</p>	<p>Elevation A-Grid 13. Beam Column joint underside of level 3.</p> <p>DS 2 2.75%</p> <p>DS 1 2.0%</p>	<p>Width of vertical cracks range from 1-3 mm. Approximately 6 cracks at the B/C (beam/column) joint.</p> <p>Spalling/ loss of concrete in several locations around the joint. Loss of support at the joint.</p>

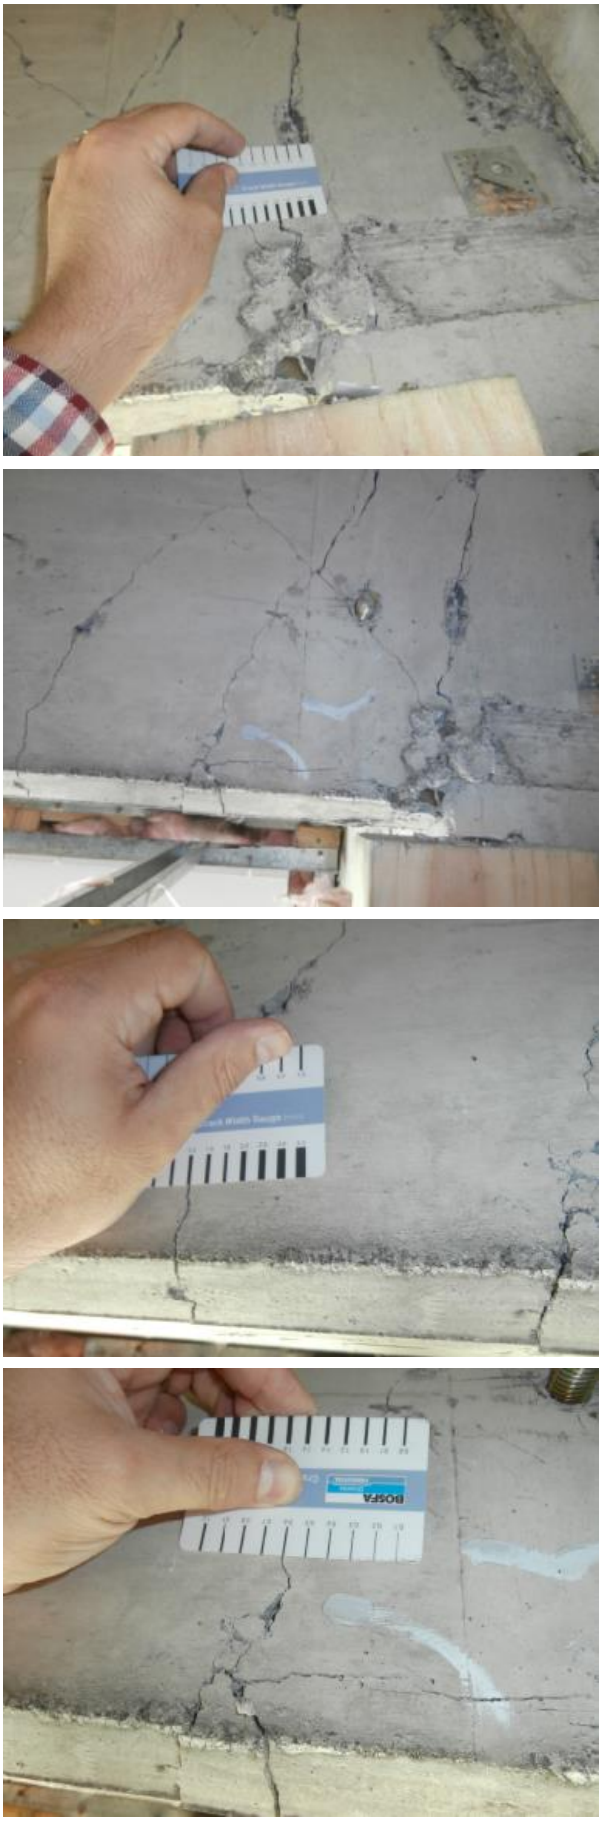
<p>28/29</p>	<p>Elevation A-Grid 10A. Beam Column joint underside of level 3.</p> <p>DS 2 2.75%</p> <p>DS 1 2.0%</p>	<p>Width of the vertical cracks range from 2-2.5 mm on both sides of the joint.</p> <p>Several smaller cracks of width range from 0.6-1.4 mm.</p> <p>Diagonal cracks on the in the joint and in the column.</p> <p>Several hairline cracks along the beam.</p> <p>Loss of concrete, spalling and concrete crush in the joint.</p>

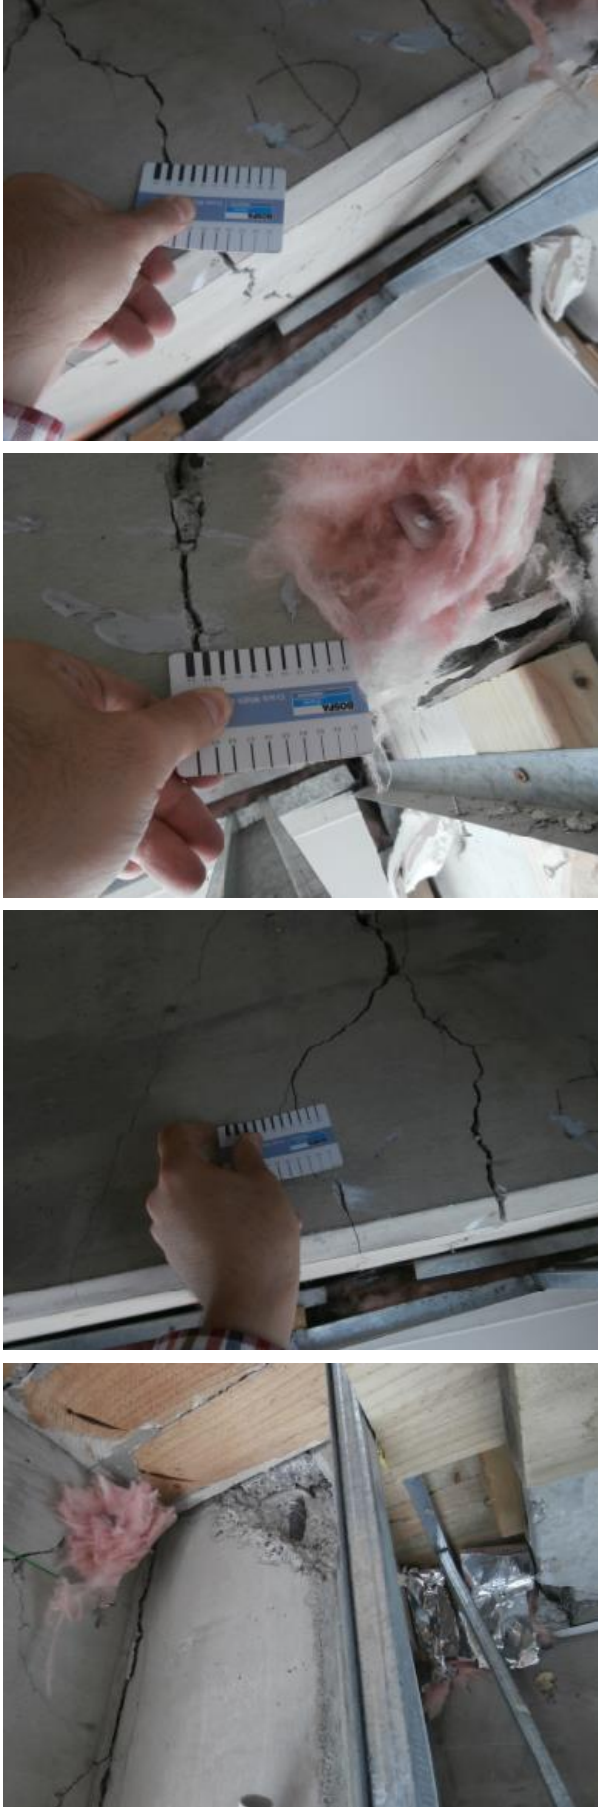
<p>32</p>	<p>Elevation A-Grid 8A. Beam Column joint underside of level 3.</p> <p>DS 3 5.0%</p> <p>DS 2 2.75%</p>	<p>Combination of diagonal and vertical cracks in the joint. The width of the cracks range from 1-3 mm.</p> <p>Loss of concrete in the column, reinforcement is exposed.</p> <p>Concrete crushed in the joint.</p>

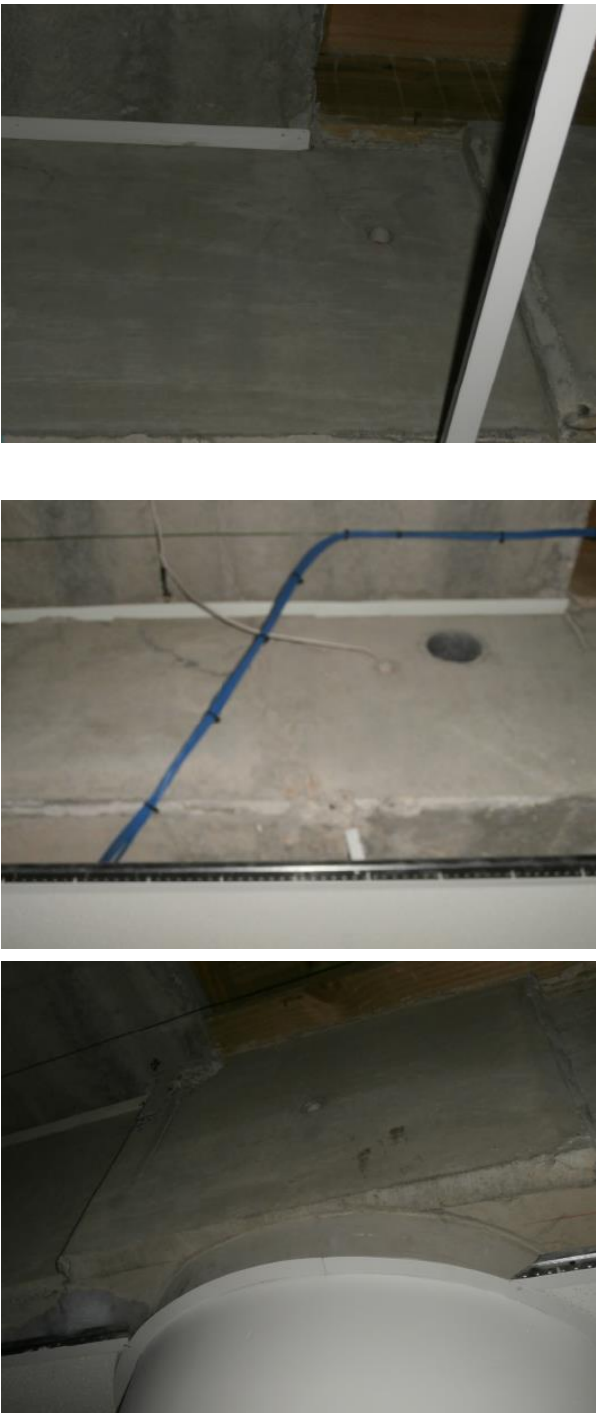
117/118	Elevation KA-Grid 8'. Beam column joint underside of level 3	Diagonal hairline cracks of width less than 0.3 mm. Concrete crushed at the edge in the beam column joint.

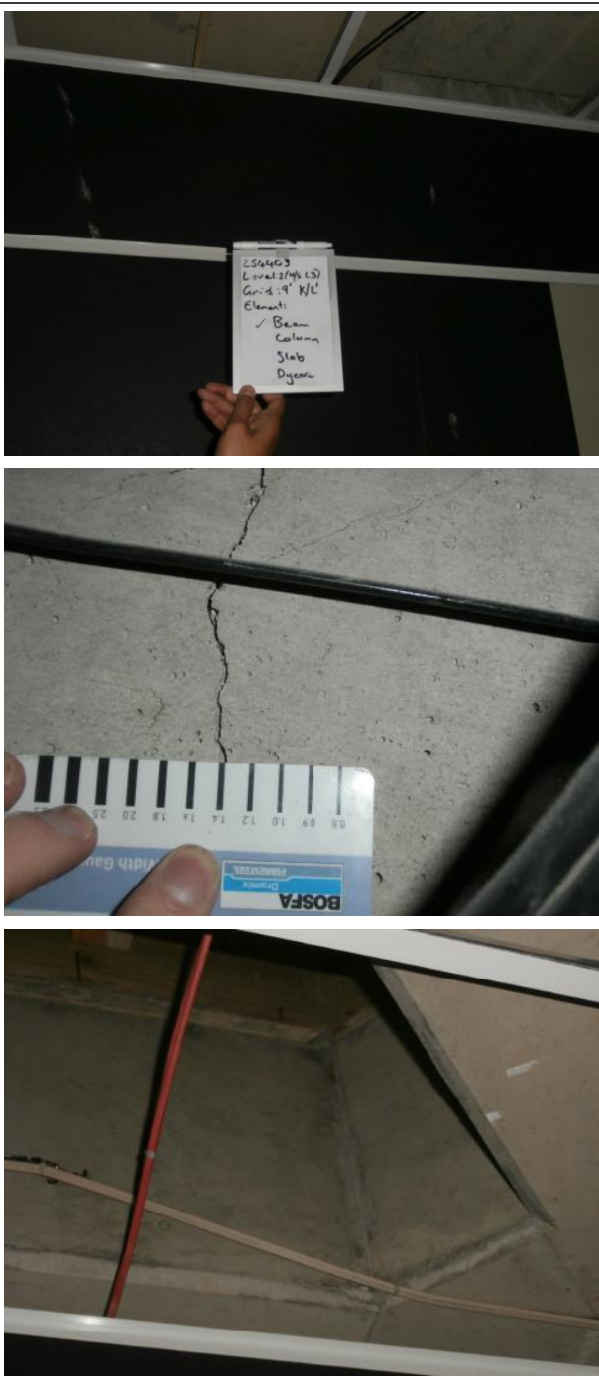
<p>127(d)</p>	<p>Elevation 9'- Grids between K to L'. B/C joints and beams underside of level 3 (Refer to Dycore plan for the reference)</p>	<p>A vertical crack, width of 1.4 mm in the beam. 1 mm wide crack underside of the Dycore at the beam-to- beam joint.</p>

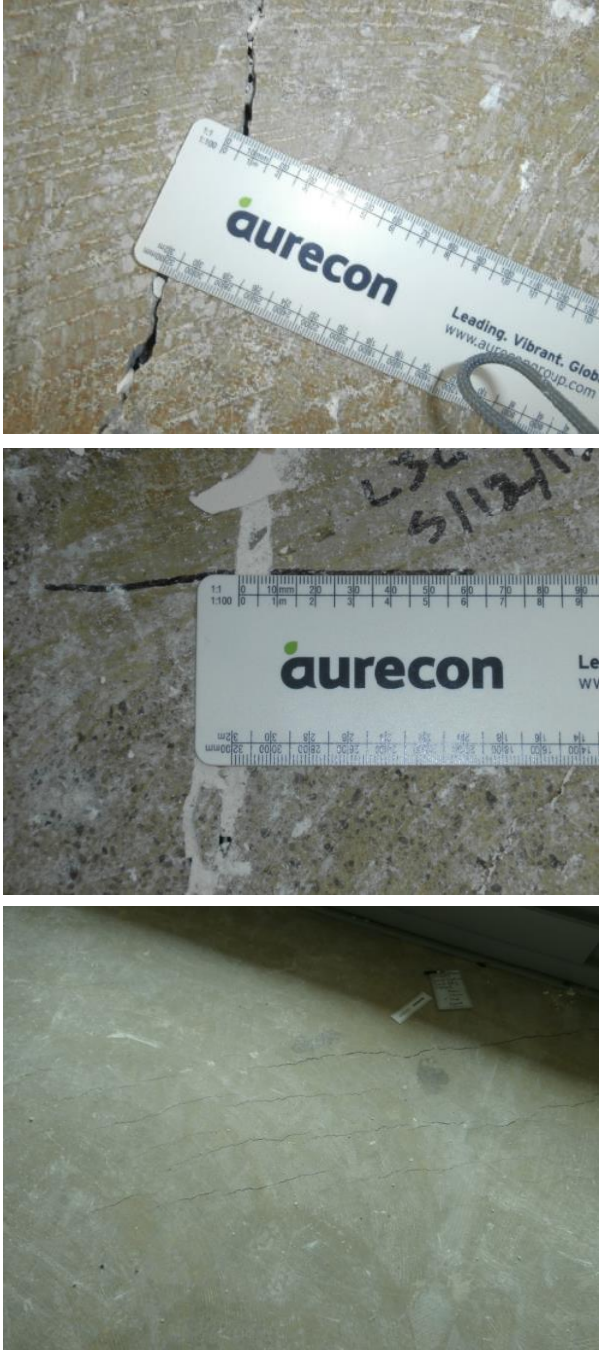
<p>144</p>	<p>Floor slab level 2. Grid numbers between KA-N and 1-2.</p>	<p>Diagonal cracks on the floor range from 1 mm to 1.4 mm wide. More cracks close to the corner column.</p> <p>Cracked concrete topping slab removed to inspect reinforcement. One bar of the mesh was fractured while another mesh bar and one saddle bar were</p>

<p>Some of the cracks vertically dislocated.</p> <p>A longitudinal crack of 5 mm wide along the grid line between KA/N and 2.</p> <p>A transverse crack width of 1.8 mm along the grid KA and between 1 to 2.</p>

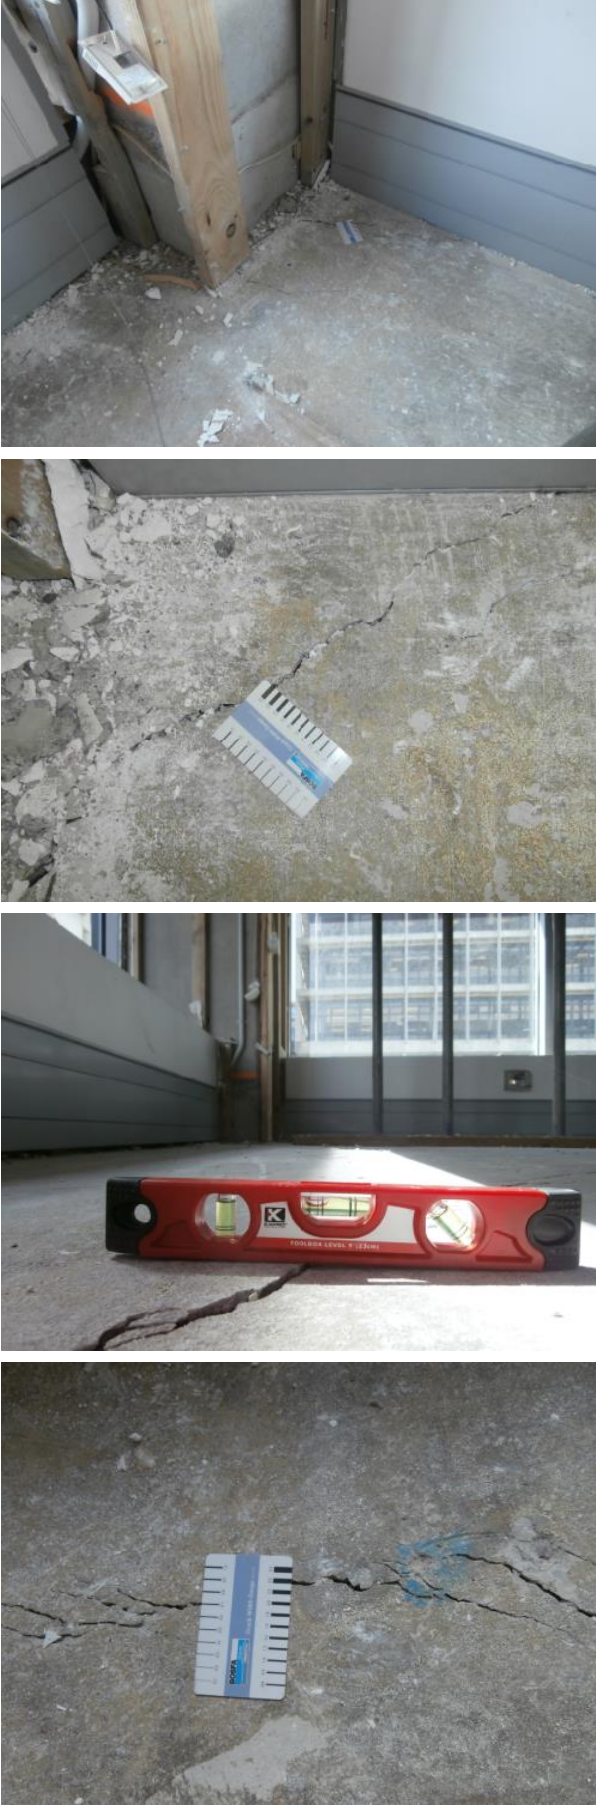
156	Floor slab level 2. Grid numbers between 10A-8A and A-B.	<p>Diagonal cracks on the floor range from 1.2 mm to 3.5 mm wide.</p> <p>More cracks around the corner column on grid 8A/A.</p> <p>Some of the cracks vertically dislocated.</p> <p>Longitudinal cracks 3.5 mm wide along the grid B between 8A and 10A.</p> <p>A transverse crack of 10 mm wide along the grid 10A between A and B</p>

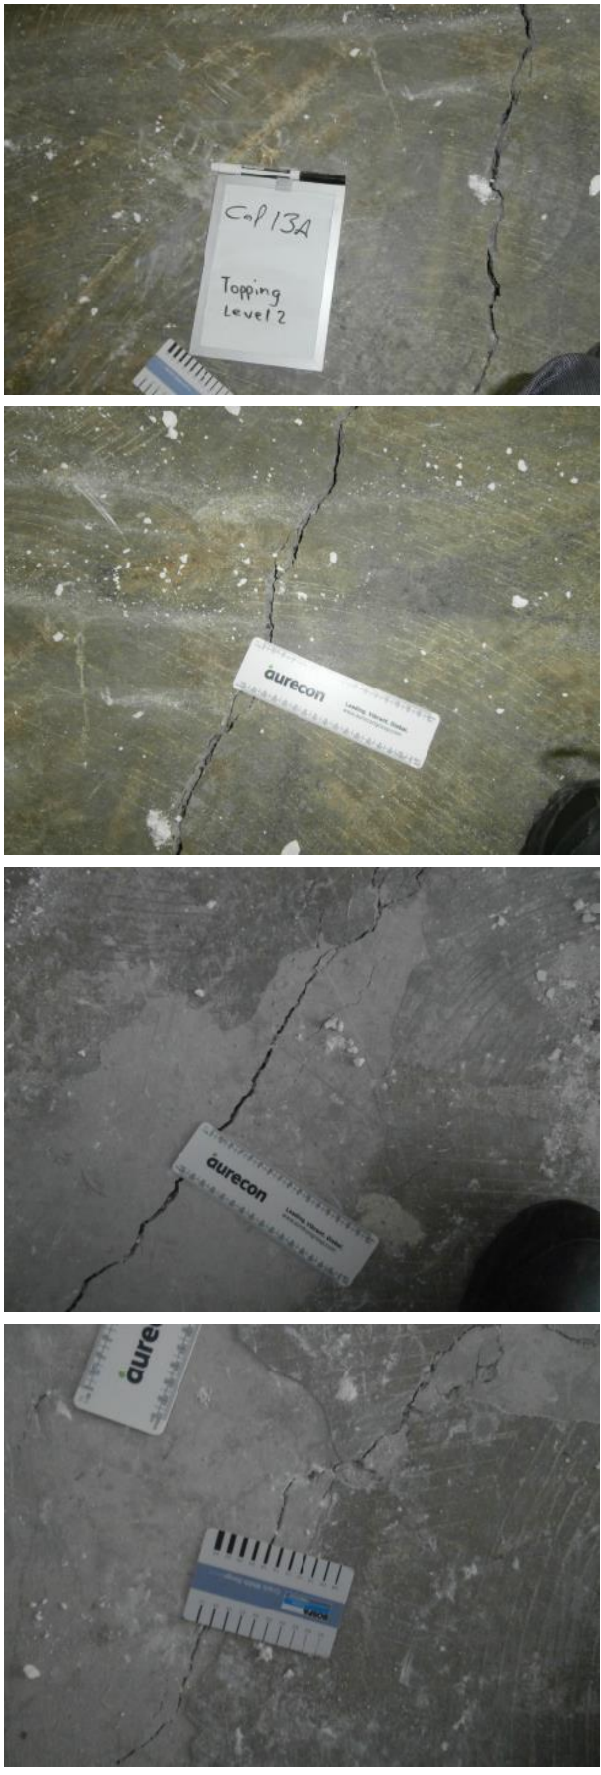
157	Floor slab level 2. Grid numbers between 10A-13 and A-B.	<p>Diagonal cracks on the floor range from 1.8 mm to 5 mm wide.</p> <p>More cracks around the corner column on grid 13/A.</p> <p>Some of the cracks vertically dislocated.</p> <p>A longitudinal crack 10mm wide along the grid B between 13 and 10A.</p> <p>A wide crack along the grid 10A between A and B. Concrete has been removed to inspect the slab reinforcement. Slab reinforcement fractured.</p>

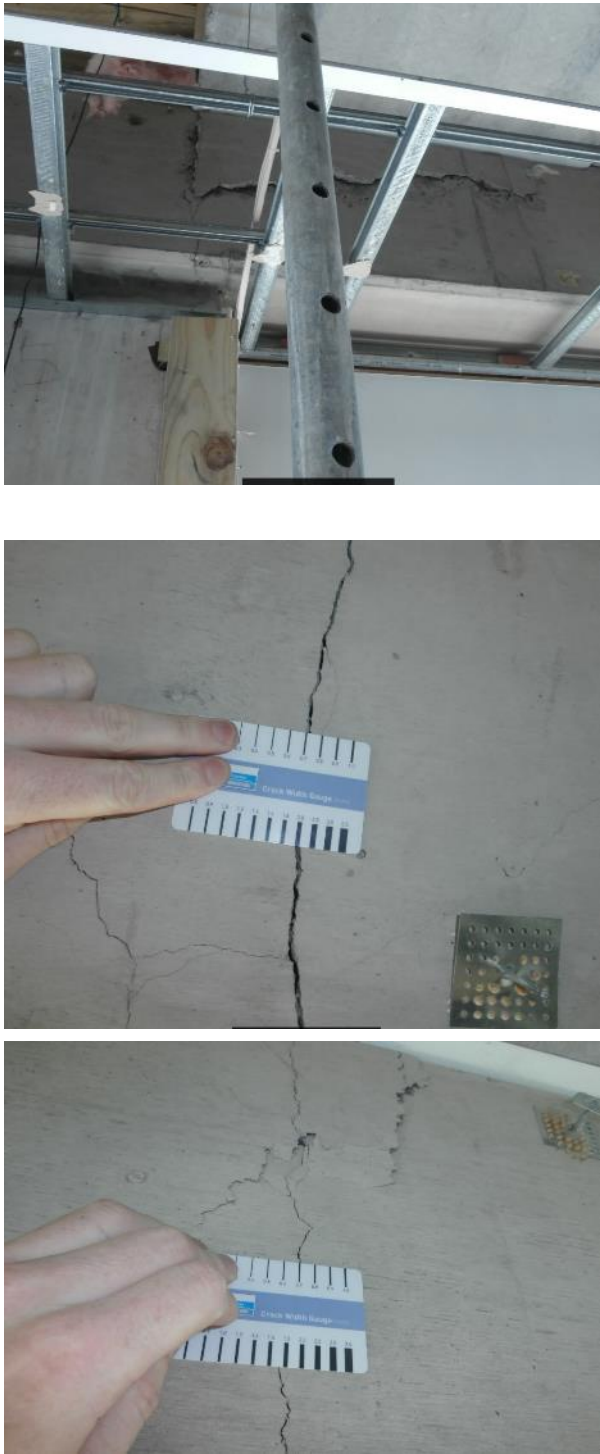
<p>159/160</p>	<p>Elevation 8A-Grid B. Beam column joint underside of level 4</p> <p>DS 1 2.0%</p>	<p>Combination of vertical and diagonal cracks in the plastic hinge region of the beam. Width of the vertical cracks are 2.5 mm. Diagonal cracks are approximately 0.5 mm wide.</p> <p>Beam damage, and loss of cover concrete.</p>

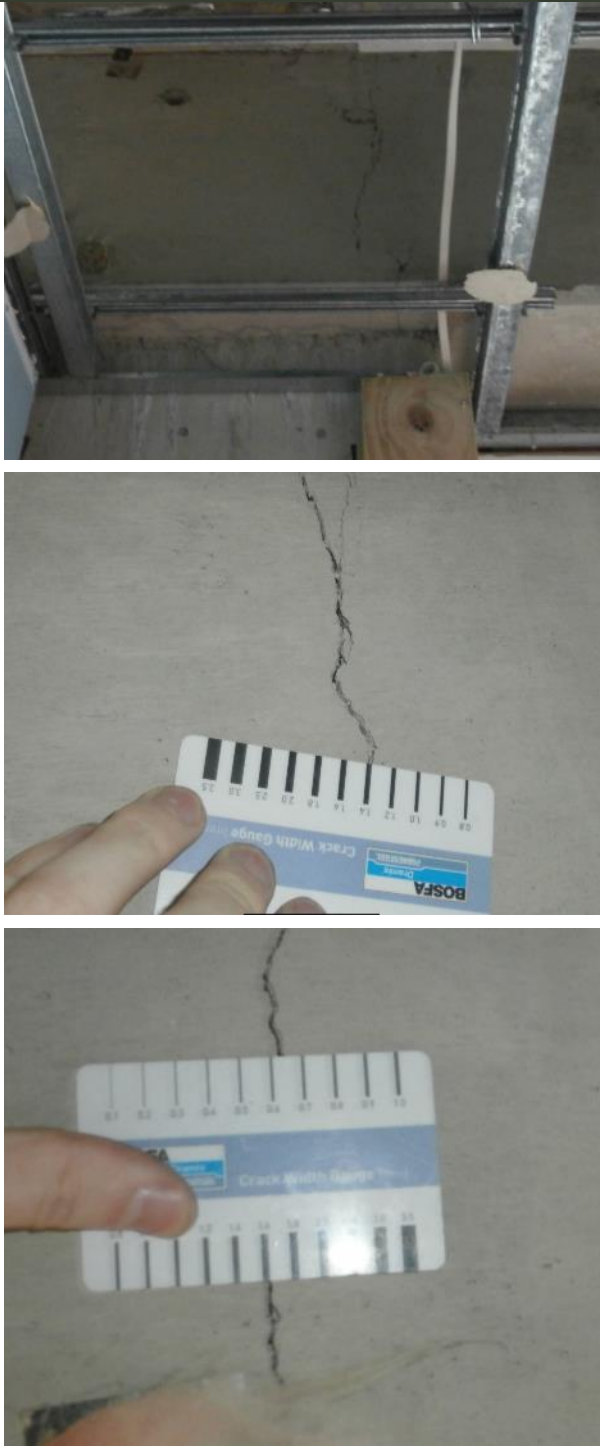
<p>161/162</p>	<p>Elevation 8A-Grid C. Beam column joint underside of level 4</p> <p>DS 1 2.0%</p>	<p>Vertical cracks in the beam column joint are 2.5 mm wide.</p> <p>Damage around the joint and spalling of concrete.</p>

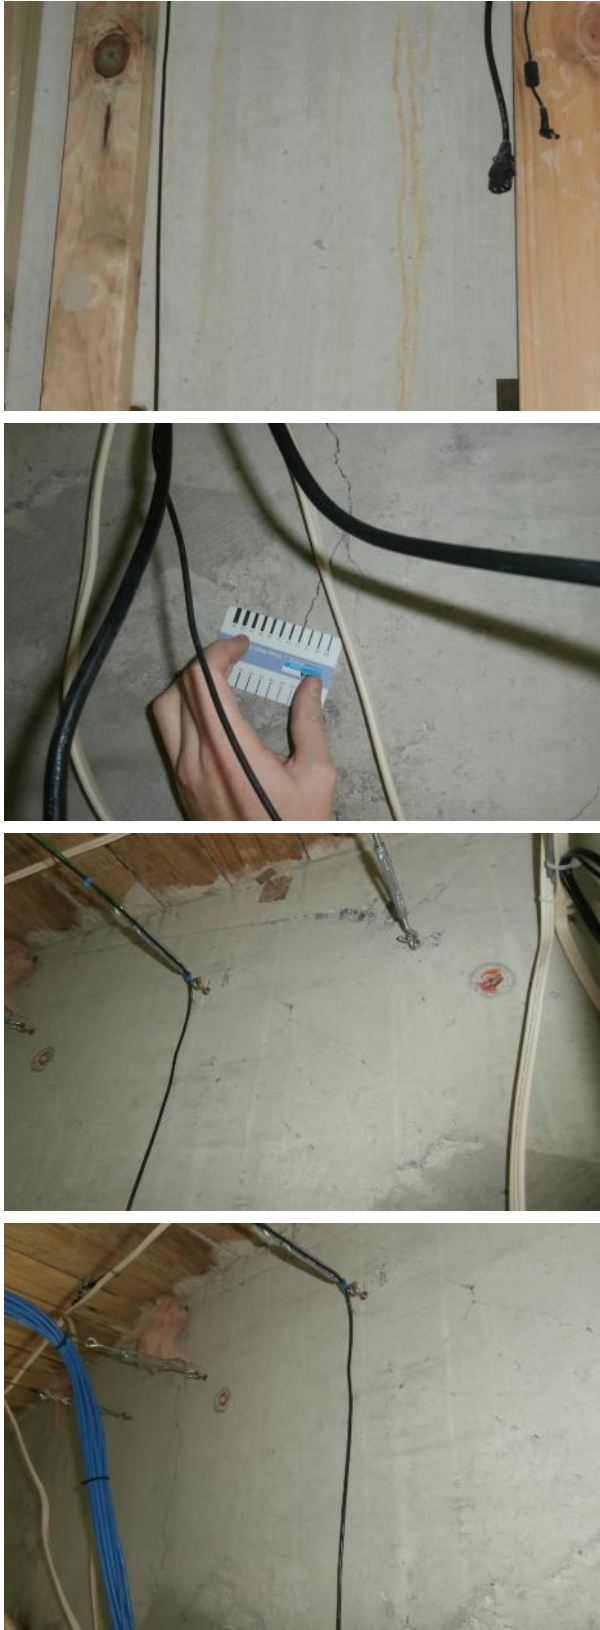
179/180	Elevation 1- Grid KA/N. Beam column joint underside of level 4 DS 0 1 %	Combination of diagonal and vertical cracks around the beam column joint. Width of the cracks range from 0.5-1.2 mm. Diagonal hairline cracks in the column. Approximately 8 hairline cracks along the beam length.

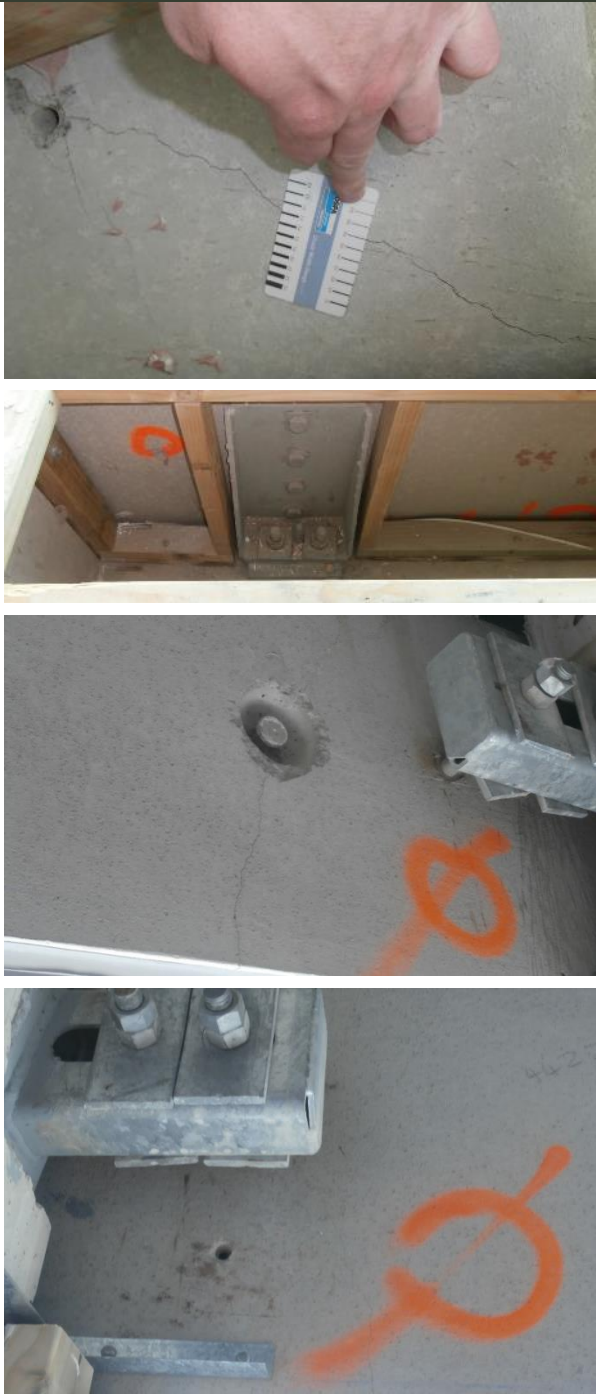
359	Elevation N, Grids between 10-11. Precast façade panels in level 3.	Diagonal cracks between 0.2mm to 0.3mm wide around the bottom connections and in the panel.

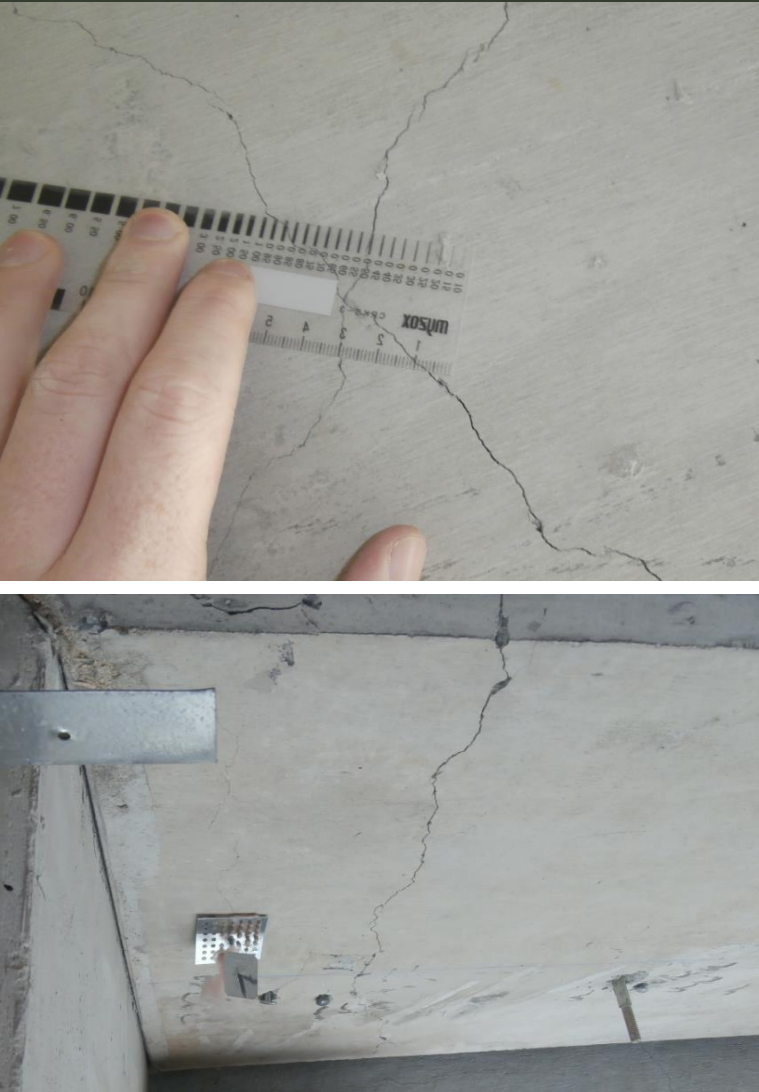
<p>384/3 85</p>	<p>Elevation 1-Grid KA/N. Beam column joint underside of level 3</p> <p>DS 0 1 %</p>	<p>Diagonal hairline cracking in column.</p> <p>Diagonal cracking in each side of beam column joint spreading out into beam 0.2-1.5 mm wide.</p> <p>6 hairline cracks along beam span.</p>

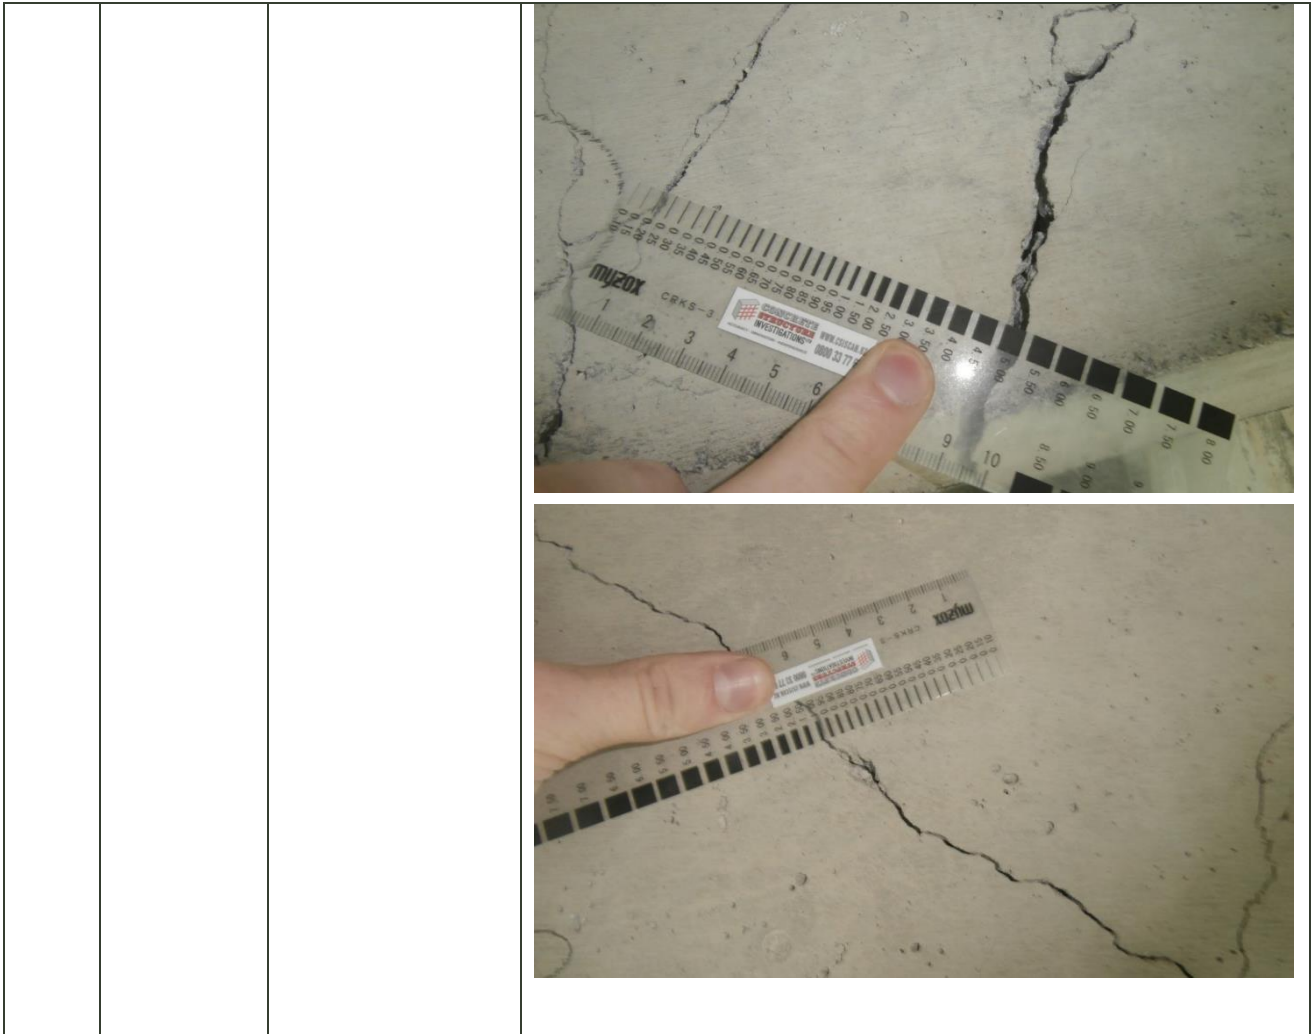
<p>395</p>	<p>Elevation HA-Grid 8A. Beam column joint underside of level 5 DS 1 2.0%</p>	<p>Vertical crack at column face approx. 2 mm.</p>
