Resilient Repair Guide Source Report: Case Study Annex

APPLIED TECHNOLOGY COUNCIL
201 Redwood Shores Parkway, Suite 240
Redwood City, California 94065
www.ATCouncil.org

FEDERAL EMERGENCY MANAGEMENT AGENCY
Michael Mahoney, Project Officer
William T. Holmes, Technical Monitor
Washington, D.C.

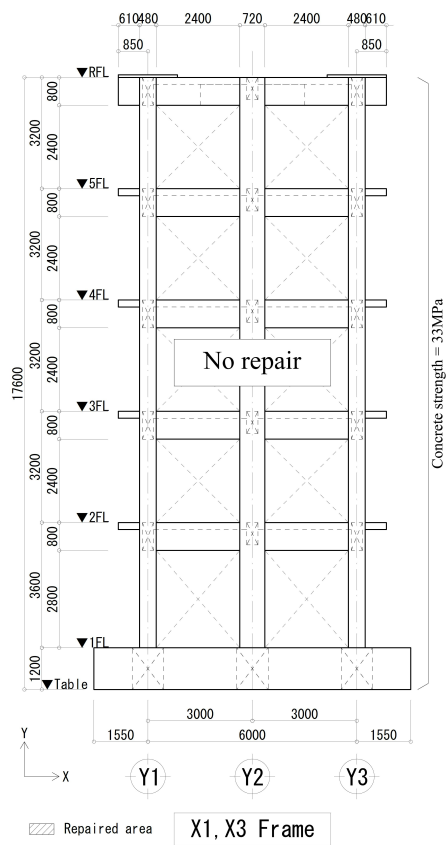
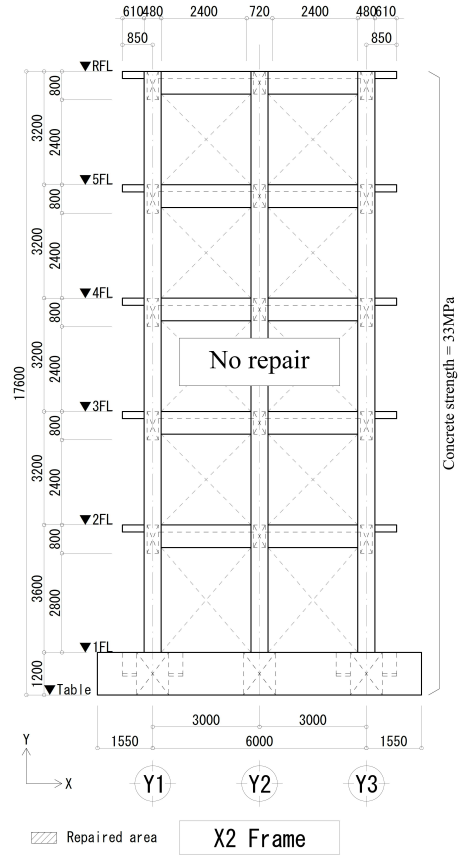
Figure 3-4(cont) Repaired area in test building.

Figure 3-4 illustrates the areas where the repair was applied. Each beam, column and beam-column joint was repaired up to the third floor level. On the fourth floor level, beams were repaired only at the critical section, and beam-column joints were repaired in the same way as the lower floors. Due to the time restriction between tests, the fourth and fifth stories were not repaired. As the drift demands in these stories were less 1.0% during the previous Runs, it was deemed acceptable to leave these stories un-repaired.

The concept of the repair was to determine the ability of a simple repair methodology to recover the original structural capacity. In this test, the specimen was repaired with epoxy injection and mortar patching. The scope of the repair was the plastic hinge zone of each component and beam-column joints. In order to simplify the repair work, the plastic hinge length of each member was defined as 1.0 m from the face of the beam-column joint. However, repair was not always contained to this 1.0 m distance because if the cracks straddle the plastic hinge region, the epoxy resin also penetrated into the cracks out of this range.

The repair technique was able to inject down to 0.05 mm cracks. Therefore, basically all the cracks in the plastic hinge zone and the beam-column joint were repaired.

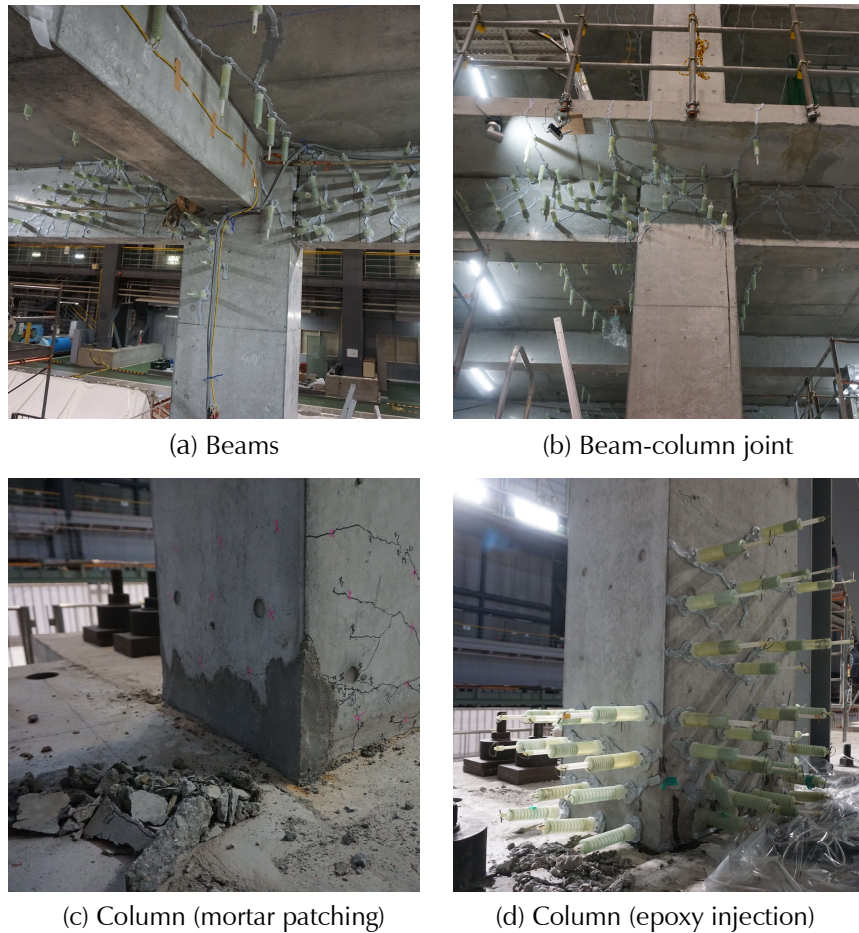
Figure 3-5 Epoxy injection and mortar patch.

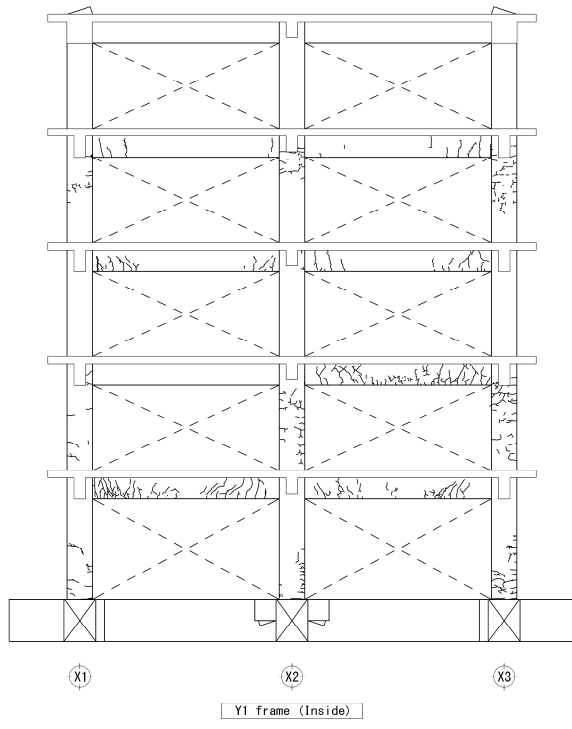
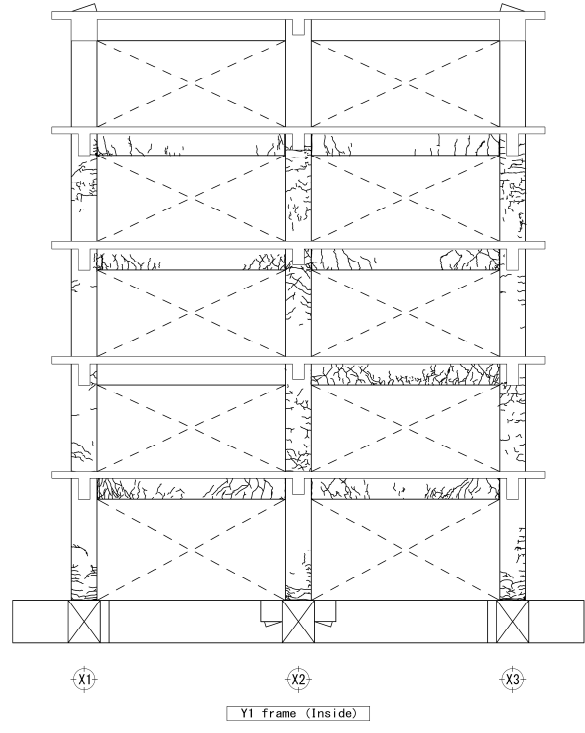
Figure 4-3 shows crack patterns observed in the test and Figure 4-4 shows maximum residual crack width in the test. Crack width highlighted represents crack width exceeding DS1 crack width criterion (1.5 mm). In the Figure 4-4, story drift demand measured in the test and story drift estimated with the fragility function is also shown. Damage State shown in the joints are estimated by taking the maximum Damage State of beams and columns around the joint. Median story drifts of each joint’s Damage States were then averaged at each floor level. This averaged drift was taken as the estimated story drift demand. As seen, the figure indicates that story drift demands per fragility function reasonably correlates with measured story drift demands in the test.

Figure 4-3 Crack patterns of the Y1 frame.

Table 4-2 summarizes the degree of damage and damage state of each excitation. The specimen was observed only after Run 2 and Run 3, since no damage from Run 1 was observed. In Run 2, maximum crack width of 0.8mm was observed in the beam in the third story (3GX1). As no other damage except this light cracking was observed, the damage state of Run 2 was classified as DS0. In Run 3, a maximum crack width of 5.0mm was measured in the beam in the third story (3GX1), and some minor spalling was also observed. Based on this damage the damage state of Run 3 was determined as DS1.

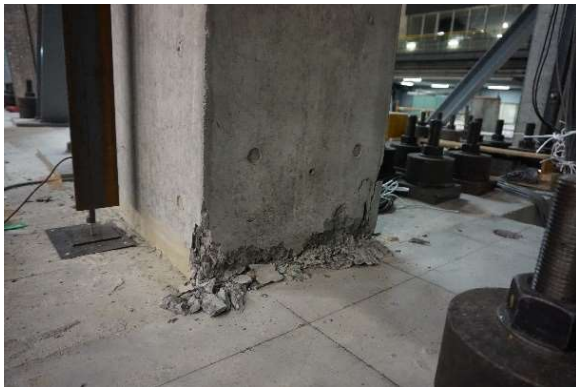
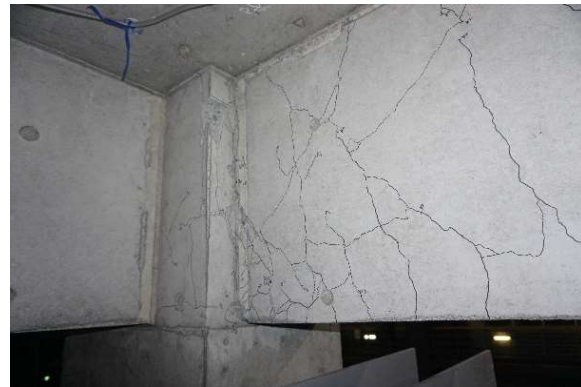
Figure 5-12 shows photos of damaged members during Run 4, and supplemental damage photos are provided in Figure J-1. After Run 4 (125%), the specimen reached the mechanism of the structure. The cracks occurred mainly in the plastic hinge zone of the members forming plastic hinges. Only minor spalling was observed on the bottom of the columns in 1st story and plastic hinge zone in the beams. There was no severe spalling or crushing of core concrete, so it does not appear that bar buckling occurred with Run 4. Overall, this specimen passed the Concentrated damage check and goes to Serviceability assessment.

Figure 5-12 Damage occurred during Run 4.

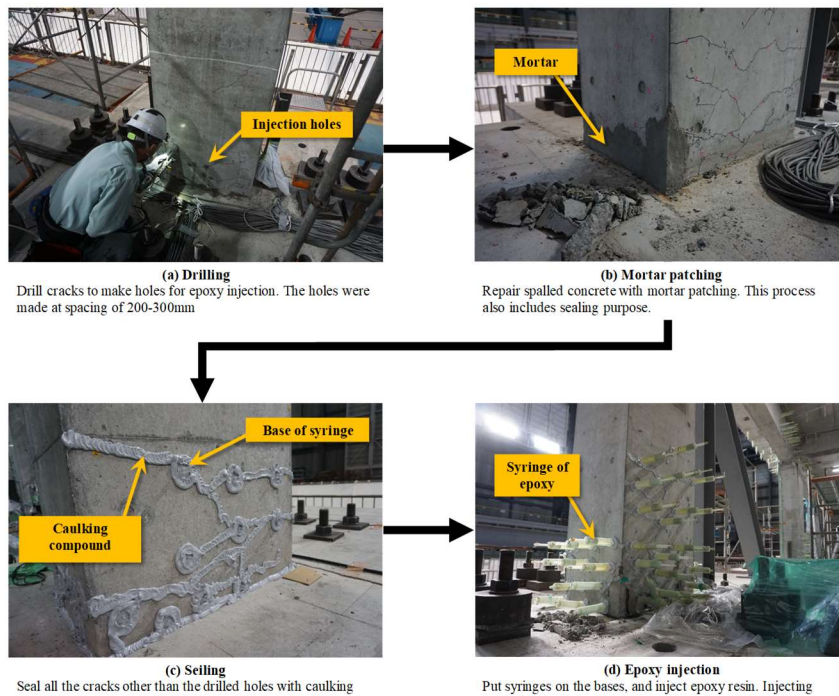
Figure A-1 Repair process.

Figure A-1 describes repair process applied to the test building. After the building was damaged, initially, cracks were drilled to make holes to inject epoxy resin (Figure A-1 (a)). Then all the cracks other than the drilled holes and spalled area were sealed with caulking compound and mortar not to get leaking of epoxy and put base of syringes (Figure A-1 (b-c)). Set syringes on the bases and inject epoxy resin into cracks. The design injecting pressure was $0.06 \pm 0.01 \text{ N/mm}^2$. Figure A-2 shows those repair process on each component.

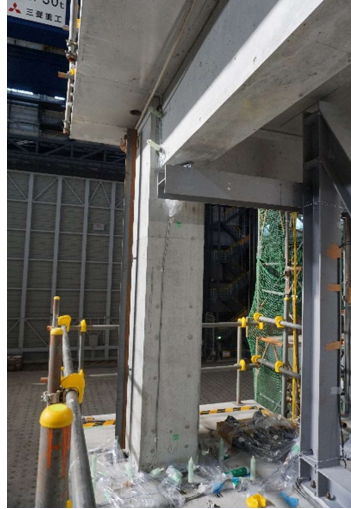
4FL X1Y1

Figure A-2 Photos of epoxy injection.

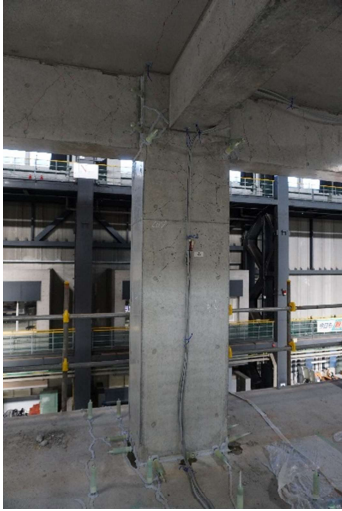
4FL X2Y3

Figure A-2(cont) Photos of epoxy injection.

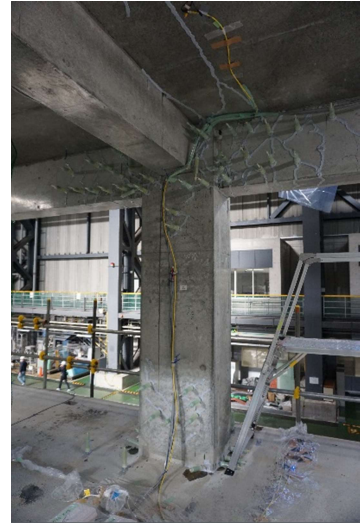
3FL X3Y2

Figure A-2(cont) Photos of epoxy injection.

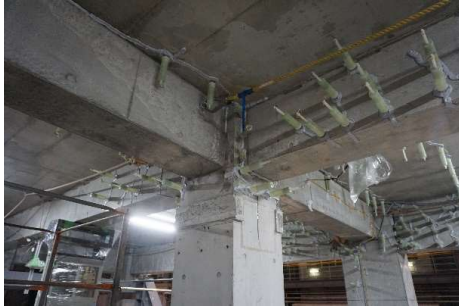
2FL X1Y2

Figure A-2(cont) Photos of epoxy injection.

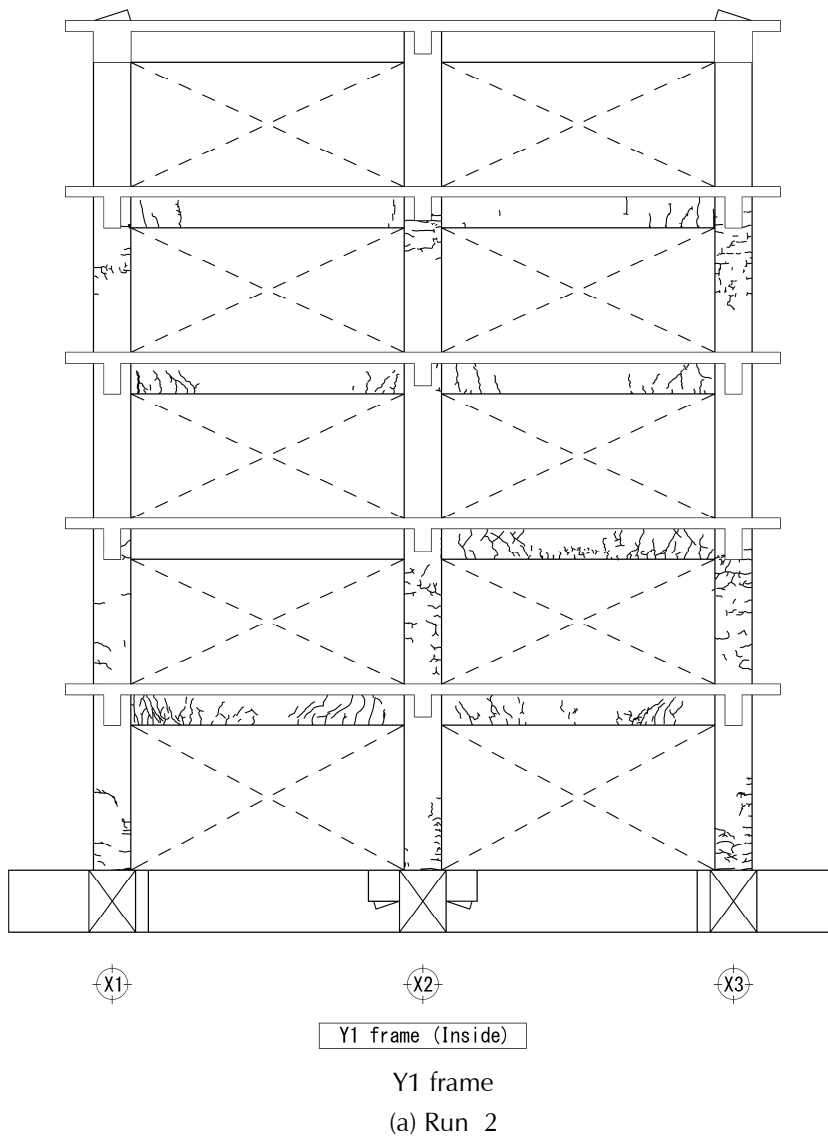
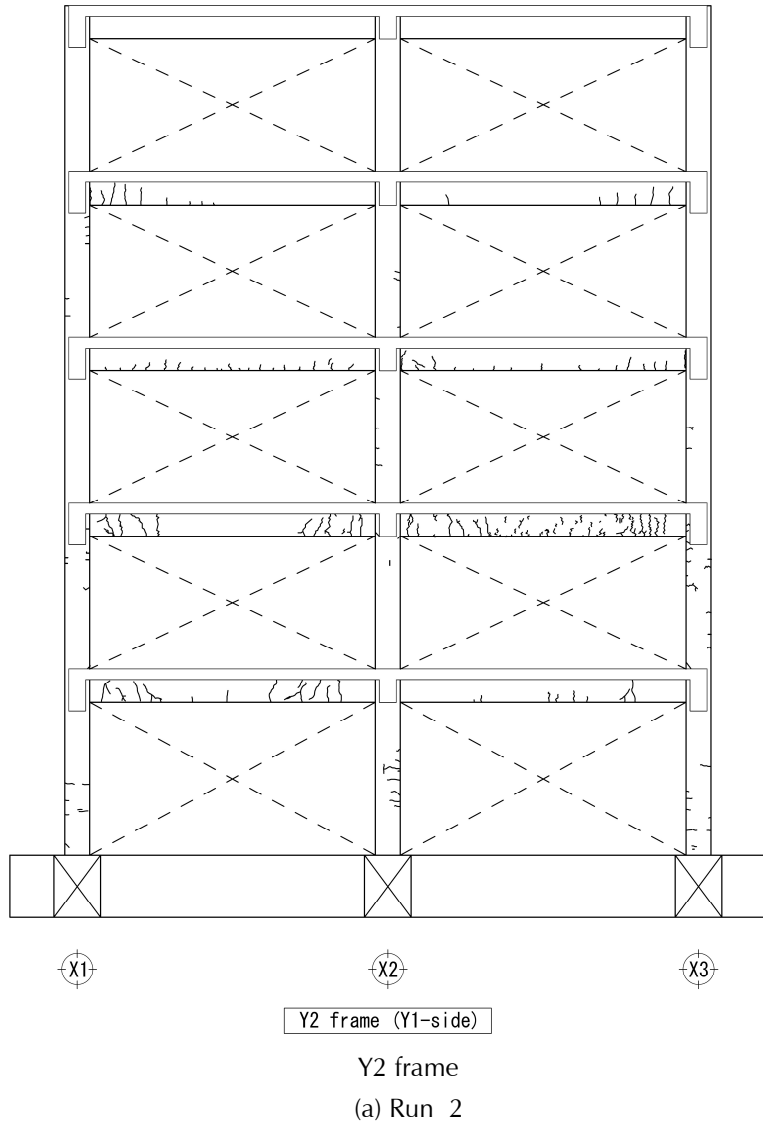
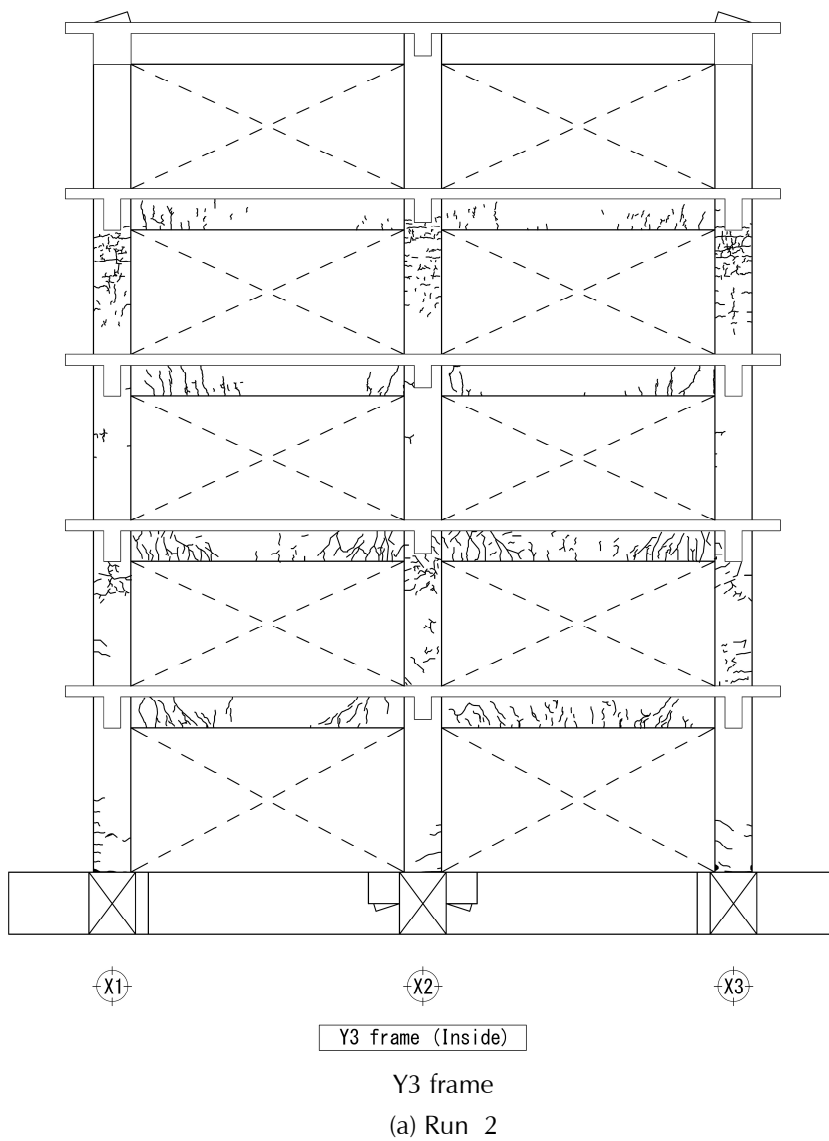
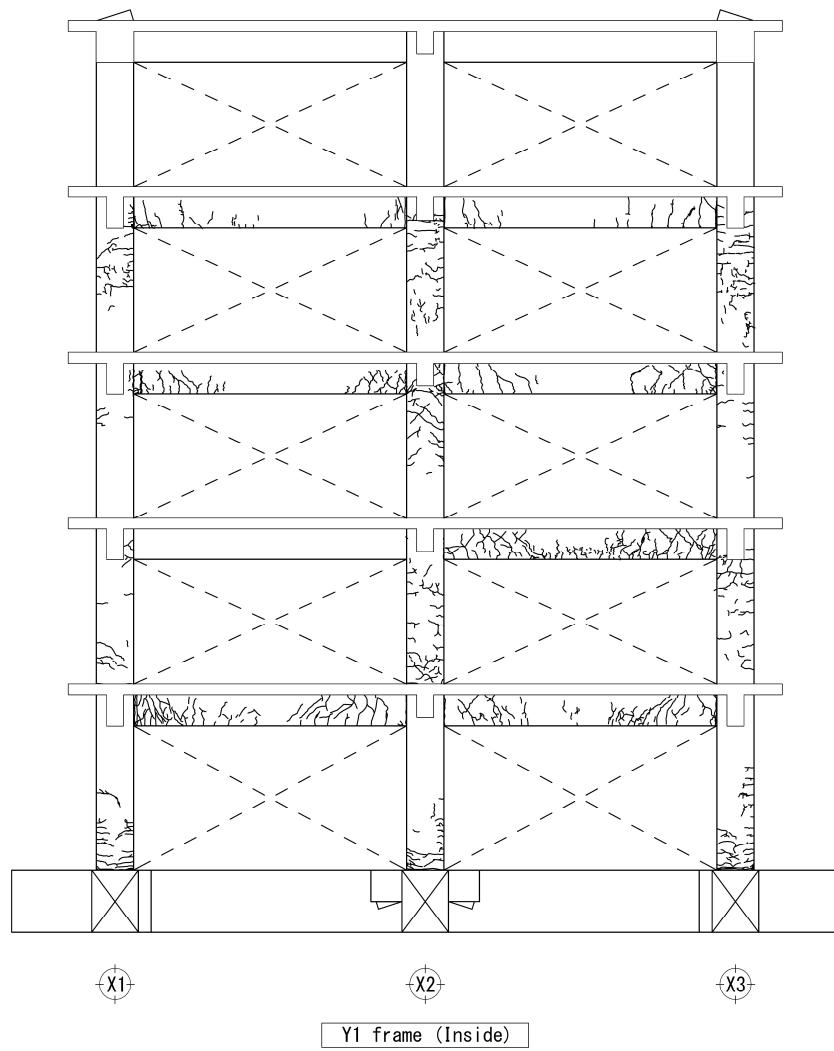
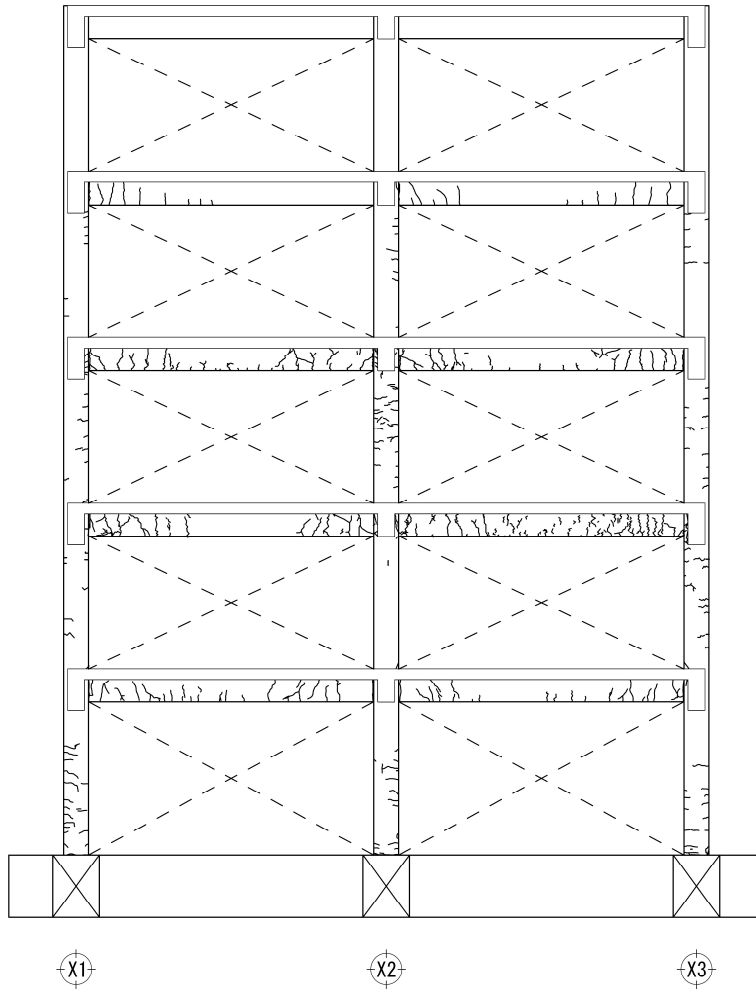
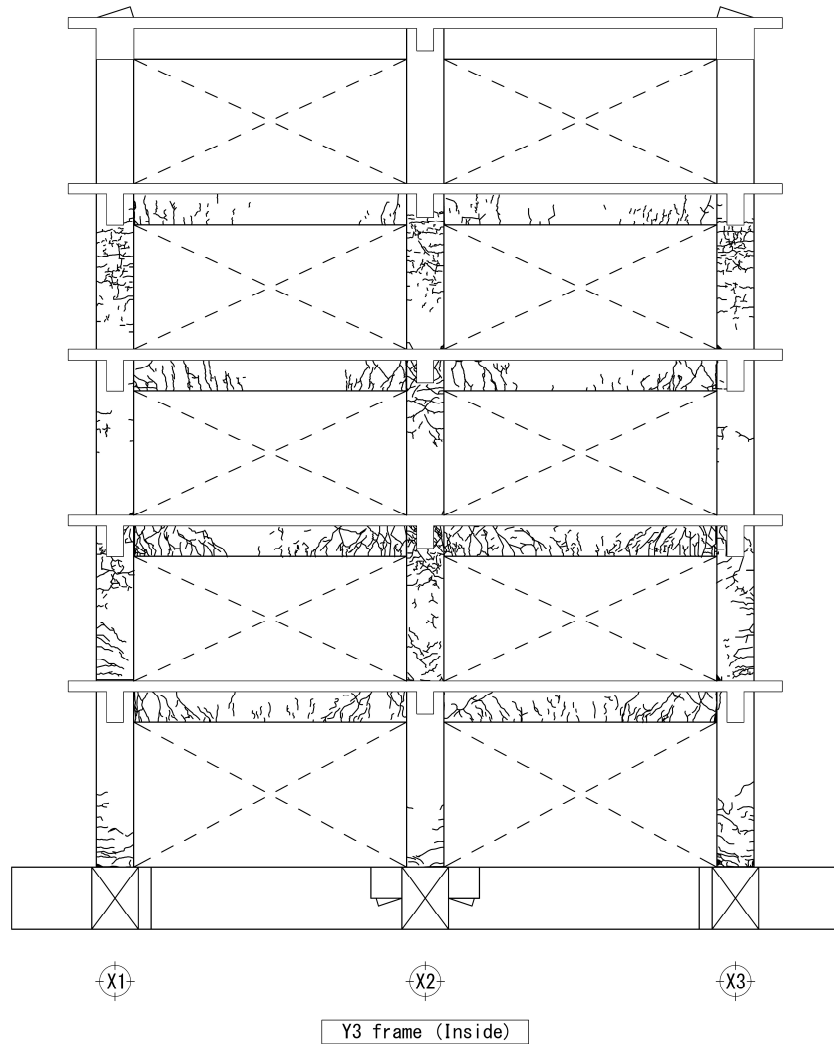
Figure D-1 Crack patterns.

Figure D-1 shows crack mapping of the original specimen after Run 2 and Run 4.

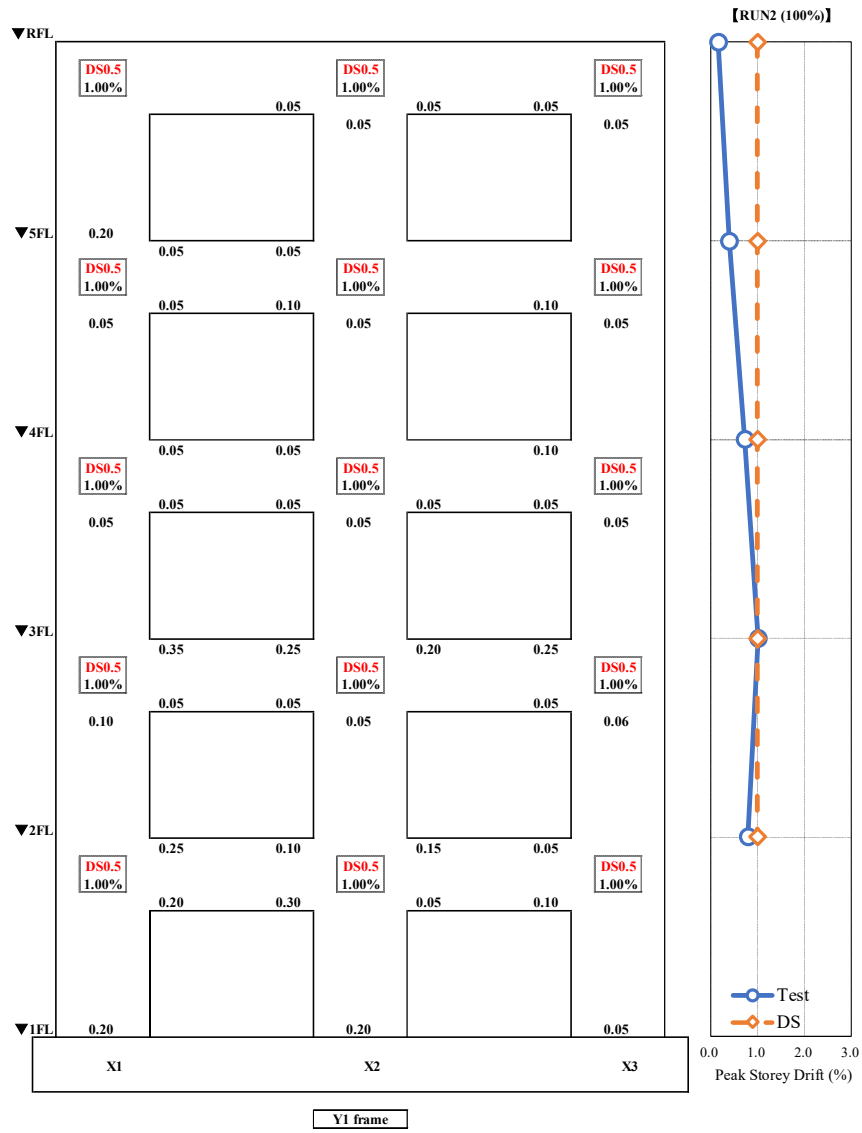
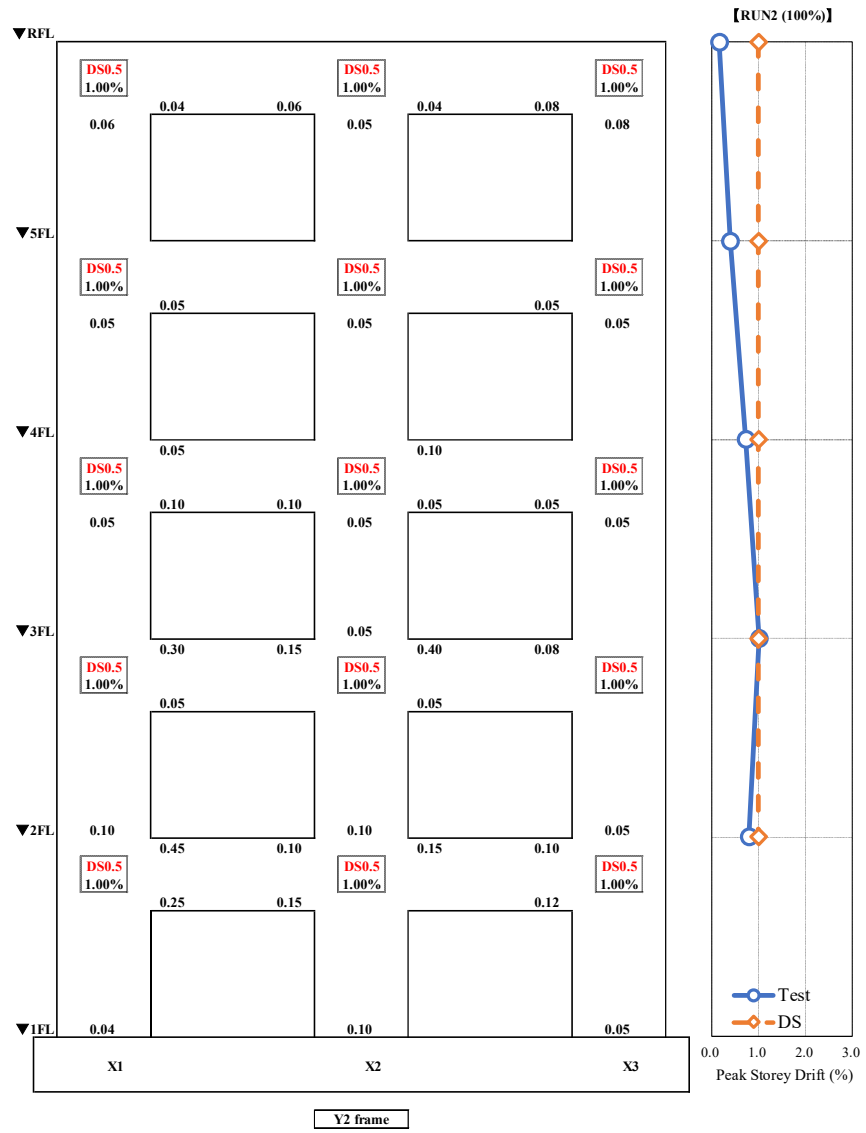
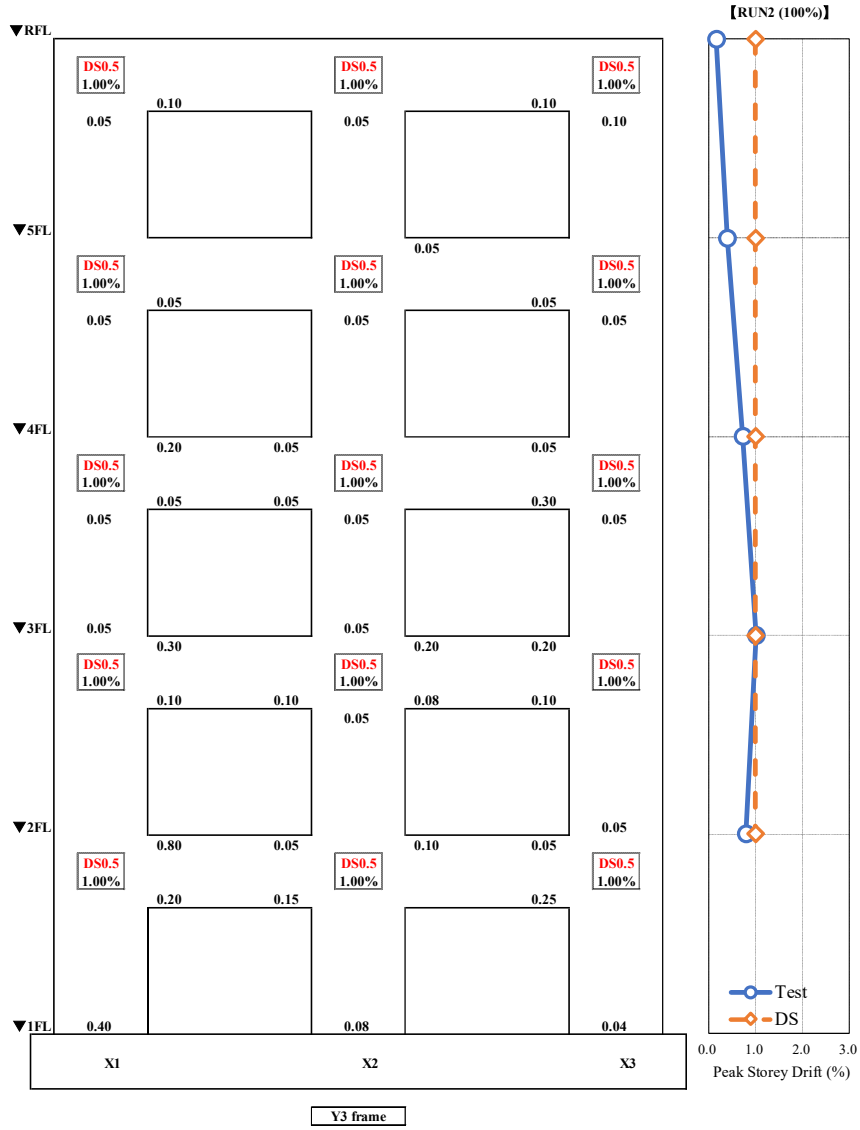
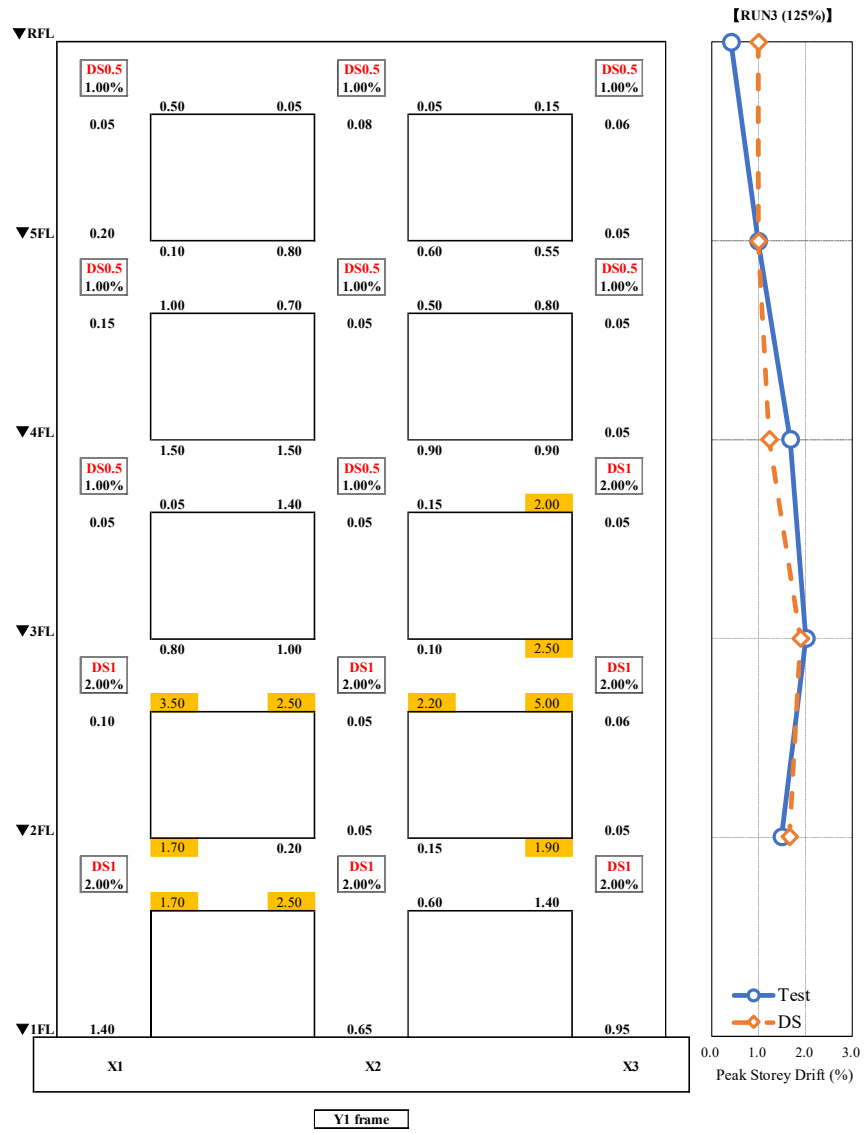
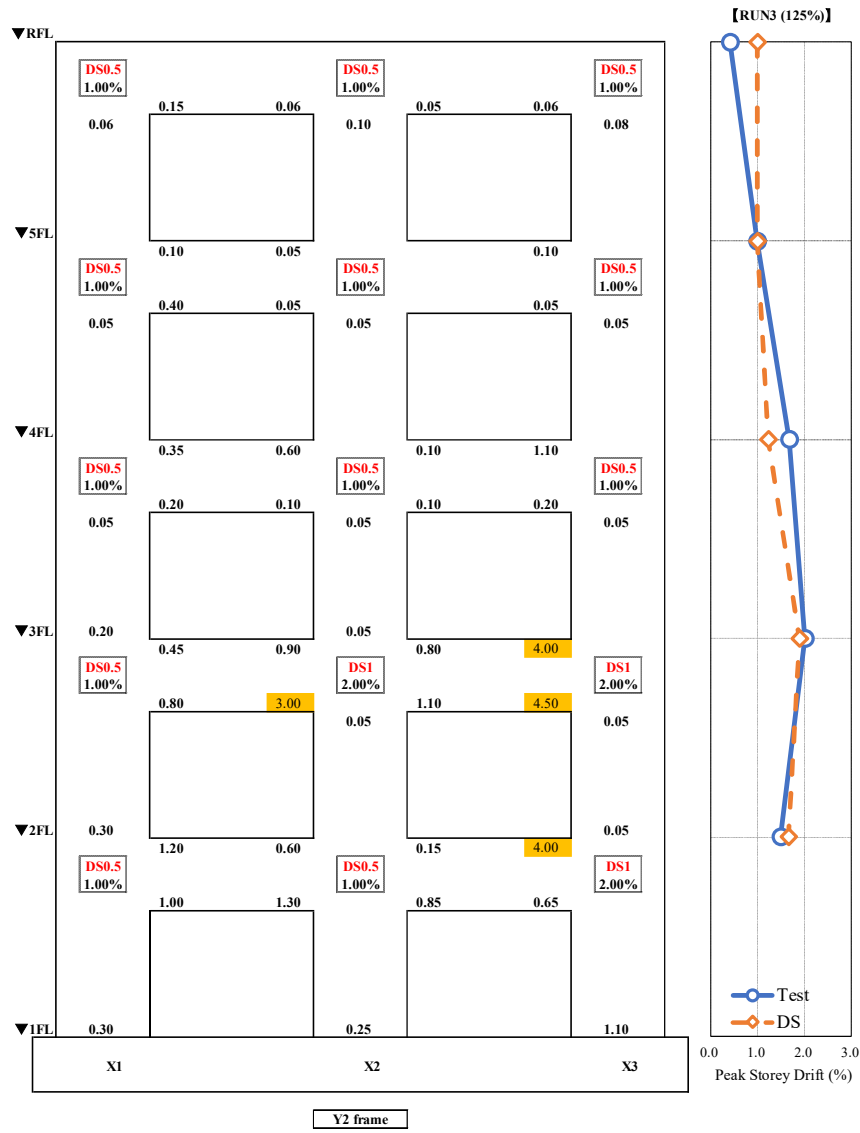
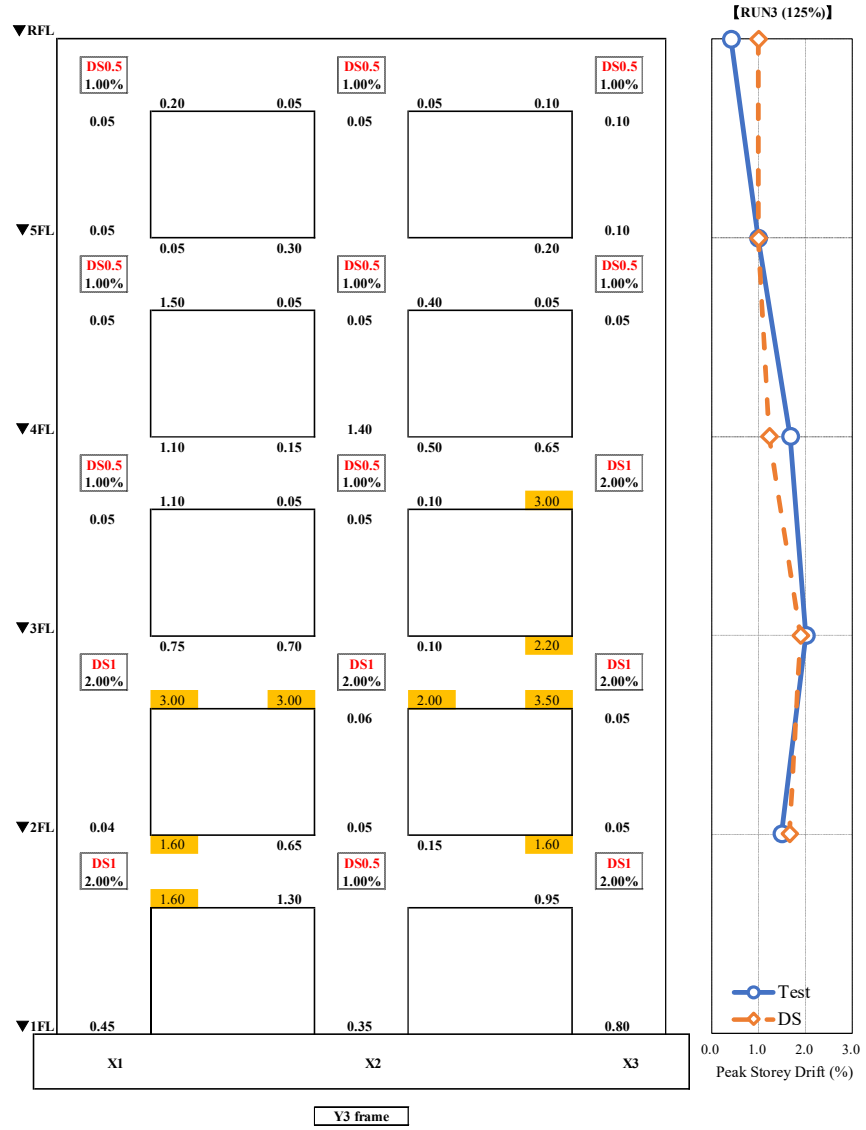
Figure D-2 shows the maximum residual crack width in Run 2 and Run 3, and story drift demand measured in the test and averaged median story drift estimated with Damage State.

Figure D-2 Maximum residual crack width. Crack width colored represents crack width exceeding DS1 criterion (1.5mm).

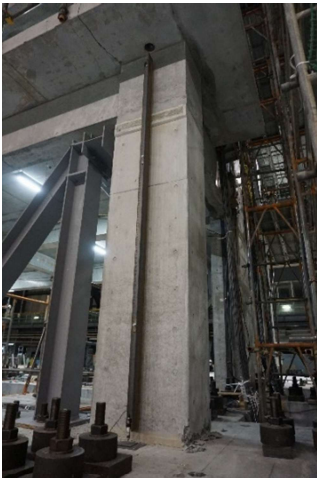
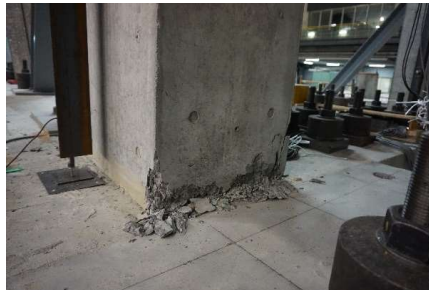
Column 1F X3Y1

Figure J-1 Damage photos after Run 4.

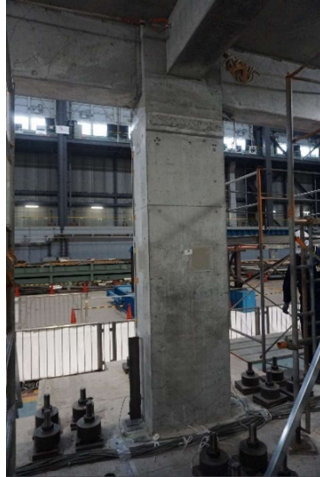
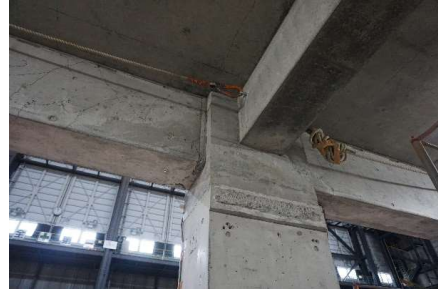
Column 1F X2Y1

Figure J-1(cont) Damage photos after Run 4.

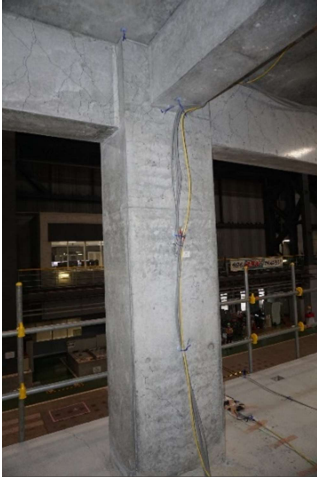
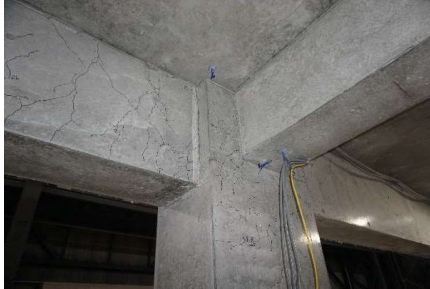
Column 2F X2Y3

Figure J-1(cont) Damage photos after Run 4.

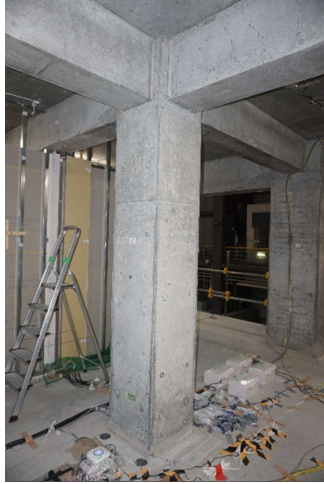
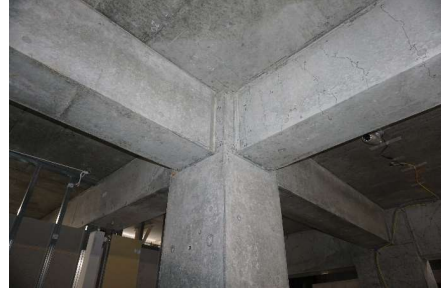
Column 2F X2Y2

Figure J-1(cont) Damage photos after Run 4.

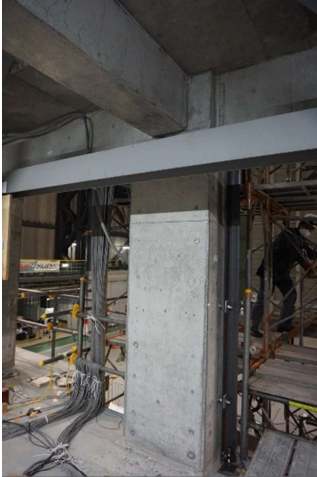
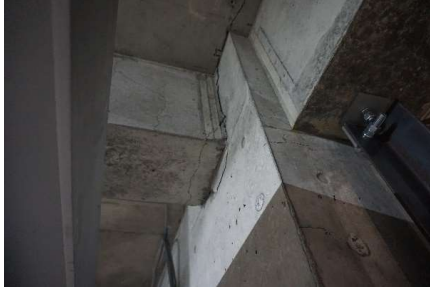
Column 2F X3Y2

Figure J-1(cont) Damage photos after Run 4.

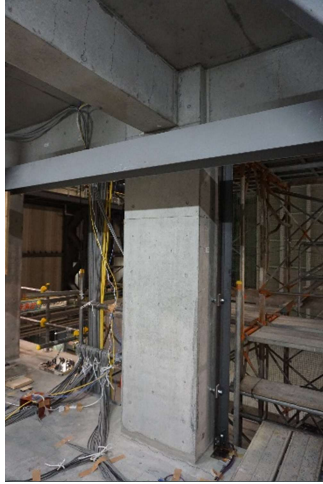
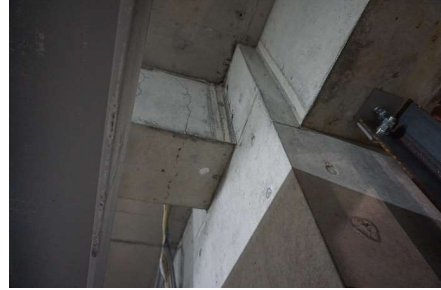
Column 3F X3Y2

Figure J-1(cont) Damage photos after Run 4.

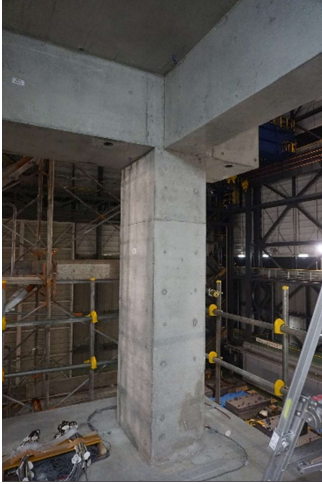
Column 5F X3Y1

Figure J-1(cont) Damage photos after Run 4.

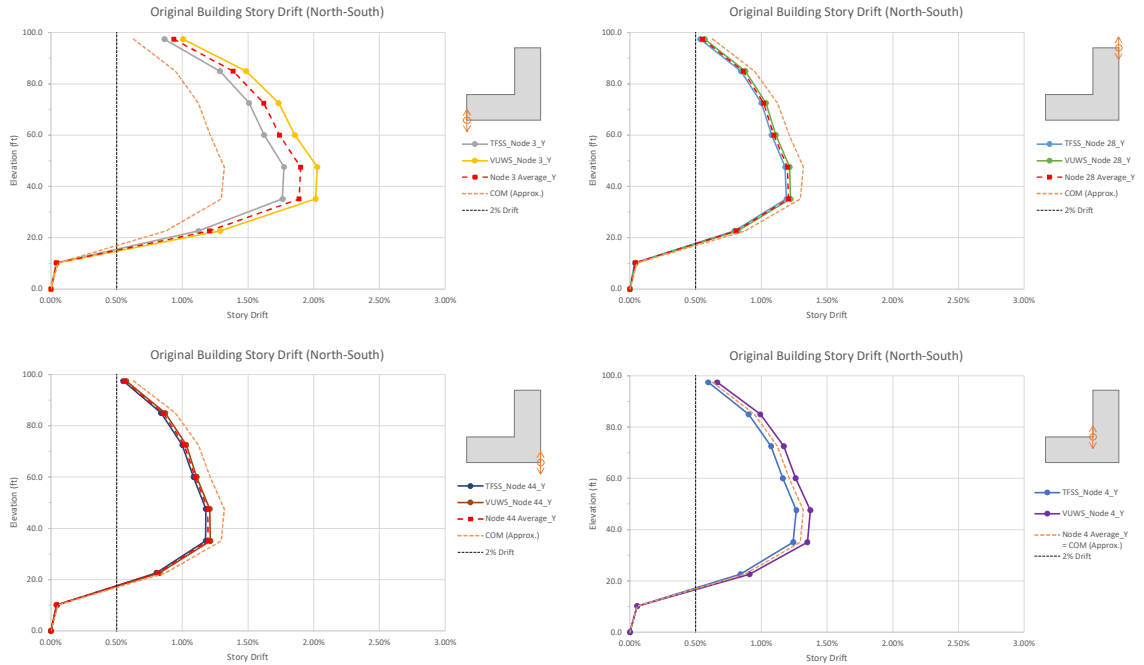
Figure 4-2 Drift estimates in the north-south direction due to the Damaging Earthquake.

Drift estimates at four column lines – identified in Figure 4-1 – around the perimeter of the building are presented in Figure 4-2 and Figure 4-3.

Consistent with the visual observations presented in section 4.1.1, maximum average drifts were estimated to occur in the short moment frame bays at the ends of the L-shaped floor plate (grids A and 1, approaching 2%). This suggests a torsional response, as the average drift demands on the four perimeter moment frames were less than 1.5%.

Using the results from the Inspection and Analysis phase, a system-level check is performed to determine if amplification in drift demand during a repeated design-level ground motion is anticipated. The adopted drift demand threshold in the Source Report is 2% story drift. As shown in Figure 4-2 and Figure 4-3, for all perimeter frames, the max drifts, averaged between TFSS and VUWS excitation response, were below 2% story drift, and therefore, meet the system-level safety check.

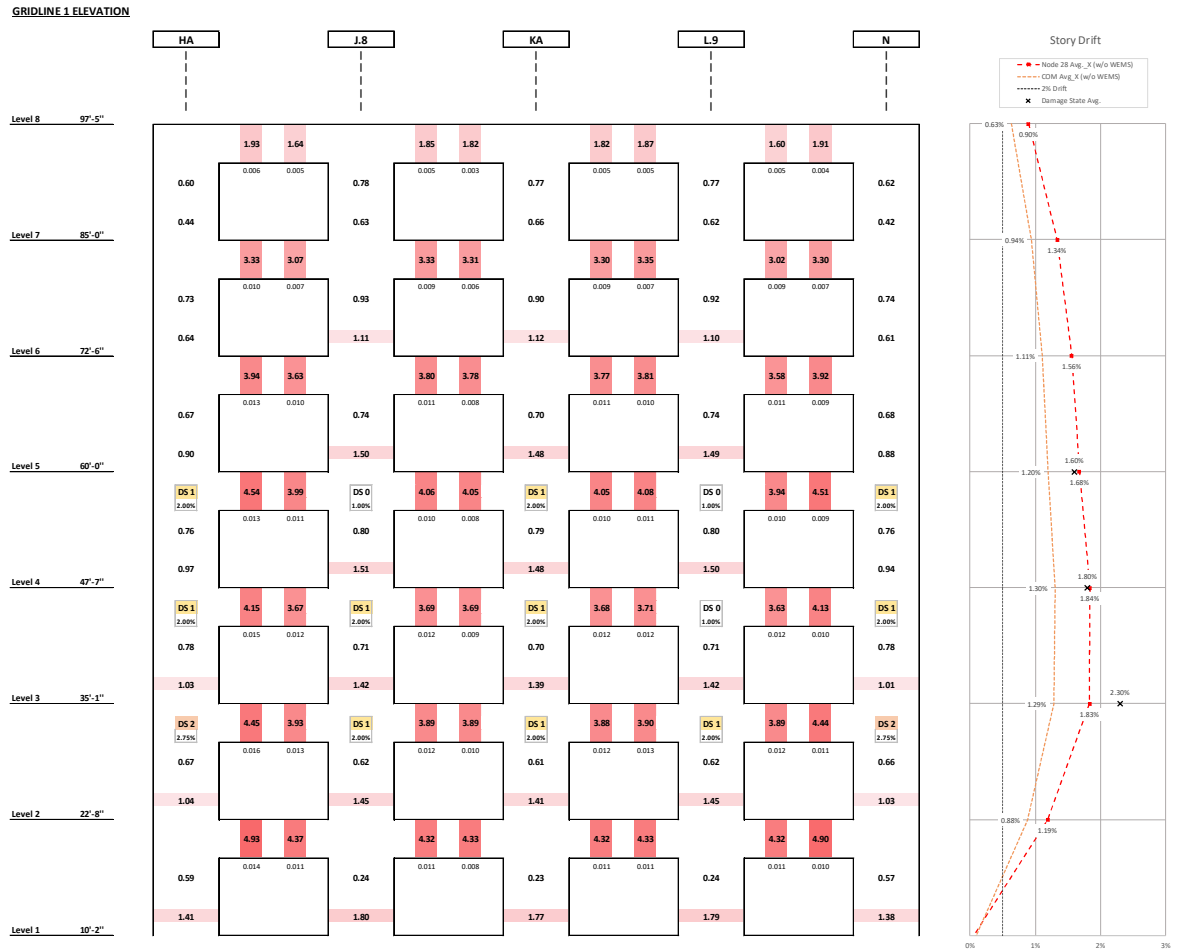
Figure 4-6 Gridline 1 damage elevation.

The maximum ductility factor at each beam and column end for each spectral analysis were averaged together and overlaid on moment frame elevations. A detail key for a single frame joint is presented in Figure 4-5. The frame elevation along Gridline 1 is presented in Figure 4-6 with the balance of perimeter moment frame elevations provided in Appendix B. Note that published damage inspection observations were only available for Levels 3, 4 and 5. Additionally, the interior gravity moment frame was found to not significantly contribute to the lateral response of the building. Therefore, the DCR and Inspection Location checks have only been performed at the perimeter moment frames where observations were available. Damage States and inspection findings are further discussed in Section 4.1.7.

The analysis reported lower ductility demands than the Primary Life Safety acceptance criteria provided by ASCE/SEI 41. This suggests that significant strength degradation is unlikely to have occurred in the building. Still, at least one round of reconciliation between observation and analysis results is recommended to improve correlation.

The Source Report (ATC, 2020) recommends a plastic mechanism check to identify additional inspection locations that may not be captured during the initial analysis. However, based on the damage elevations and regular frame layout, the additional check was not needed to identify additional locations for inspections. The beam DCRs from the analysis being consistently and significantly larger than the column DCRs, indicative of a sway mechanism (e.g., Figure 4-6.)

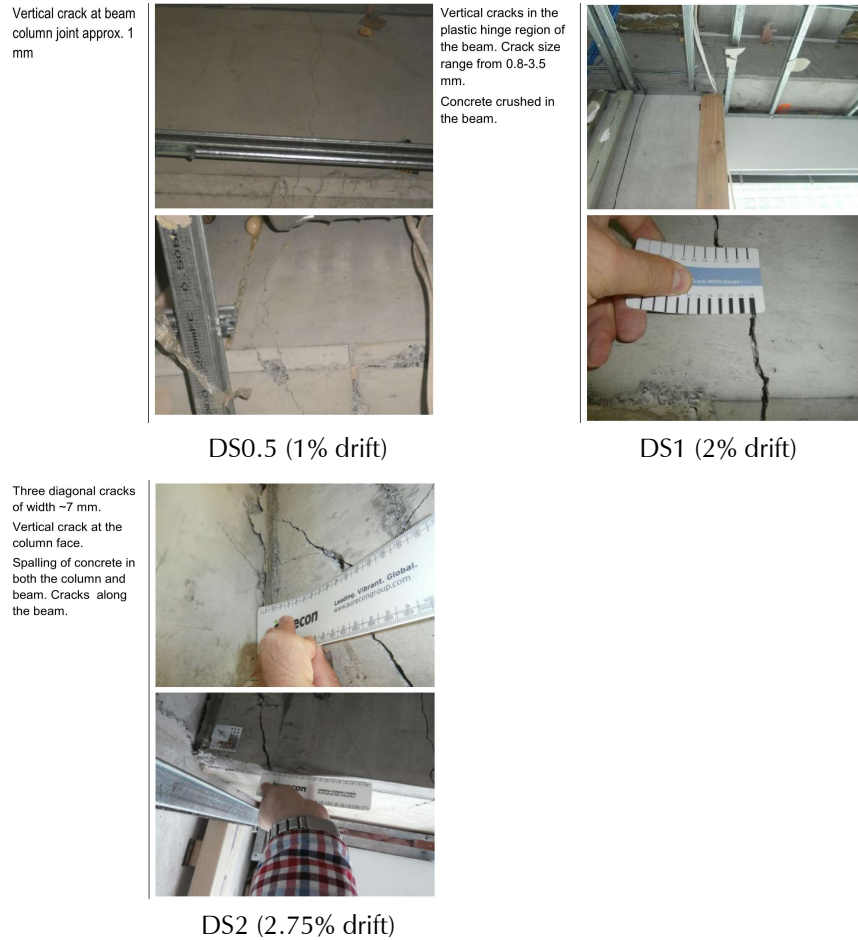
Figure 4-8 Damage state examples.

Fragility curves were used to infer drift demands based upon the observed damage at each beam-column joint. As identified by Case Study 1, modification of the FEMA P-58 (FEMA, 2018) concrete moment frame fragility curve was recommended. The curve was modified by adding DS 0.5 (See Section 4.1.7) to fill the gap between “no observed damage” (0% drift) and DS 1 (2% drift). The proposed story drift associated with DS 0.5 is 1% and would align with a 50% probability of occurrence. See Figure 4-7. Examples of each Damage State observed in the building inspection are presented in Figure 4-8. This modified approach gave drift estimates that were in reasonable agreement with those estimated by analysis and overall

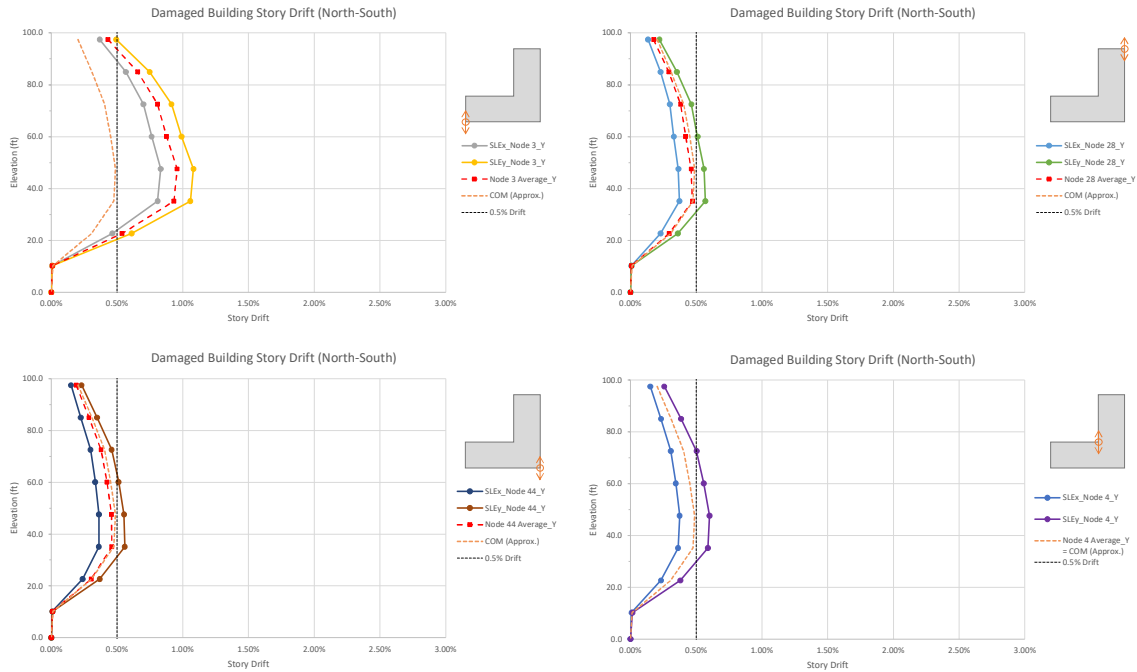
Figure 6-2 and Figure 6-3 below show the drift behavior of the damaged model during the service-earthquake. The damaged building did not satisfy the NZS 1170.5 serviceability drift limit of 0.5%; however, it was noted that the building did not satisfy this limit in the original condition (See Figure 6-4 and Figure 6-5) and it was unlikely to have been a requirement at the time of the building's design and construction.

Figure 6-2 Story drift plots of damaged building under service-level earthquake. Drifts measured in north-south direction.
