Resilient Repair Guide Source Report: Case Study Annex

APPLIED TECHNOLOGY COUNCIL
201 Redwood Shores Parkway, Suite 240
Redwood City, California 94065
www.ATCouncil.org

FEDERAL EMERGENCY MANAGEMENT AGENCY
Michael Mahoney, Project Officer
William T. Holmes, Technical Monitor
Washington, D.C.

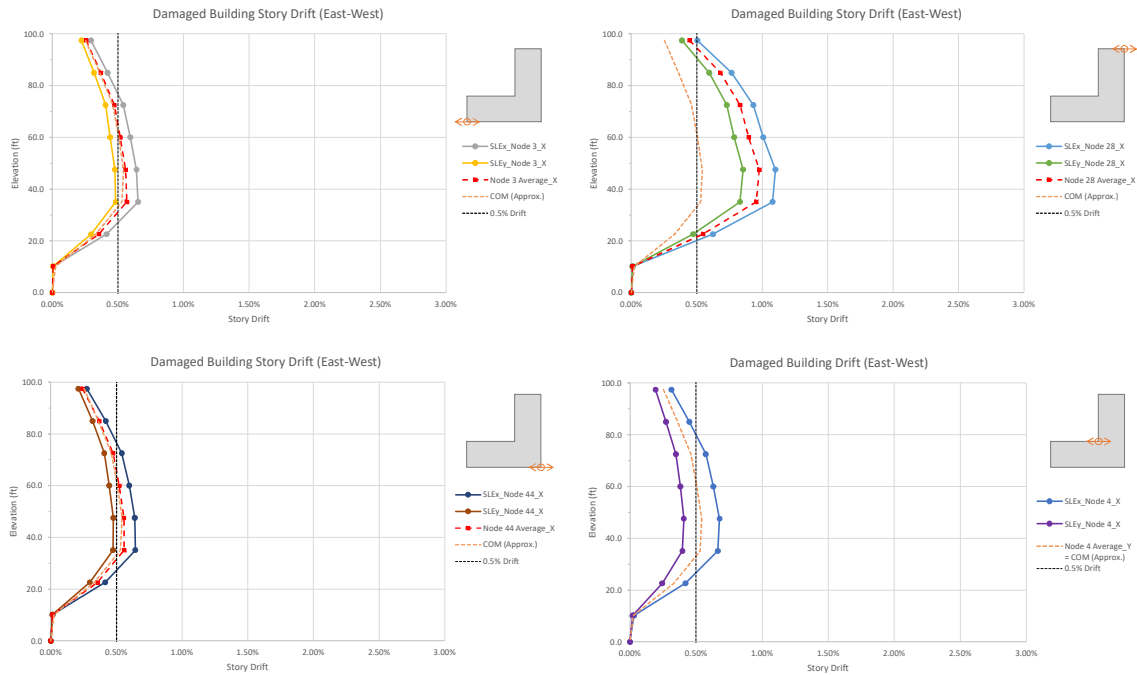
Figure 6-2 and Figure 6-3 below show the drift behavior of the damaged model during the service-earthquake. The damaged building did not satisfy the NZS 1170.5 serviceability drift limit of 0.5%; however, it was noted that the building did not satisfy this limit in the original condition (See Figure 6-4 and Figure 6-5) and it was unlikely to have been a requirement at the time of the building's design and construction.

Figure 6-3 Story drift plots of damaged building under service-level earthquake. Drifts measured in east-west direction.

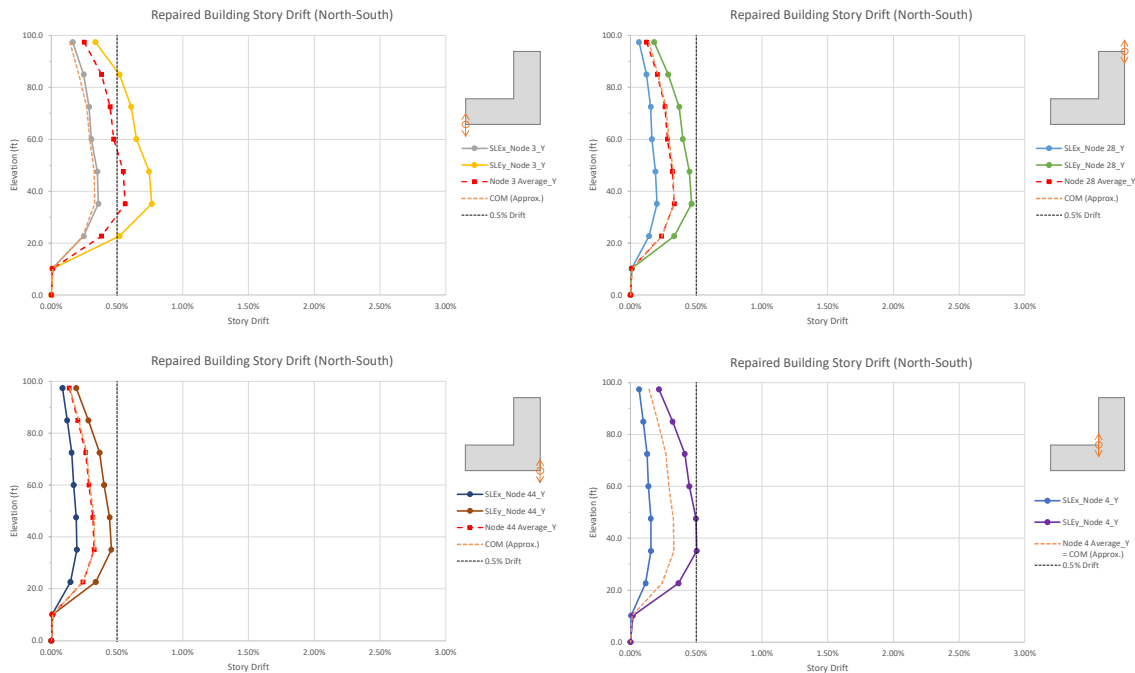
It is clear from the figures that the simple repair would not be sufficient to meet the 0.5% drift limit, predominantly in the transverse direction towards the ends of the L-shaped floor plate. Given the limit has not been met, the Source Report methodology results in triggering Repair Category 2 – Complex Repair, defined by epoxy injection of damaged structural frame members and stiffening of the structure or upgrading nonstructural components to accommodate the anticipated drifts.

Figure 6-6 Story drift plots of repaired building under service-level earthquake. Drifts measured in north-south direction.

Since the story drifts of the damaged building exceed the limit of 0.5%, the building was reanalyzed in the simple repair condition under the same service-level hazard. The repaired building model was generated by starting with the damaged building model and increasing the flexural stiffnesses of the softened perimeter beams to $0.8EI_g$. Damaged columns were not stiffened for the repaired condition, due to the assumed difficulty of effectively epoxy injecting columns with sustained (gravity) axial compression. Story drift plots for the repaired building under NZS1170 are provided in Figure 6-6 and Figure 6-7.

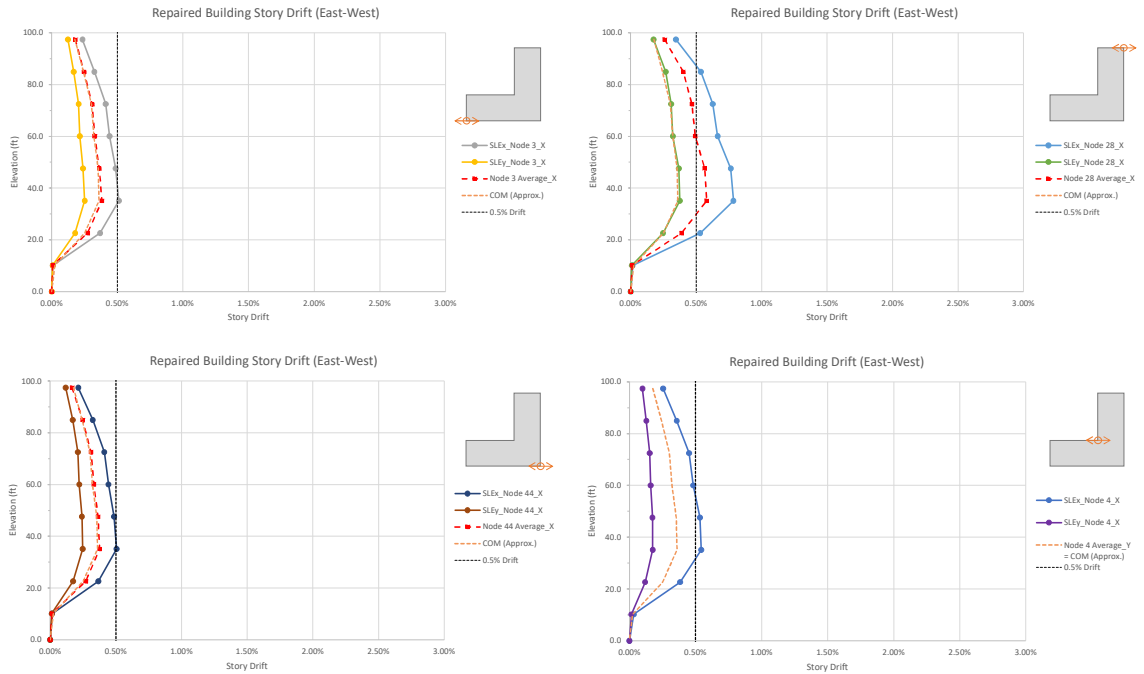
Figure 6-7 Story drift plots of repaired building under service-level earthquake. Drifts measured in east-west direction.

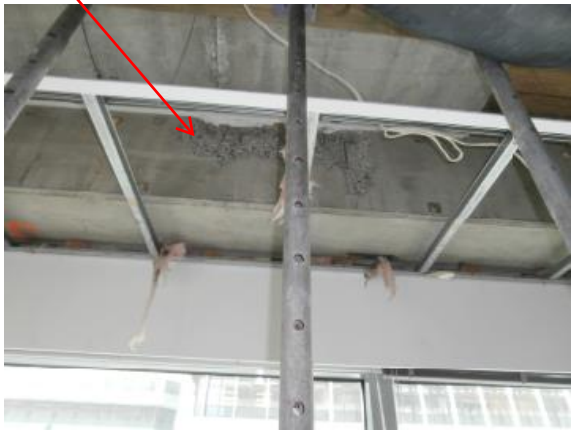
ID.	Location	Comment	Photographs
1	Elevation 8A-Grid A. Beam column joint underside of level 3 DS 0 1 %	Loss of concrete in the beam. Loss of support to Dycore units, seating is exposed. Approximately 11 hairline cracks along the beam

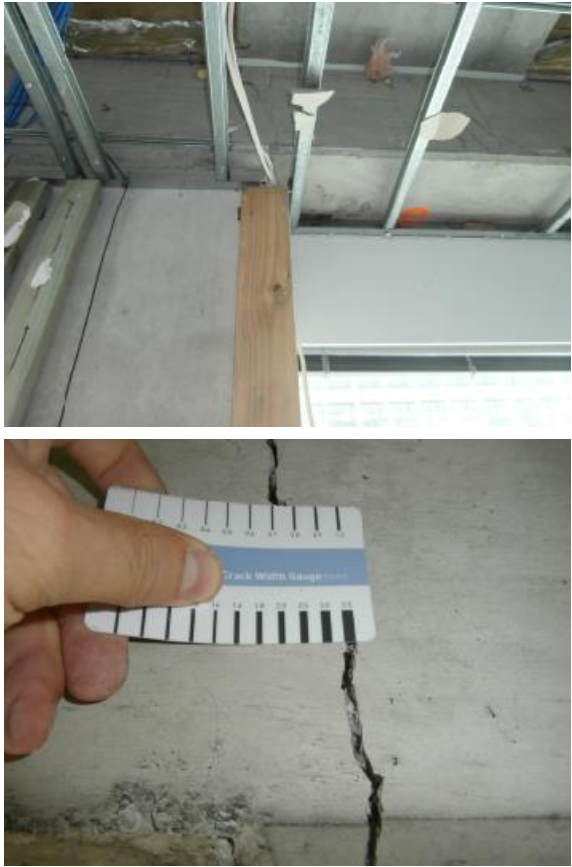
2/3	Elevation 8A-Grid B. Beam column joint underside of level 3 DS 1 2.0%	Vertical cracks in the plastic hinge region of the beam. Crack size range from 0.8-3.5 mm. Concrete crushed in the beam.

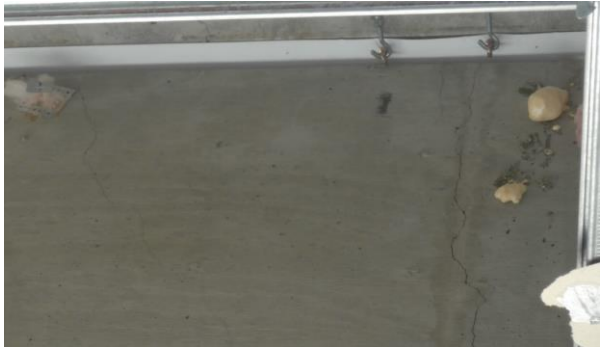
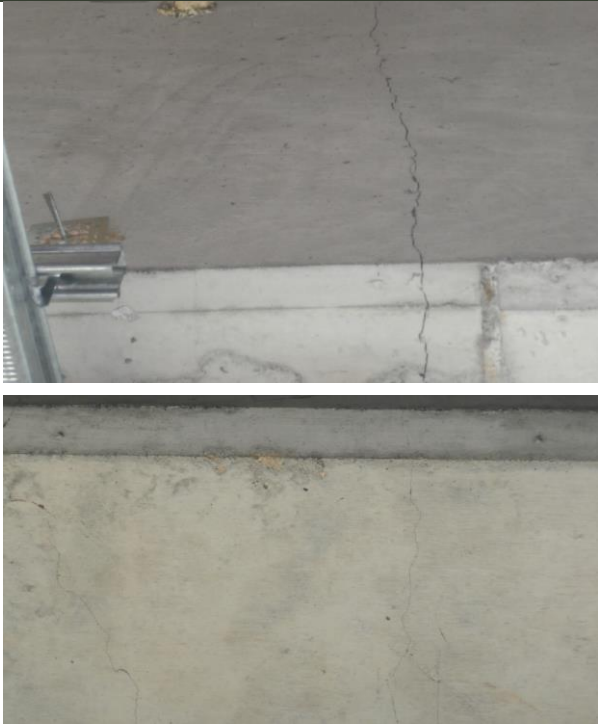
4/5	Elevation 8A-Grid C. Beam column joint underside of level 3 DS 0 1 %	Vertical cracks at beam column joint 0.8-1.5 mm Diagonal cracks in beam approx. 0.3 mm

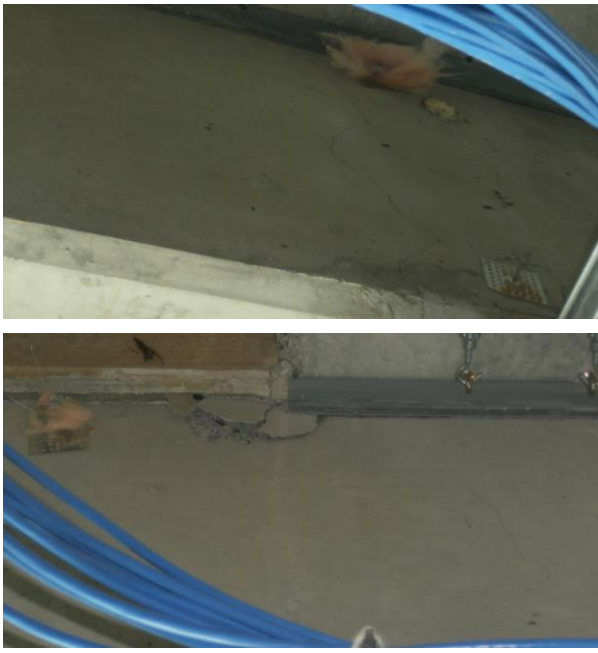
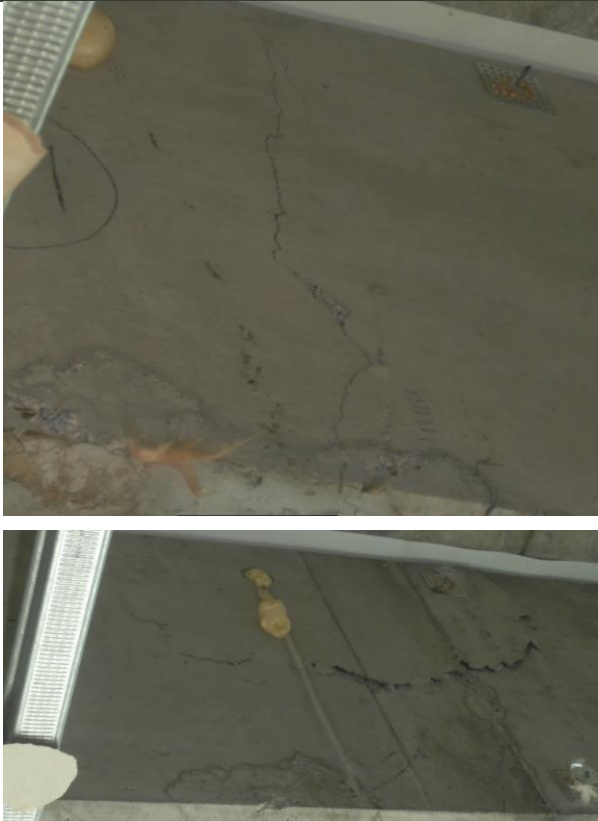
6/7	Elevation 8A- Grid D. Beam column joint underside of level 3 DS 1 2.0%	Vertical cracking at beam column joint 0.8-1.5 mm Spalling of concrete in beam column joint

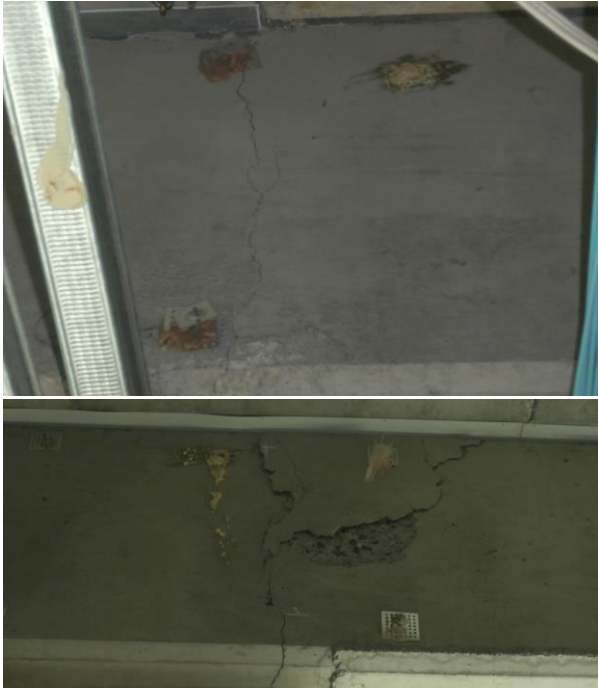
<p>8/9</p>	<p>Elevation 8A- Grid E. Beam column joint underside of level 3</p> <p>DS 1 2.0%</p>	<p>Spalling of concrete on right hand side of beam column joint Vertical crack at beam column joint 0.8 mm</p>

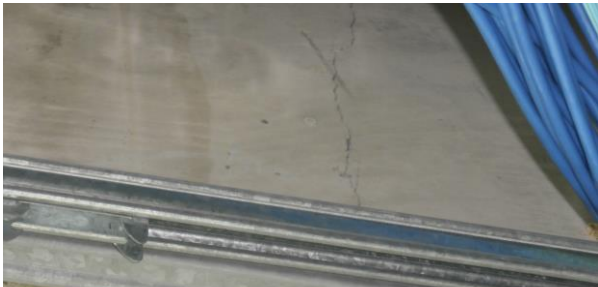
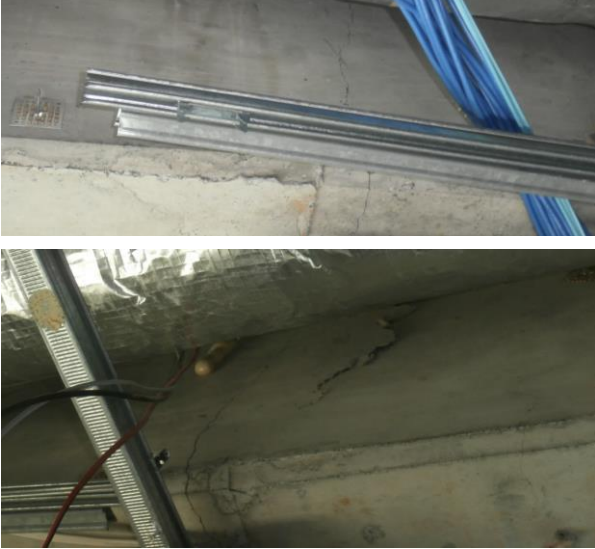
<p>10/11</p>	<p>Elevation 8A- Grid F. Beam column joint underside of level 3</p>	<p>Vertical cracking at beam column joint approx. 1-1.5 mm Spalling in beam</p>

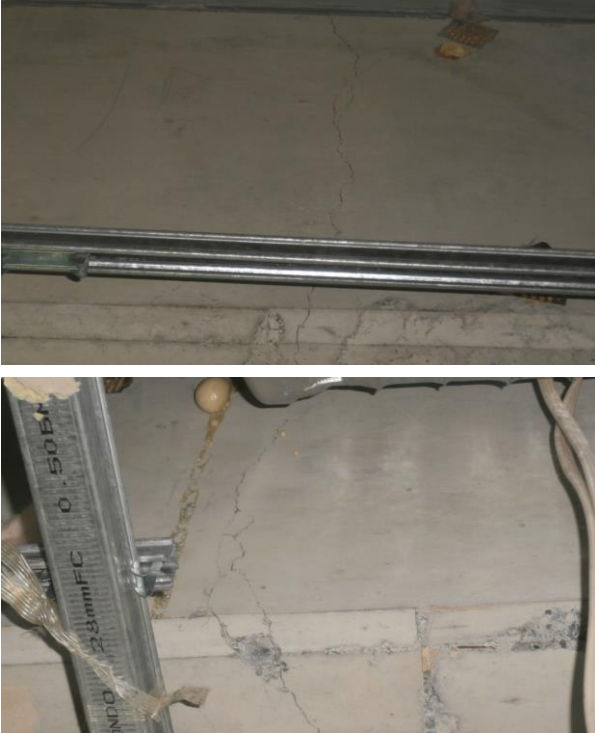
<p>12/13</p>	<p>Elevation 8A- Grid G. Beam column joint underside of level 3</p> <p>DS 0 1 %</p>	<p>Vertical crack at beam column joint approx. 1 mm</p>

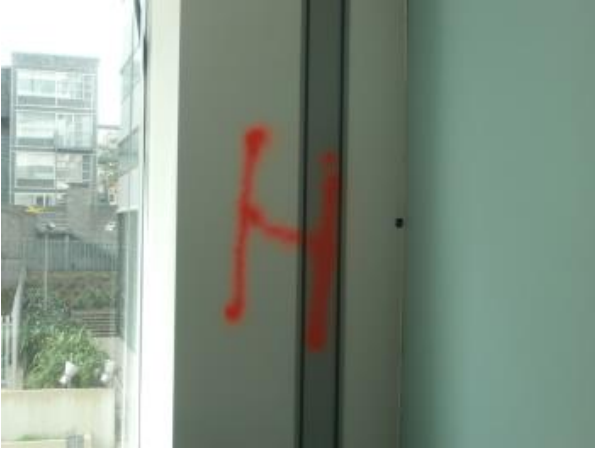
<p>14/15</p>	<p>Elevation 8A- Grid H. Beam column joint underside of level 3</p> <p>not exposed</p>	<p>Column lining was still in place, as per photo. Beam column joint was exposed but we could not inspect for cracking.</p>

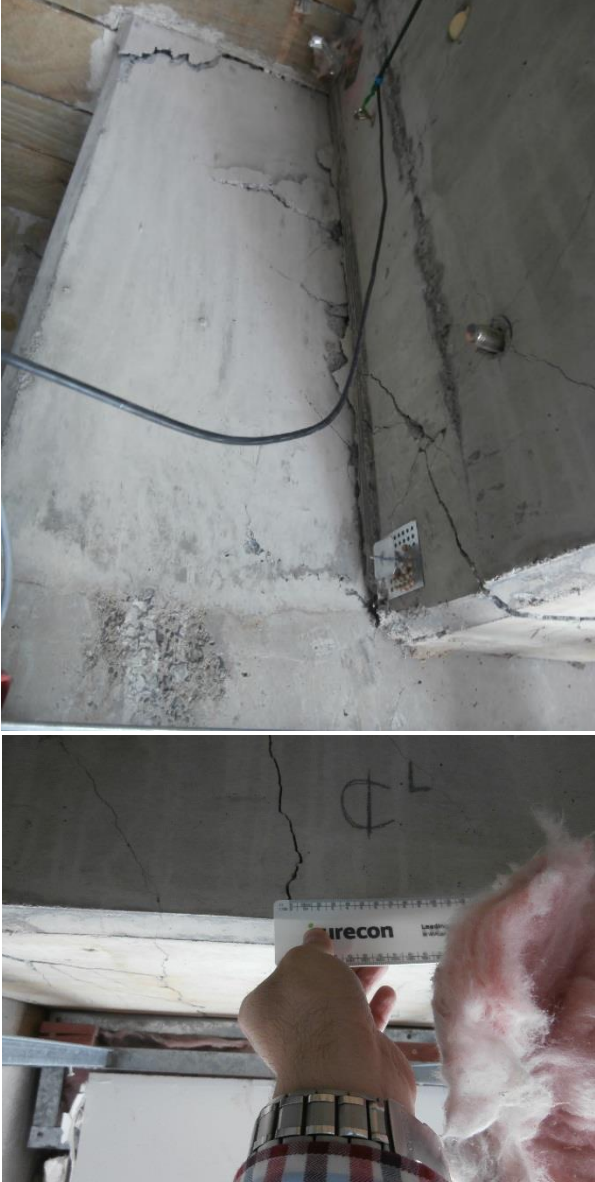
<p>18/19.</p>	<p>Elevation 1- Grid HA/KA. Beam Column joint underside of level 3 DS 1 2.0%</p>	<p>Width of the diagonal cracks in the beam column joint range from 0.2-2 mm. Width of verical cracks range from 2-4 mm in the beam column joint. Diagonal hairline cracks in the column. 10 hairline cracks along the beam between HA/KA and KA.</p>

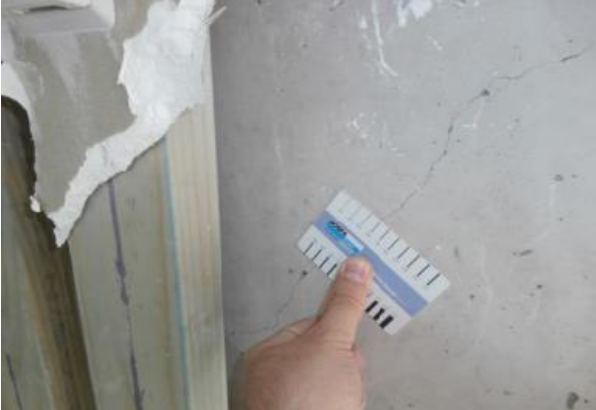
<p>26/27</p>	<p>Elevation A-Grid 13/10A. Beam Column joint underside of level 3.</p> <p>DS 1 2.0%</p>	<p>Three vertical cracks of 3 mm wide on the right and 4 vertical cracks of 3.5 mm wide on the left side of the joint.</p> <p>Cracks around the joint including diagonal cracks in the column. Width of these cracks range from 0.4-0.7 mm.</p>

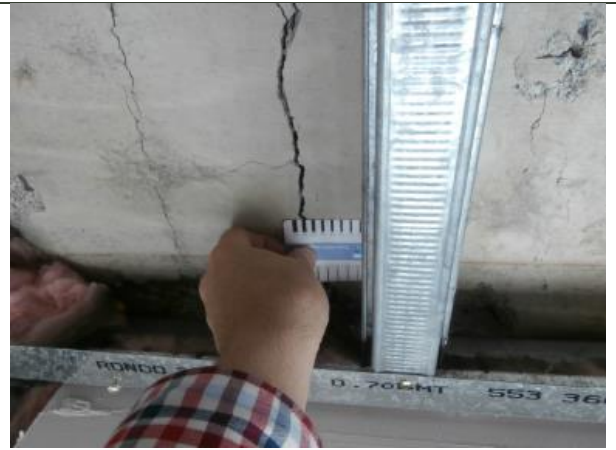
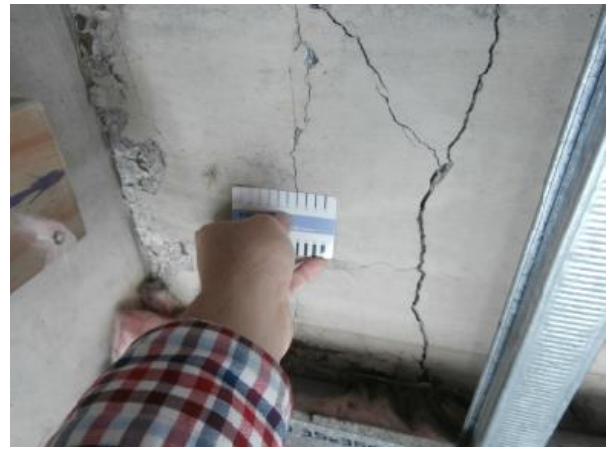
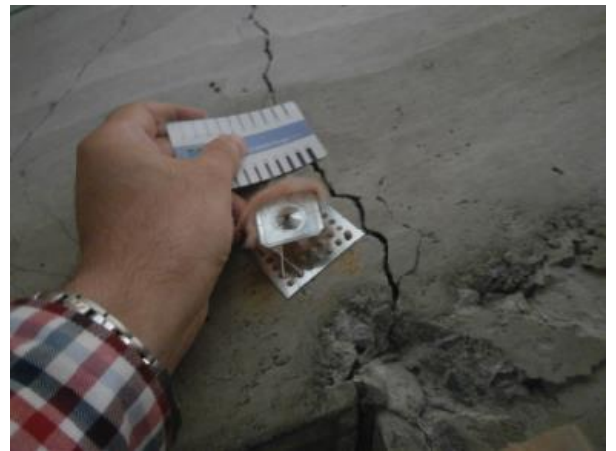
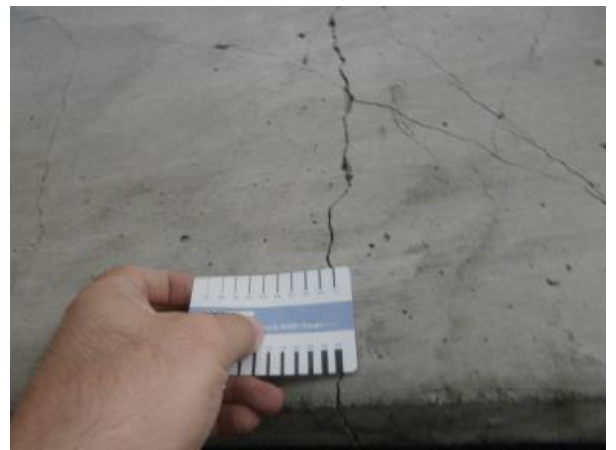
<p>28/29</p>	<p>Elevation A-Grid 10A. Beam Column joint underside of level 3.</p> <p>DS 2 2.75%</p> <p>DS 1 2.0%</p>	<p>Width of the vertical cracks range from 2-2.5 mm on both sides of the joint.</p> <p>Several smaller cracks of width range from 0.6-1.4 mm.</p> <p>Diagonal cracks on the in the joint and in the column.</p> <p>Several hairline cracks along the beam.</p> <p>Loss of concrete, spalling and concrete crush in the joint.</p>

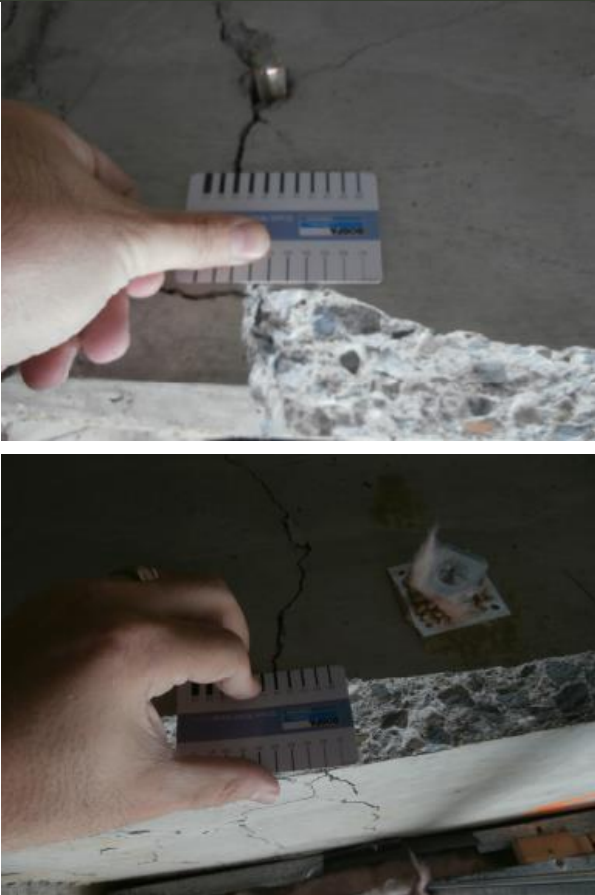
<p>30/31</p>	<p>Elevation A-Grid 10A/8A. Beam Column joint underside of level 3.</p> <p>DS 1 2.0%</p>	<p>Three diagonal cracks of width range from 0.5-2 mm on the left side of the joint.</p> <p>Two cracks of width 2 mm and 3 mm on the right side of the joint.</p> <p>Honeycomb in the concrete beam.</p> <p>Several hairline cracks around the joint and along the beam.</p>

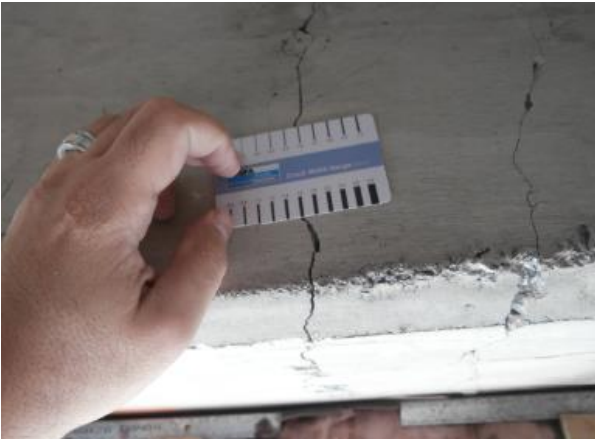
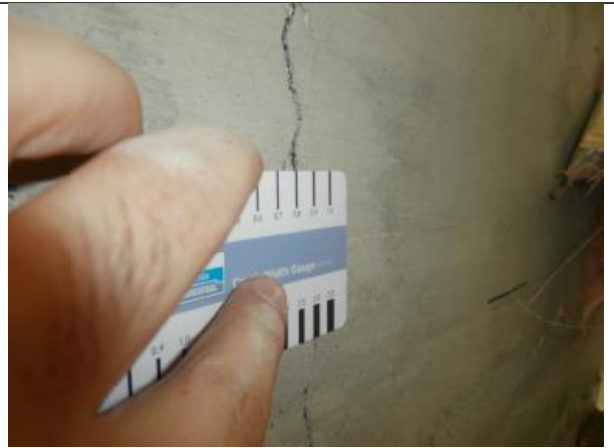
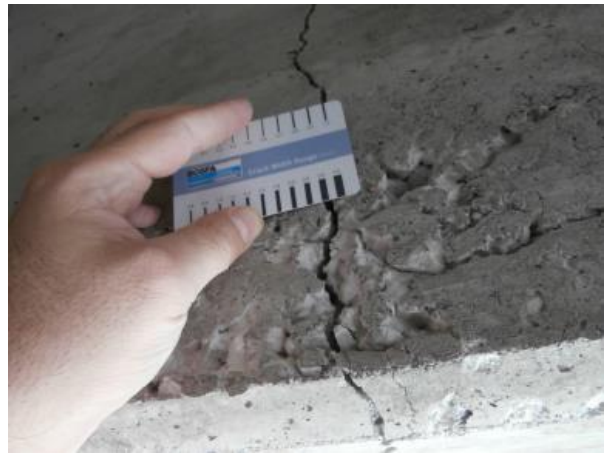
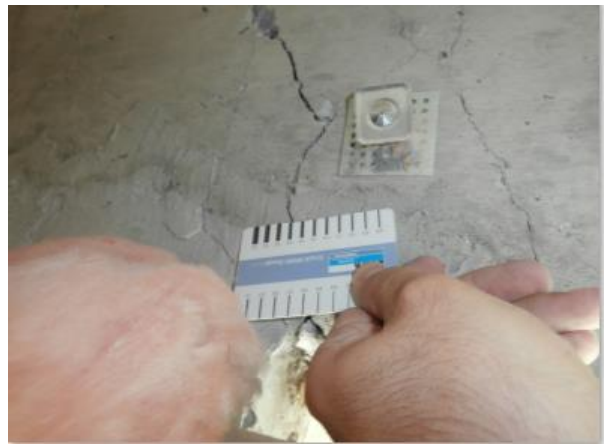
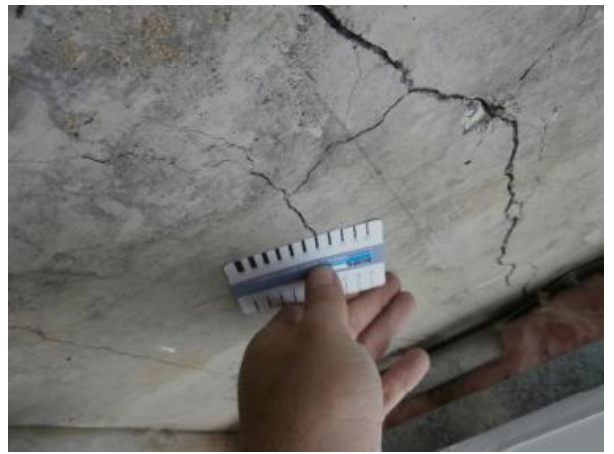
<p>32</p>	<p>Elevation A-Grid 8A. Beam Column joint underside of level 3.</p> <p>DS 3 5.0%</p> <p>DS 2 2.75%</p>	<p>Combination of diagonal and vertical cracks in the joint. The width of the cracks range from 1-3 mm.</p> <p>Loss of concrete in the column, reinforcement is exposed.</p> <p>Concrete crushed in the joint.</p>

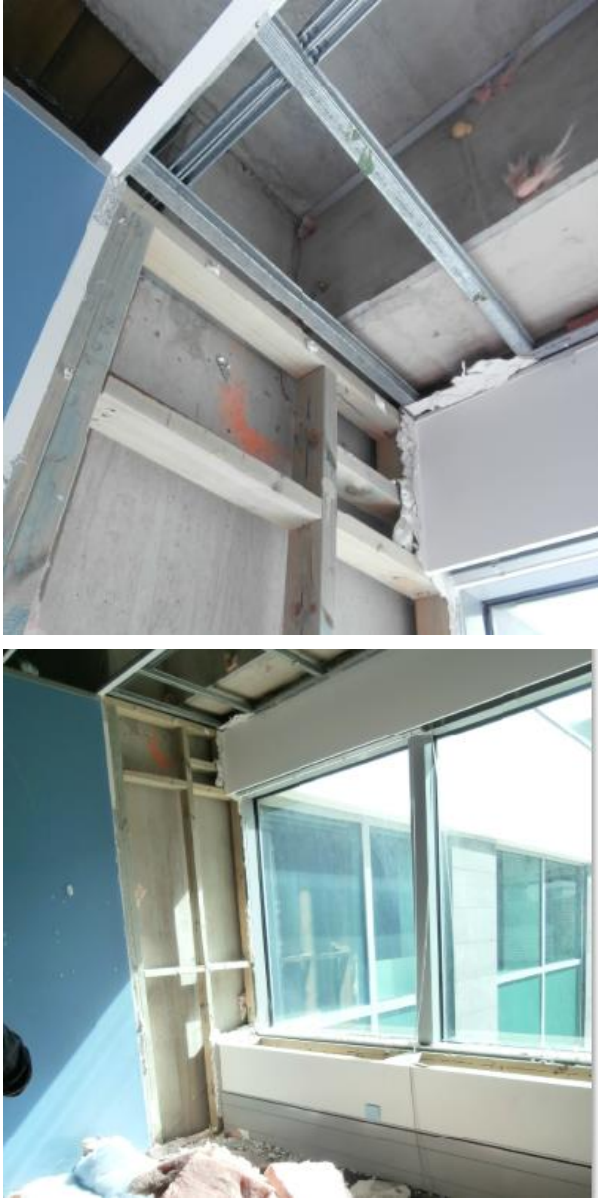
<p>33</p>	<p>Elevation HA-Grid 8A. Beam column joint underside level 3. DS 0 1 %</p>	<p>Vertical crack in the beam column joint.</p>

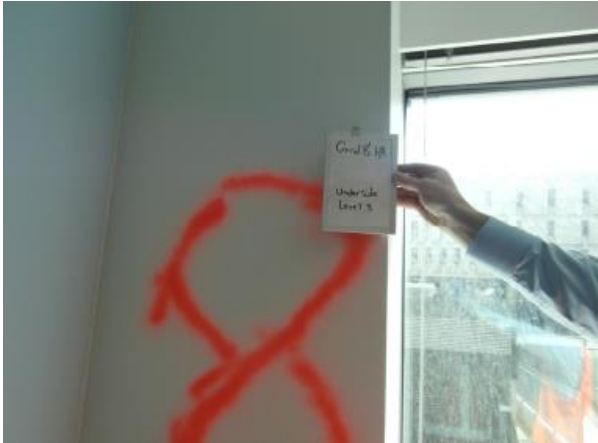
<p>34/35</p>	<p>Elevation HA-Grid 8. Beam column joint underside of level 3</p>	<p>No access to the frame.</p>

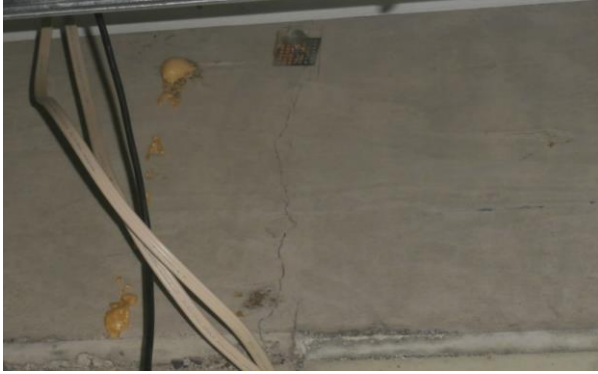
36/37	Elevation HA-Grid 7. Beam column joint underside of level 3. DS 0 1 %	Vertical crack at beam column joint.

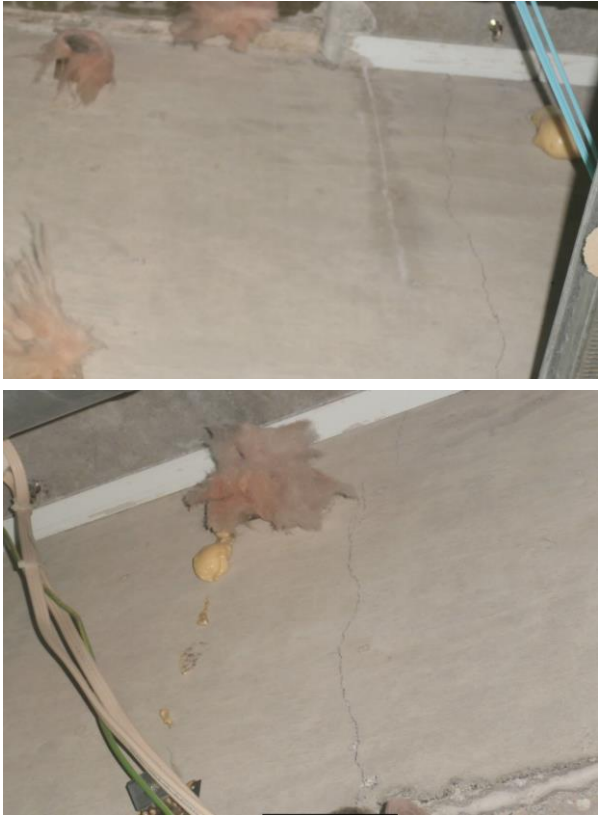
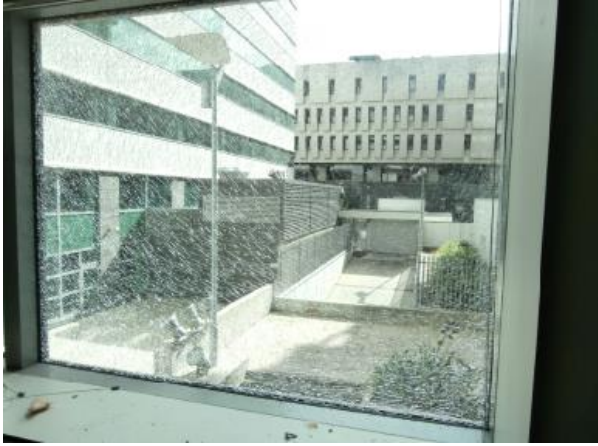
38/39	Elevation HA-Grid 6. Beam column joint underside of level 3. DS 0 1 %	Vertical cracking either side of beam column joint.

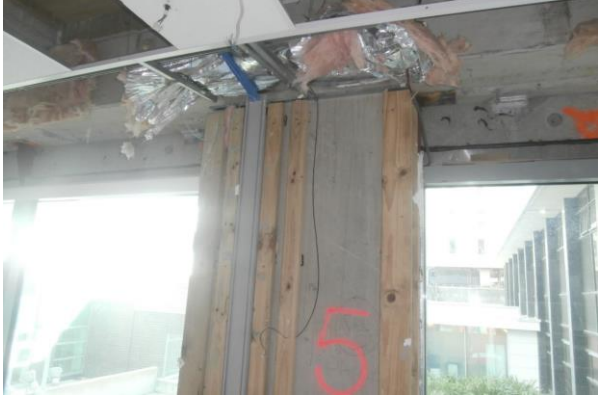
40/41	Elevation HA-Grid 5. Beam column joint underside of level 3.	We could not get access to assess damage.

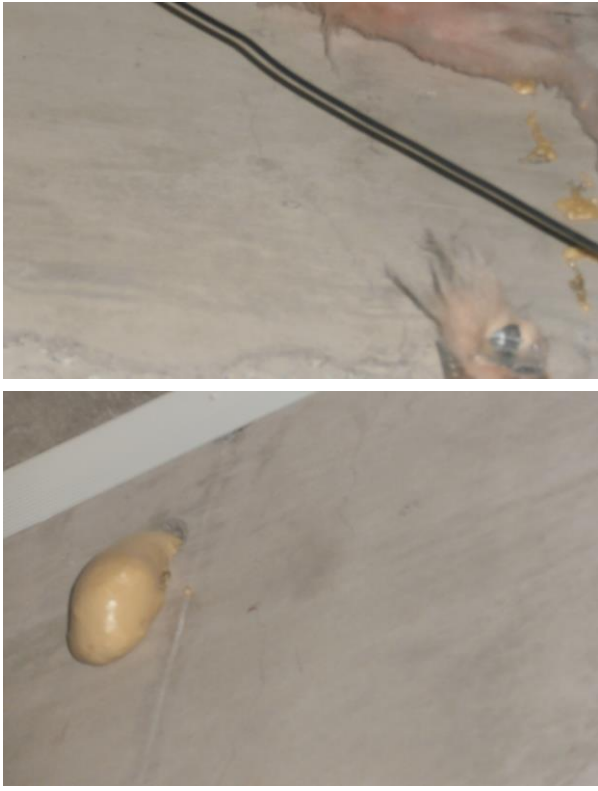
42/43	Elevation HA-Grid 4. Beam column joint underside of level 3. DS 0 1 %	Hairline diagonal cracks in beam.

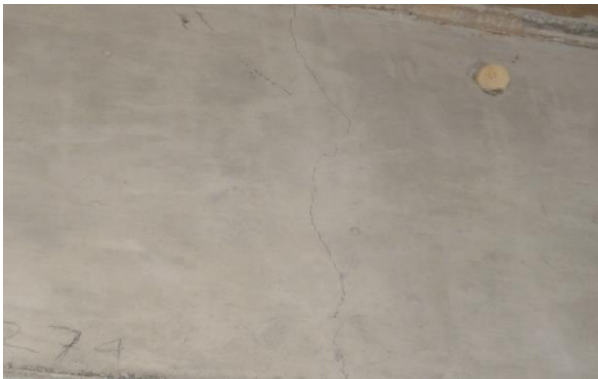
44/45	Elevation HA-Grid 3. Beam column joint underside of level 3. DS 0 1 %	Vertical crack 0.7 mm Spalling of concrete in beam and beam column joint.

appears to be due to floor unit rotation due to drift in perpendicular direction towards the end frame

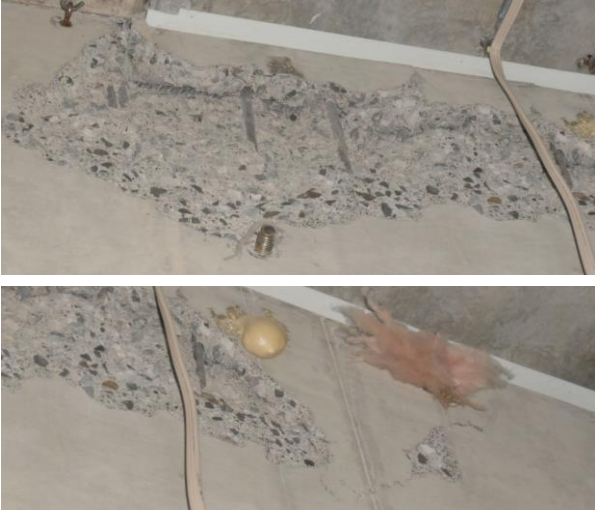
46/47	Elevation HA-Grid 2. Beam column joint underside of level 3. DS 1 2.0%	Vertical cracks range from 0.3-2 mm wide. Few hairline cracks in the beam.

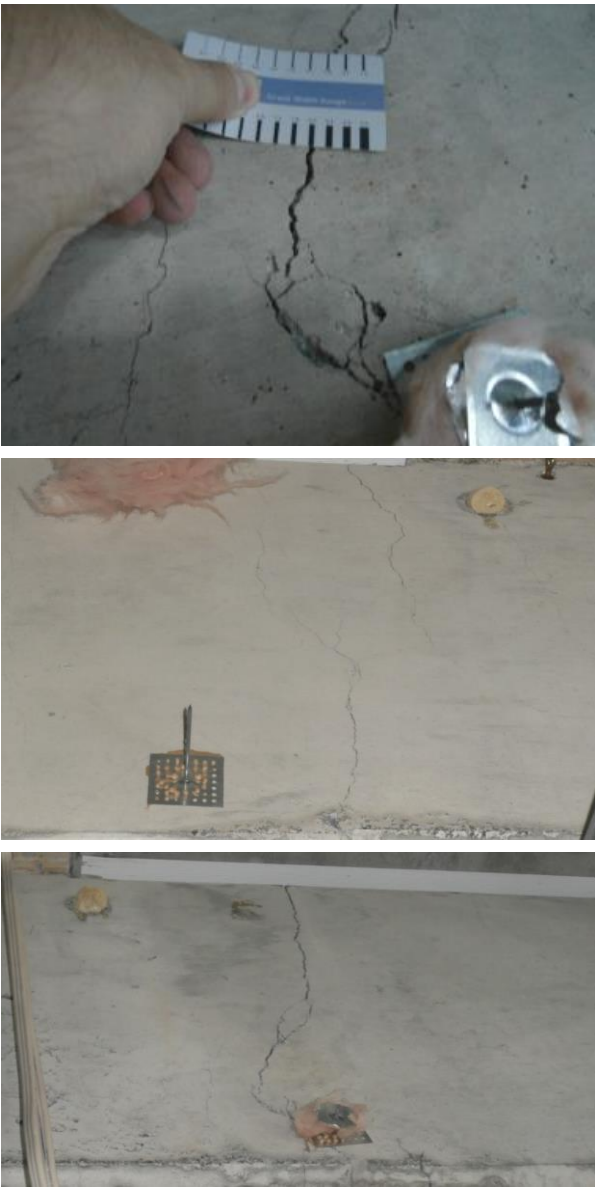
48	Elevation HA-Grid 1. Beam column joint underside of level 3. DS 0 1 %

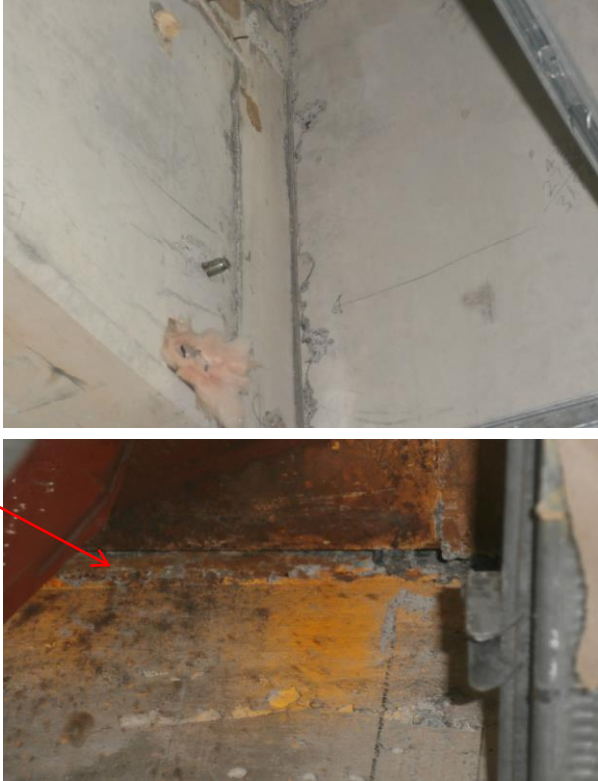
<p>crack at joint?</p>
49	Elevation 13-Grid N. Beam column joint underside of level 3. DS 0 < 2.0%	Crack underside of the B/C joint. Width of the crack is approximately 0.3-0.5 mm.

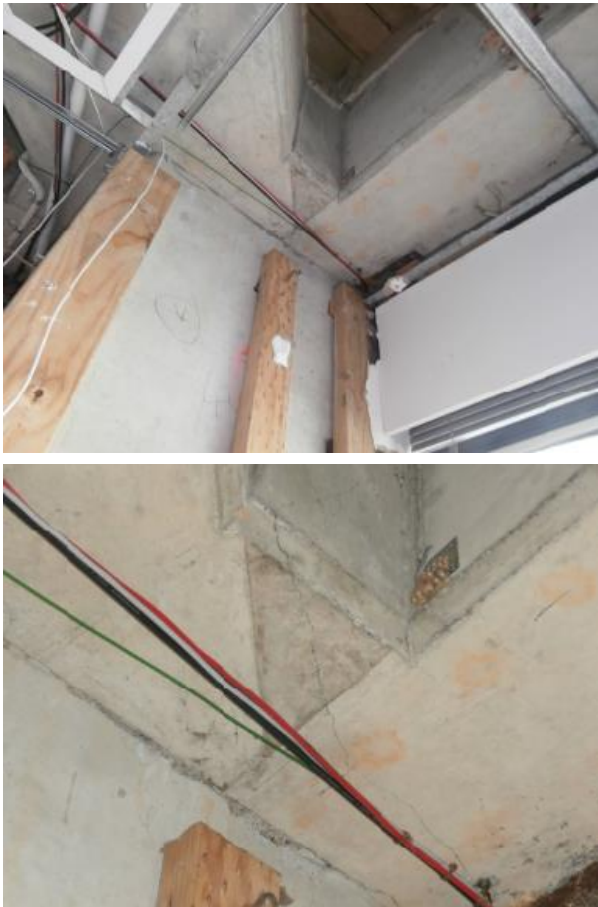
50/51	Elevation 13-Grid M. Beam column joint underside of level 3. DS 0 < 2.0%	Hairline vertical cracks.

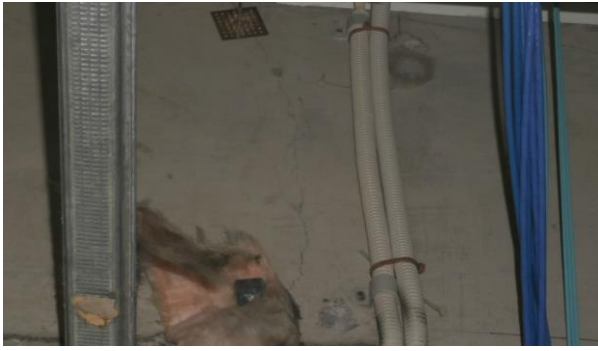
52/53	Elevation 13-Grid L. Beam column joint underside of level 3. DS 0 < 2.0%	Vertical cracks approx. 0.5 mm.

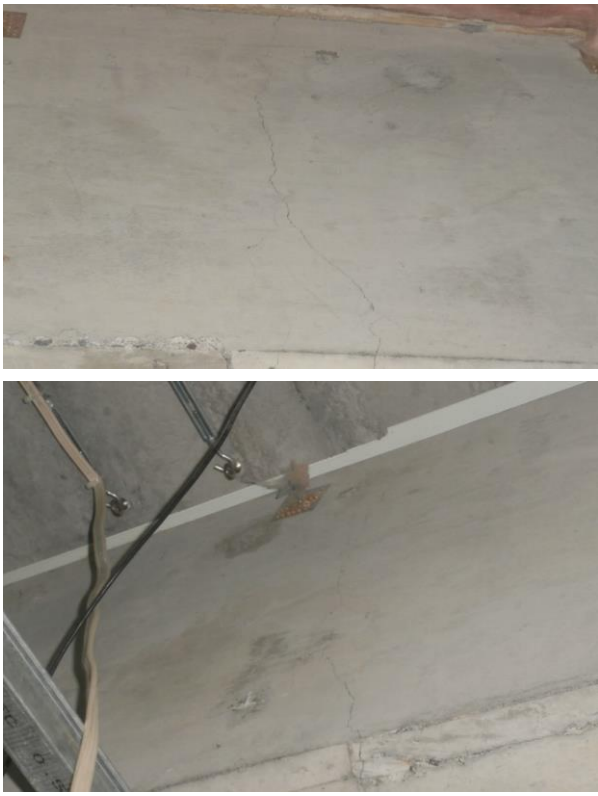
54/55	Elevation 13-Grid K. Beam column joint underside of level 3. DS 0 < 2.0%	Hairline vertical cracks.

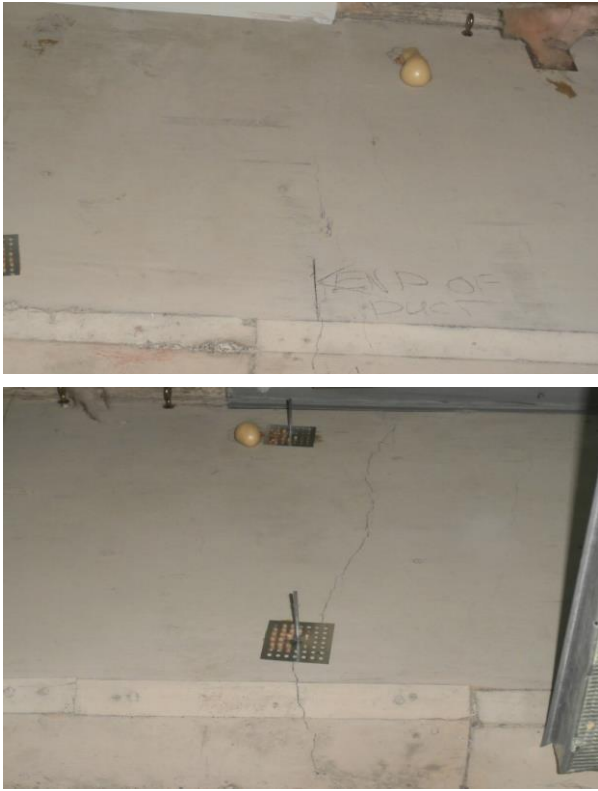
<p>60/61</p>	<p>Elevation 13-Grid G. Beam column joint underside of level 3.</p> <p>DS 0 < 2.0%</p>	<p>Vertical cracks in beam column joint 0.5-1.2 mm.</p>

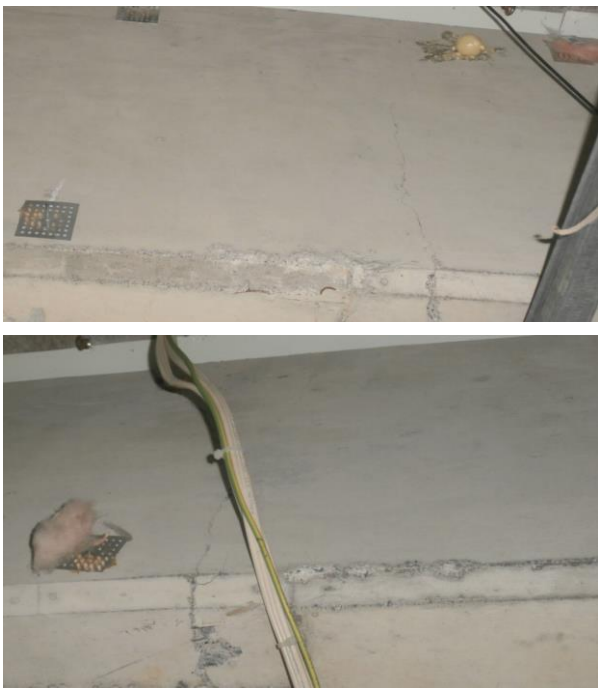
<p>62/63</p>	<p>Elevation 13-Grid F. Beam column joint underside of level 3.</p> <p>DS 0 < 2.0%</p>	<p>Hairline vertical cracks in beam column joint.</p>

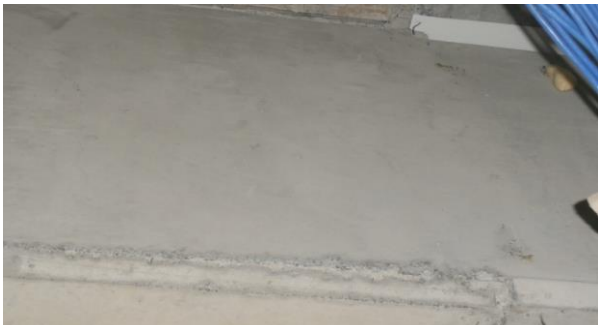
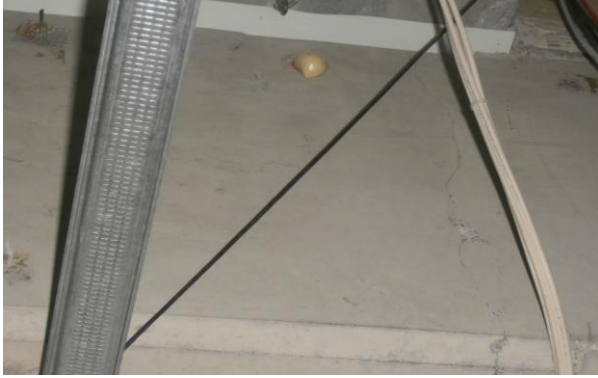
<p>64/65</p>	<p>Elevation 13-Grid E. Beam column joint underside of level 3.</p> <p>DS 1 2.0%</p>	<p>Vertical cracks in beam column joint approx 0.8 mm.</p> <p>Spalling of concrete in beam column joint.</p>

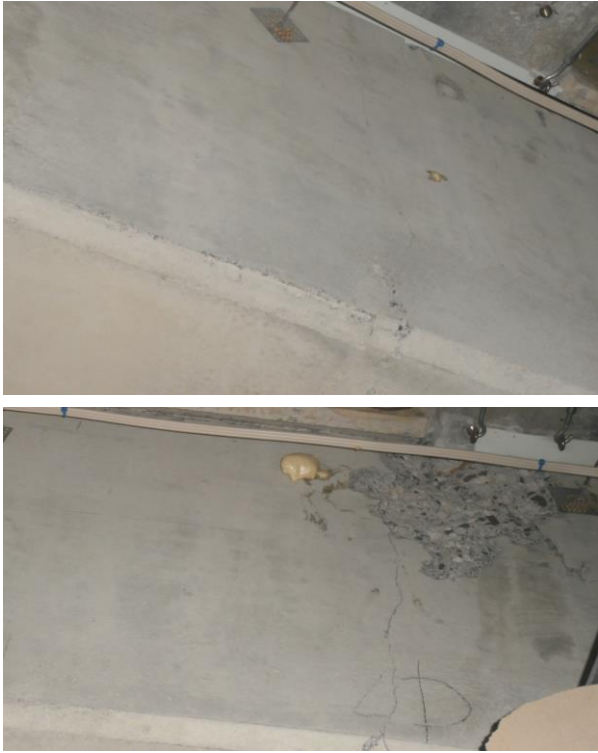
<p>66/67</p>	<p>Elevation 13-Grid D. Beam column joint underside of level 3.</p> <p>DS 1 2.0%</p>	<p>Vertical cracks in beam column joint 0.5-1 mm</p> <p>Significant spalling of concrete in plastic hinge region of beam.</p>

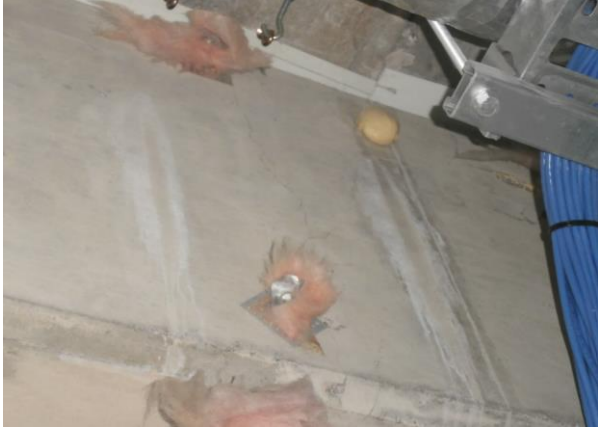
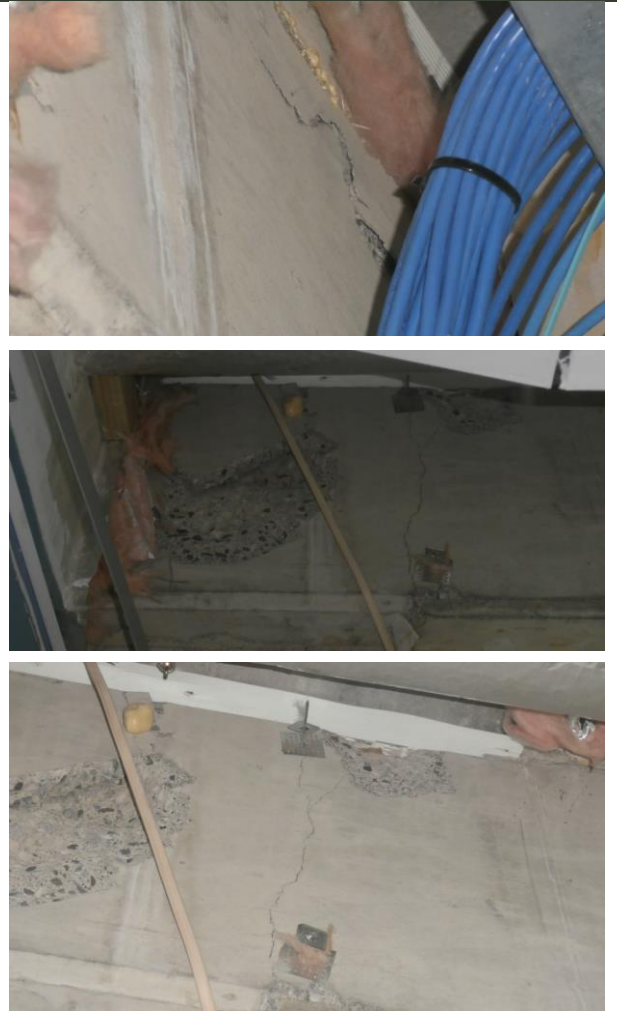
<p>68/69</p>	<p>Elevation 13- Grid C. Beam column joint underside of level 3.</p> <p>DS 1 2.0%</p>	<p>Hairline diagonal cracks in beam Spalling of concrete in plastic hinge region of beam.</p>

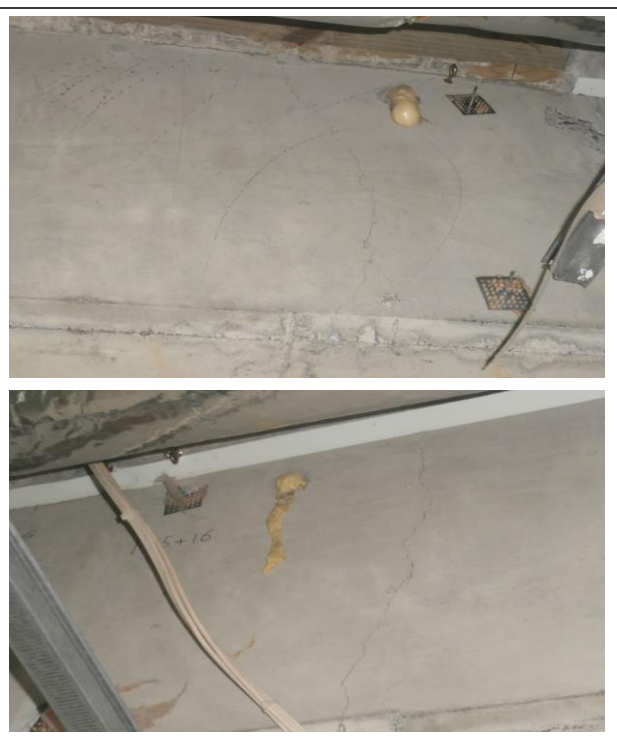
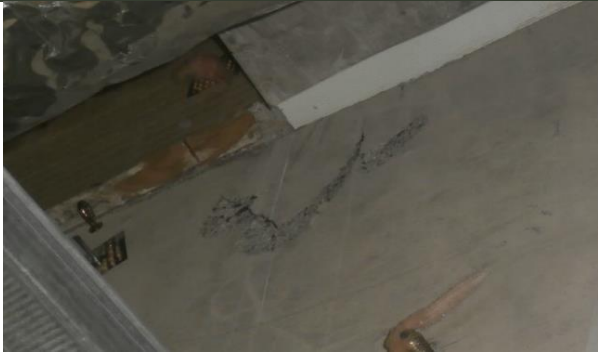
70/71	<p>Elevation 13-Grid B. Beam column joint underside of level 3.</p> <p>DS 2 2.73%</p> <p>DS 1 2.0%</p>	<p>Width of the vertical cracks are 1.8 mm and 2 mm.</p> <p>Spalling/loss of concrete in the beam.</p> <p>Loss of support to the Dycore units.</p> <p>function of transverse drift</p>

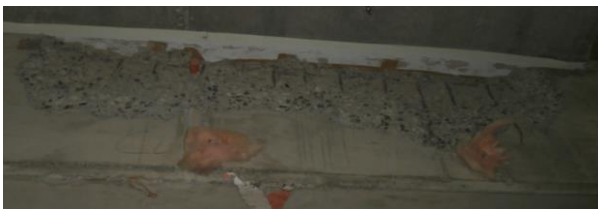
72	<p>Elevation 13-Grid A. Beam column joint underside of level 3.</p> <p>DS 2 2.73%</p> <p>DS 1 2.0%</p>	<p>Vertical crack in the B/C joint. Loss of concrete in the centre of the beam.</p> <p>Loss of support to the Dycore units.</p>

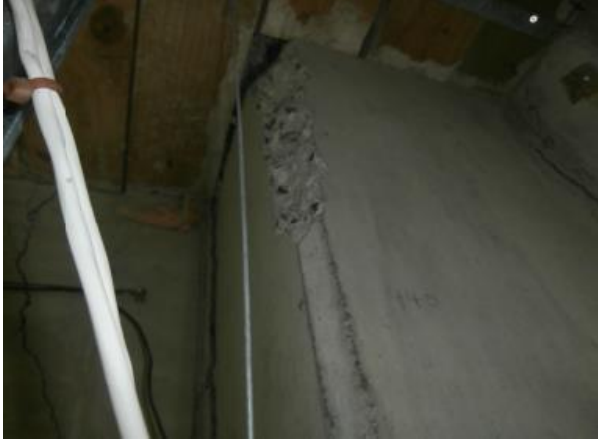
<p>73</p>	<p>Elevation N-Grid 1. Beam column joint underside of level 3</p> <p>DS 0 1 %</p>	<p>Loss of concrete cover in the column.</p>

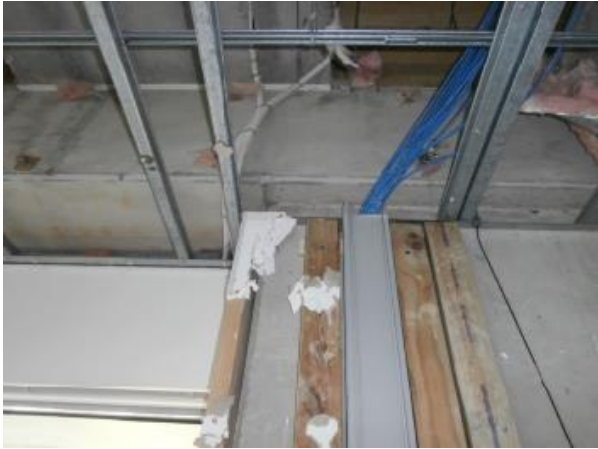
<p><u>74/75</u></p>	<p>Elevation N-Grid 2. Beam column joint underside of level 3</p> <p>DS 0 1 %</p>	<p>Three cracks in the B/C joint. The width of the cracks less than 0.3mm.</p>

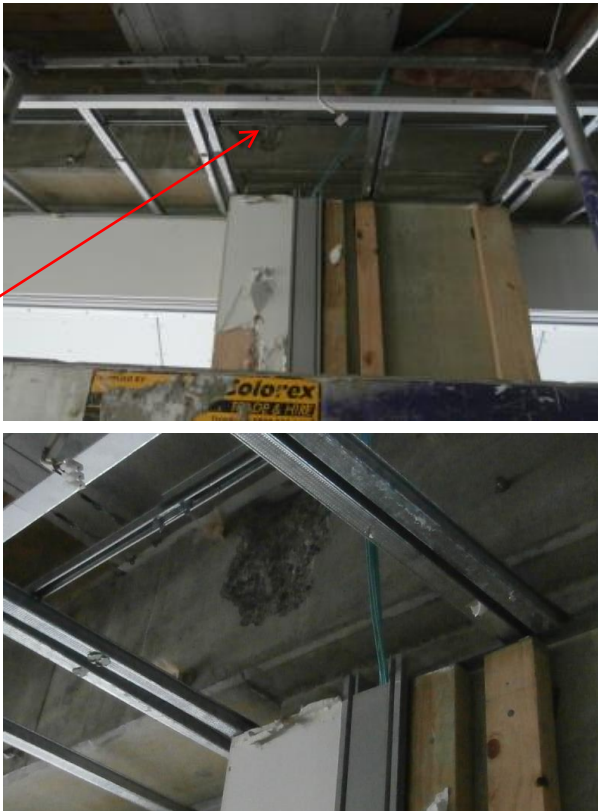
<p><u>76/77</u></p>	<p>Elevation N-Grid 3. Beam column joint underside of level 3</p> <p>DS 0 1 %</p>	<p>Loss of concrete in the beam around the B/C joint.</p> <p>A hairline crack along the beam.</p> <p>floor unit rotation</p>
