Resilient Repair Guide Source Report: Case Study Annex

APPLIED TECHNOLOGY COUNCIL
201 Redwood Shores Parkway, Suite 240
Redwood City, California 94065
www.ATCouncil.org

FEDERAL EMERGENCY MANAGEMENT AGENCY
Michael Mahoney, Project Officer
William T. Holmes, Technical Monitor
Washington, D.C.

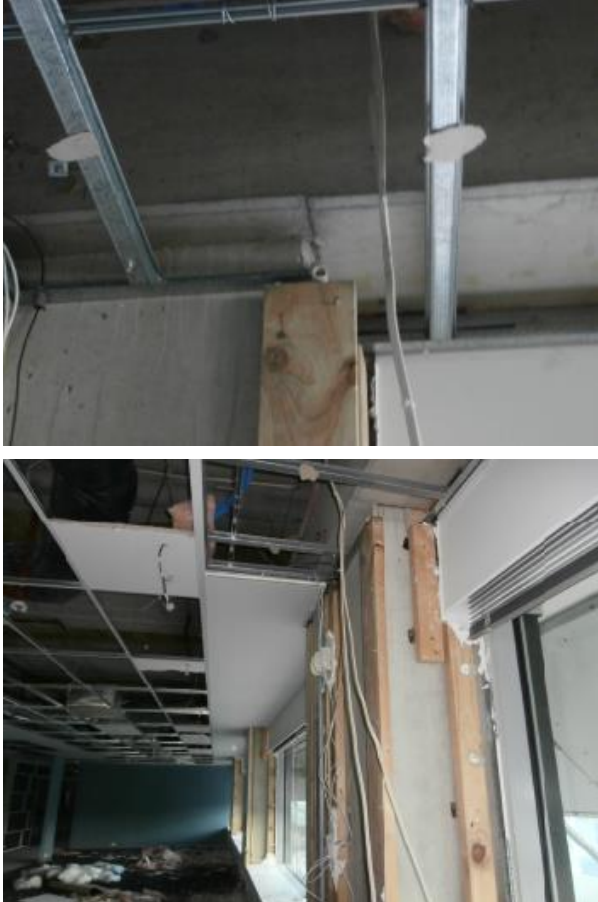
<p>90/91</p>	<p>Elevation N-Grid 10. Beam column joint underside of level 3</p> <p>DS 0 1 %</p>	<p>A crack less than 0.3 mm wide on one side. Several hairline cracks along the beam.</p>

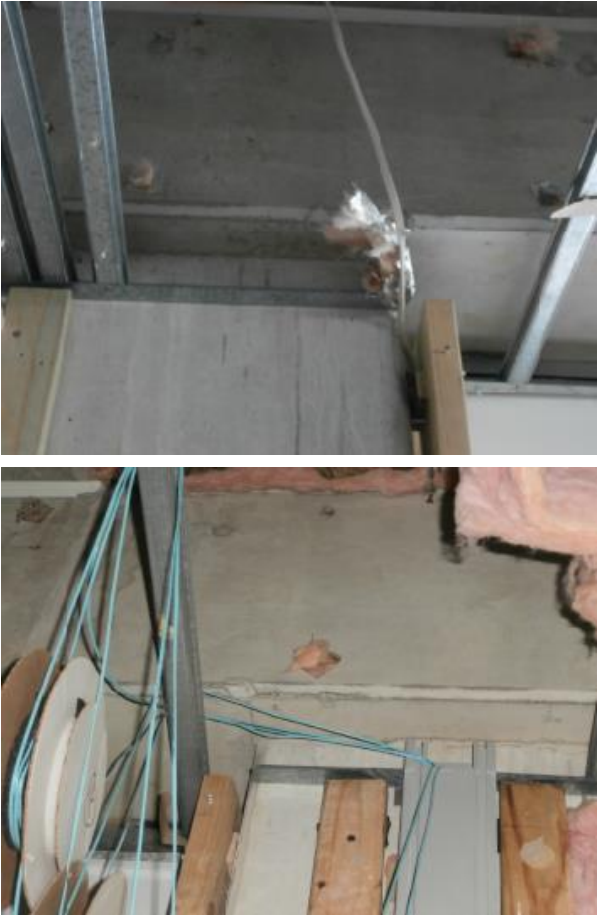
<p>92/93</p>	<p>Elevation N-Grid 11. Beam column joint underside of level 3</p> <p>DS 0 1 %</p>	<p>Two cracks in the B/C joint. The width of the cracks approximately less than 0.3 mm.</p> <p>Five hairline cracks along the beam.</p>

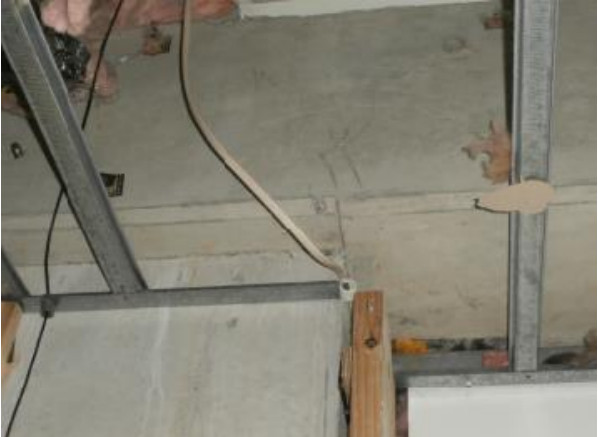
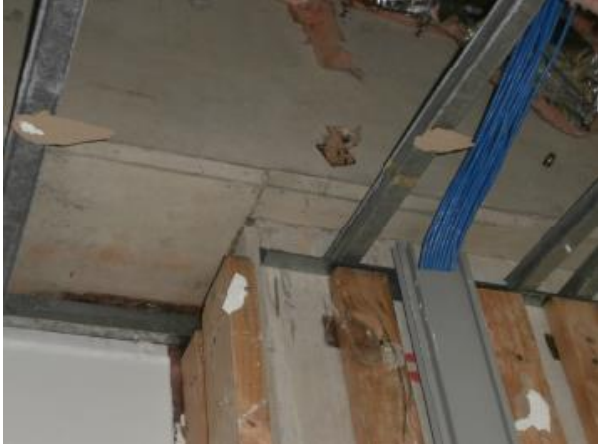
<p>94/95</p>	<p>Elevation N-Grid 12. Beam column joint underside of level 3</p> <p>DS 0 1 %</p>	<p>Two cracks in the B/C joint. The width of the cracks approximately less than 0.3 mm.</p>

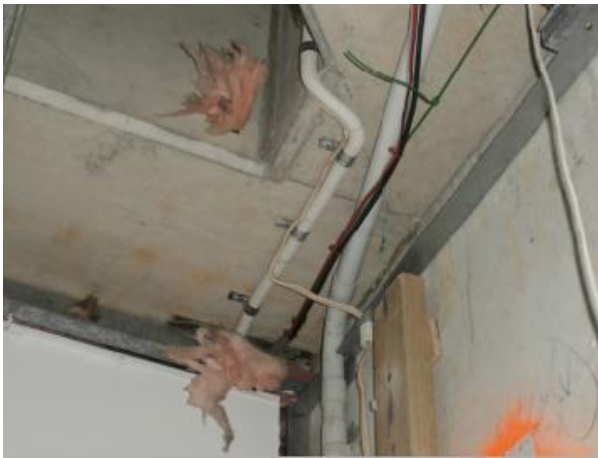
<p>96</p>	<p>Elevation N-Grid 13. Beam column joint underside of level 3</p> <p>DS 0 1 %</p>	<p>Vertical crack in the beam column joint. Hairline cracks along the beam.</p>

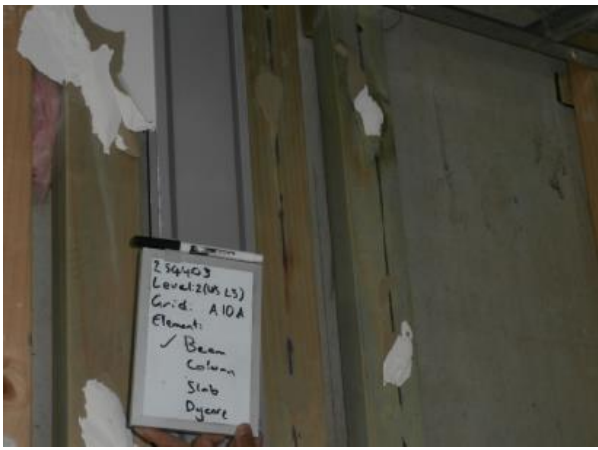
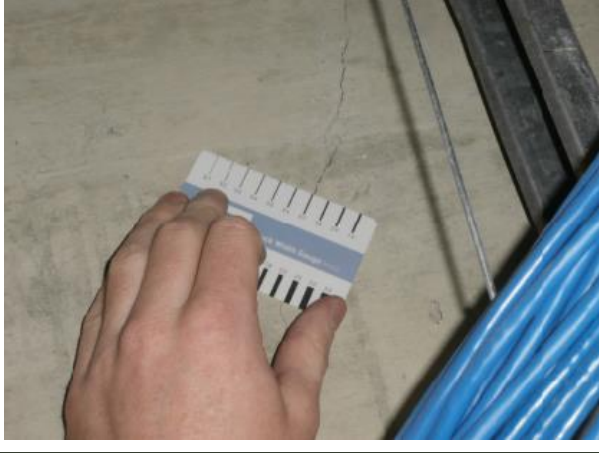
<p>97</p>	<p>Elevation 10A-Grid A. Beam column joint underside of level 3</p>	<p>Vertical crack in the beam column joint. Width of diagonal cracks in the beam range from 0.7-1 mm.</p>

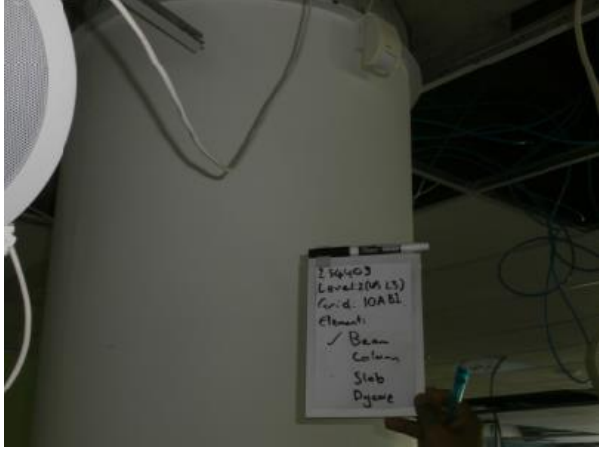
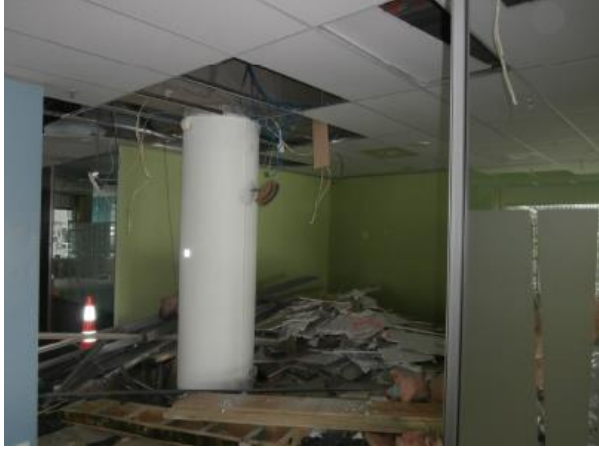
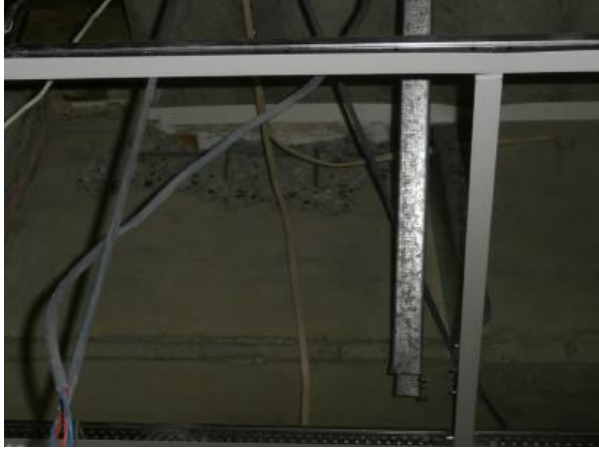
98/99	Elevation 10A-Grid B'. Beam column joint underside of level 3	<p>Width of diagonal crack in the B/C joint is less than 1 mm.</p> <p>Loss of concrete in the beam at the joint.</p> <p>Loss of Dycore support.</p> <p>Concrete column toe crushed.</p>

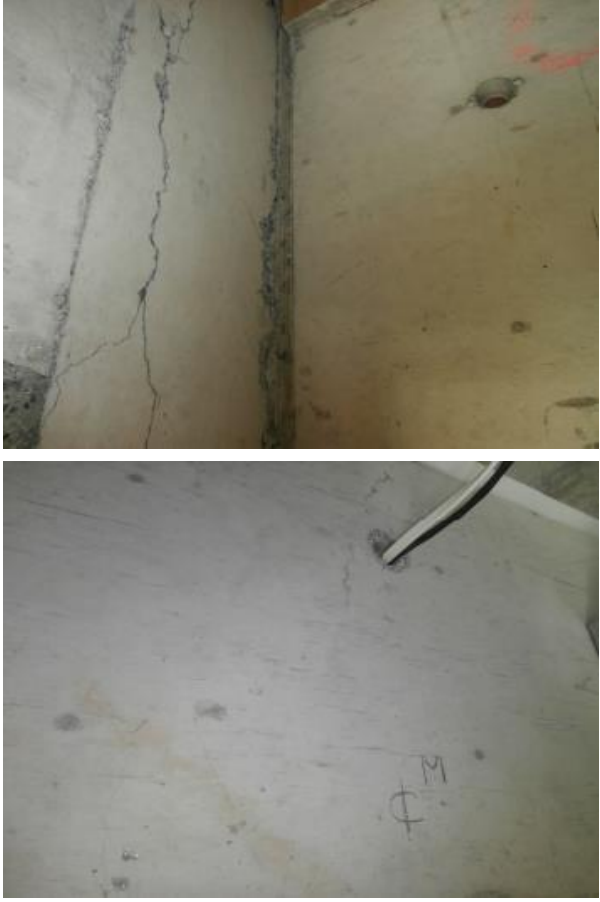
109/110	Elevation KA-Grid 2'. Beam column joint underside of level 3	Width of vertical cracks in the B/C joint is less than 0.5 mm. A width of 0.2 mm crack in the mid height of the column.

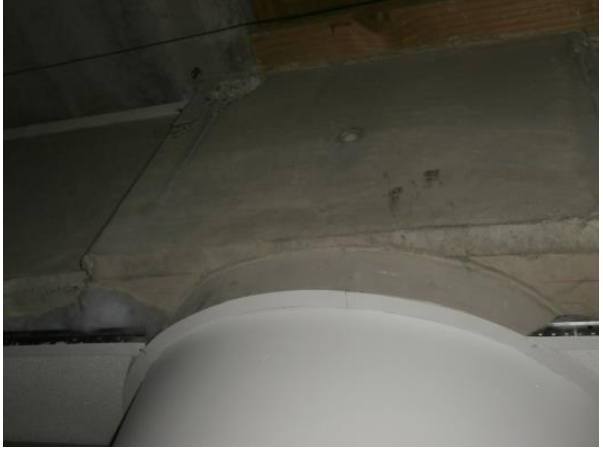
<p>119</p>	<p>Elevation KA-Grid 9/10. Beam joint underside of level 3</p>	<p>A crack of width less than 0.3 mm. The crack is on the underside of the beam to beam joint.</p>

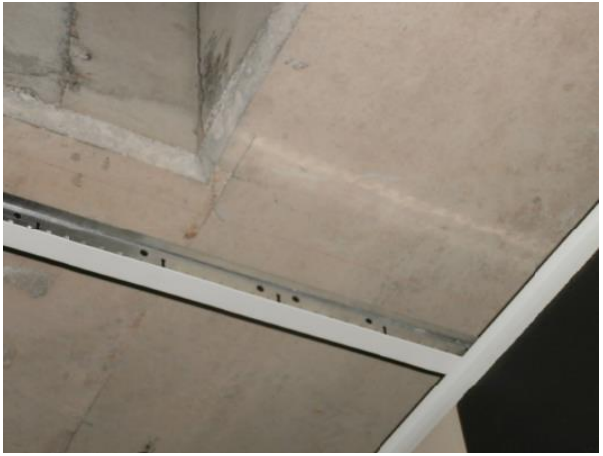
<p>120, 121/122 and 123</p>	<p>Elevation L'-Grids between 11' to 9'. Beam on the underside of level 3</p>	<p>Combined vertical and diagonal cracks along the beam. The width of the cracks range from 0.8-1.2 mm. Several hairline cracks along the beam.</p>

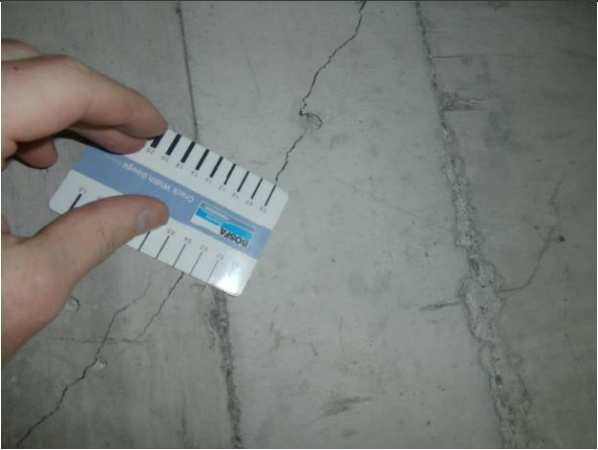
<p>124, 125/126 and 127</p>	<p>Elevation K- Grids between 11' to 9'. B/C joints and beams underside of level 3</p>	<p>Approximately four cracks along the beam. The width of the cracks are less than 0.5 mm.</p>

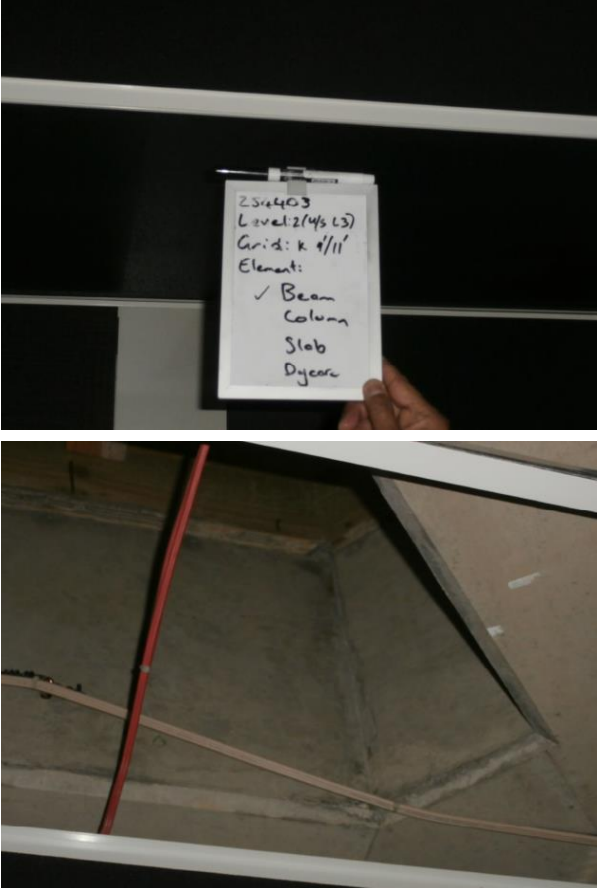
<p>127(a)</p>	<p>Elevation 11'- Grids between K to L'. B/C joints and beams underside of level 3 (Refer to Dycore plan for the reference)</p>	<p>Width of cracks along the beam range from 0.8-1.2 mm. Approximately three hairline cracks along the beam.</p>

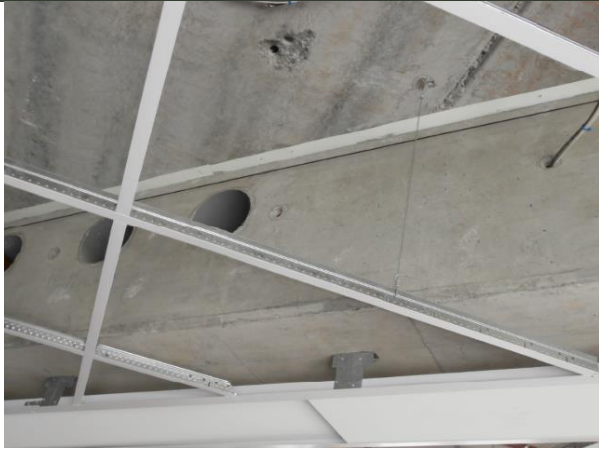
<p>127(d)</p>	<p>Elevation 9'- Grids between K to L'. B/C joints and beams underside of level 3 (Refer to Dycore plan for the reference)</p>	<p>A vertical crack, width of 1.4 mm in the beam. 1 mm wide crack underside of the Dycore at the beam-to- beam joint.</p>

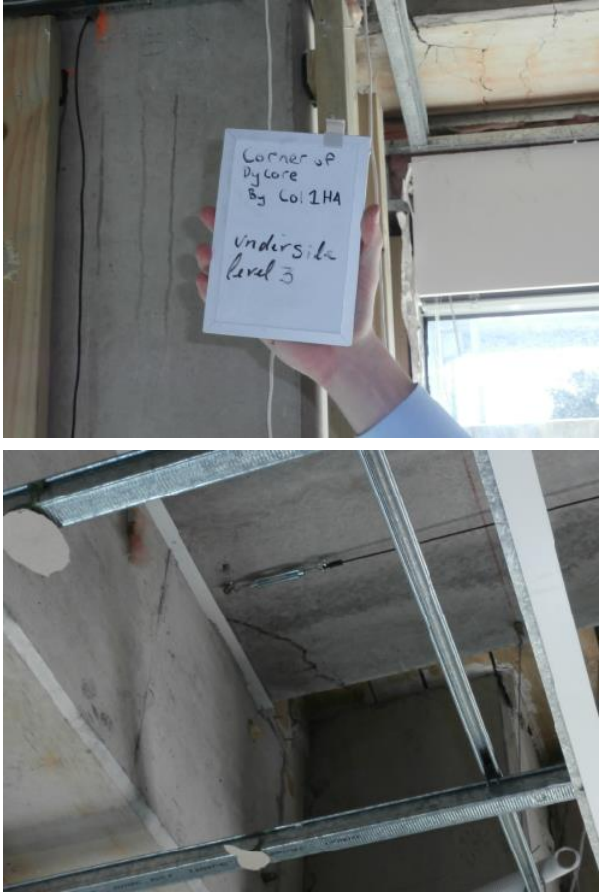
<p>129</p>	<p>Dycore units Underside of level 3. Grid numbers between KA-N and 1-2.</p>	<p>A width of 2 mm diagonal crack, underside of the Dycore unit at location 1/N.</p>

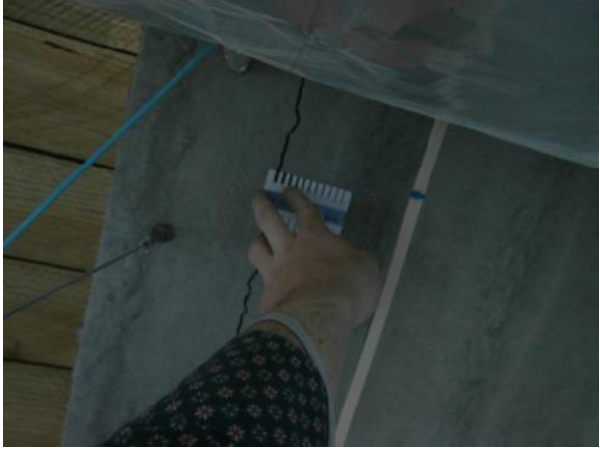
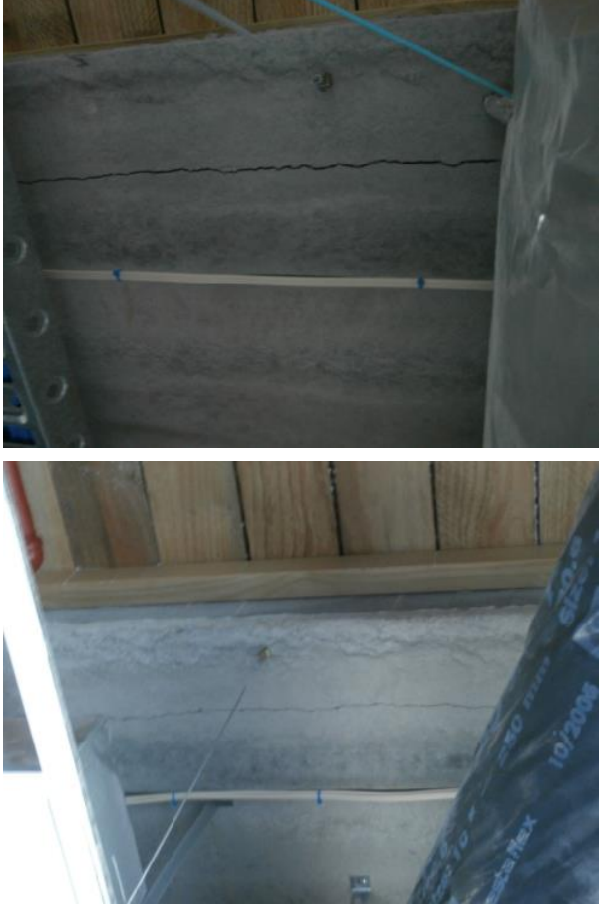
130	Dycore units Underside of level 3. Grid numbers between HA-KA and 2-3.	No visible crack observed	
131	Dycore units Underside of level 3. Grid numbers between KA-N and 2-3.	No visible crack observed	
132	Dycore units Underside of level 3. Grid numbers between HA-KA and 3-8.	A 3.5 mm wide longitudinal crack, underside of the Dycore unit at location HA/6-7

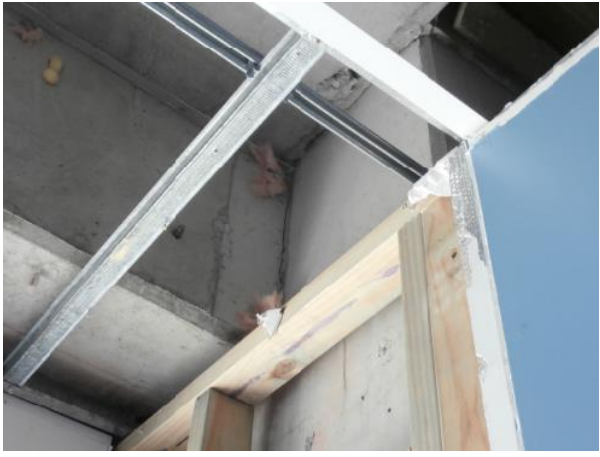
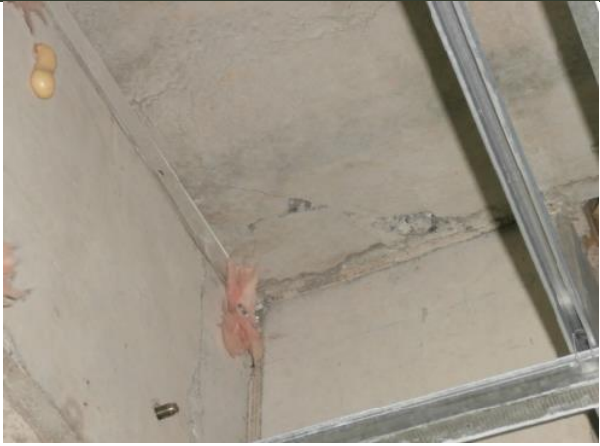
133	Dycore units Underside of level 3. Grid numbers between KA-N and 3-8.	No visible crack observed	
134	Dycore units Underside of level 3. Grid numbers between 8-11 and H-KA.	A 2 mm wide diagonal crack, underside of the Dycore unit at location HA/8A. Loss of concrete and crushed at the corner.

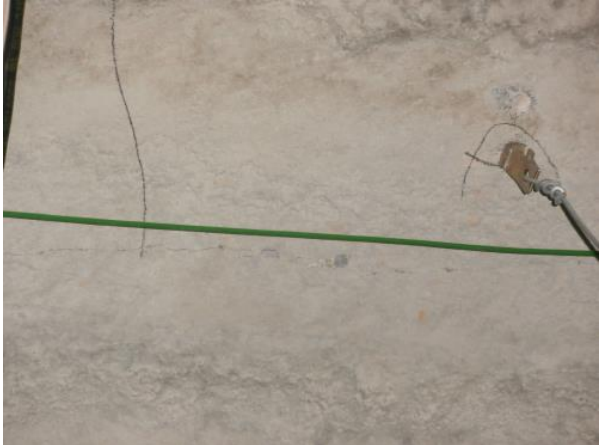
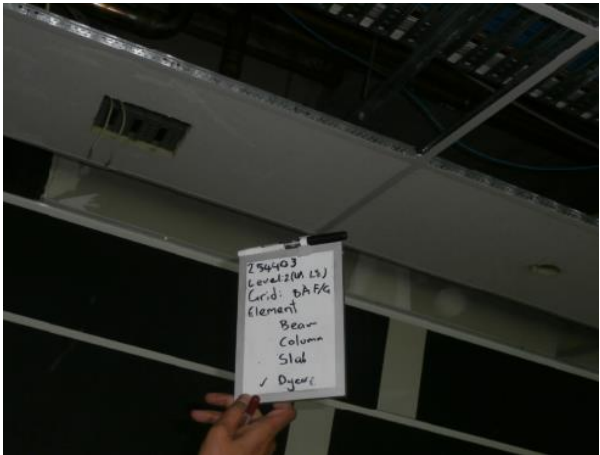
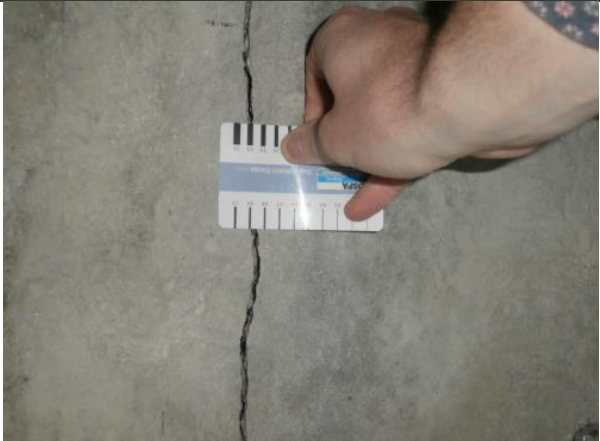
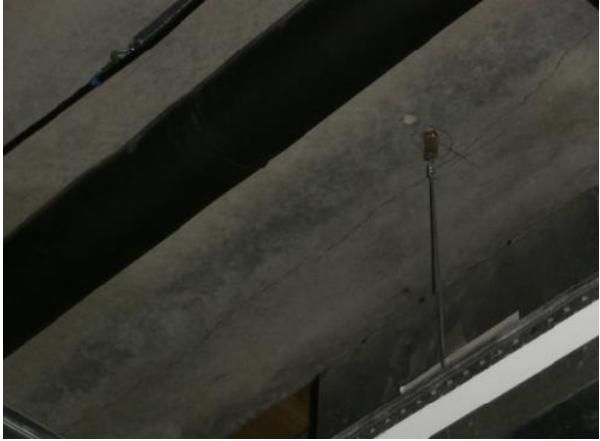
135	Dycore units Underside of level 3. Grid numbers between KA-N and 8-13.	A width of 1 mm diagonal crack, underside of the Dycore unit at location KA/9'.	
136	Dycore units Underside of level 3. Grid numbers between H-N and 11-13.	No visible crack observed	
137	Dycore units Underside of level 3. Grid numbers between 8A-10A and C-H.	A 2mm wide longitudinal crack, underside of the Dycore unit at location 8A/G. A longitudinal crack less than 0.5 mm wide, underside of the Dycore unit at location 8A/F.

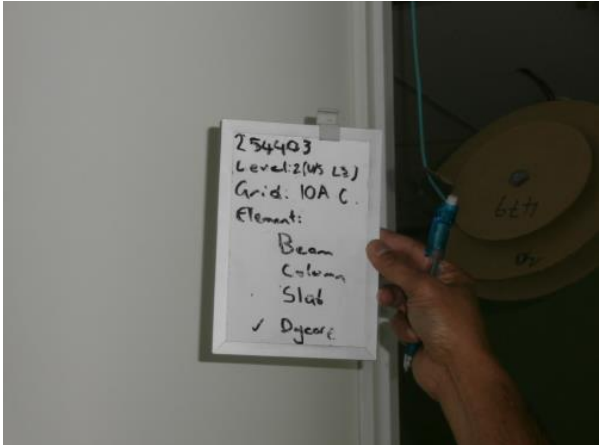
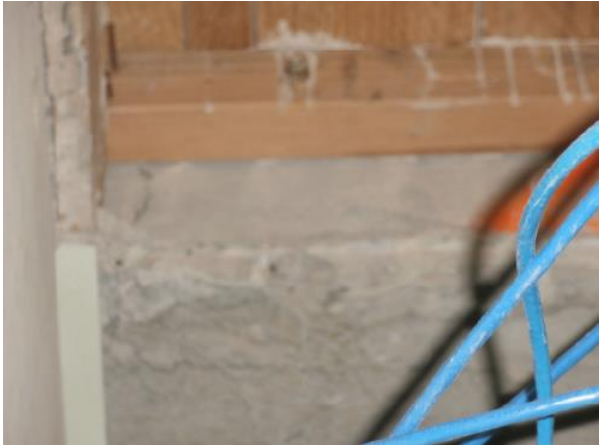
138	Dycore units Underside of level 3. Grid numbers between 13- 10A and C-H.	A longitudinal crack less than 0.5 mm wide, underside of the Dycore unit at location 13/C-H.

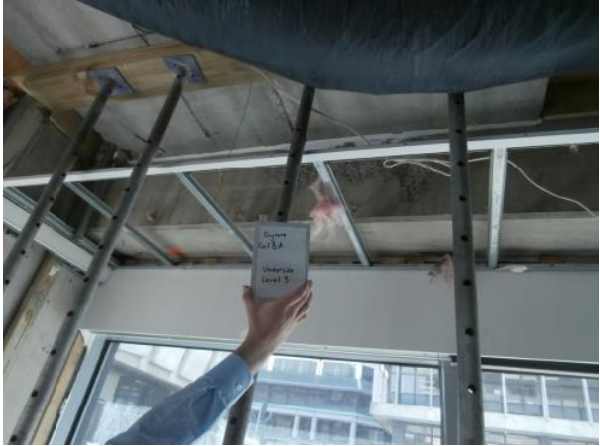
139	Dycore units Underside of level 3. Grid numbers between 8A- 10A and B-C.	No visible crack observed	
140	Dycore units Underside of level 3. Grid numbers between 10A- 13 and B-C.	A longitudinal crack underside of the Dycore unit, at location 13/D A diagonal crack underside of the Dycore unit, at location 10A/C.	
141	Dycore units Underside of level 3. Grid numbers between 8A- 10A and A-B.	A width of 5 mm diagonal crack underside of the Dycore units, at location 8A/A. A transverse crack underside of the Dycore units end. Loss of Dycore unit support. Spalling of concrete in the beam.

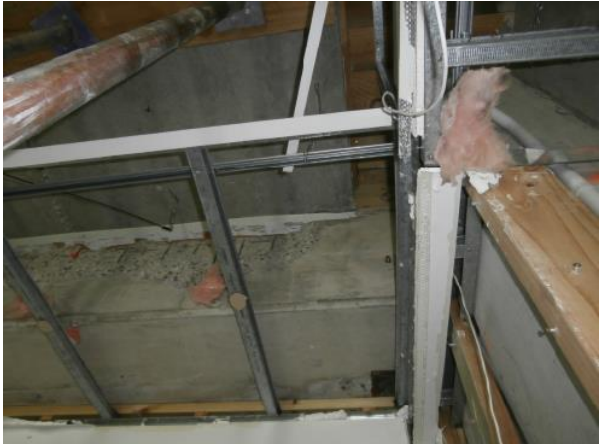
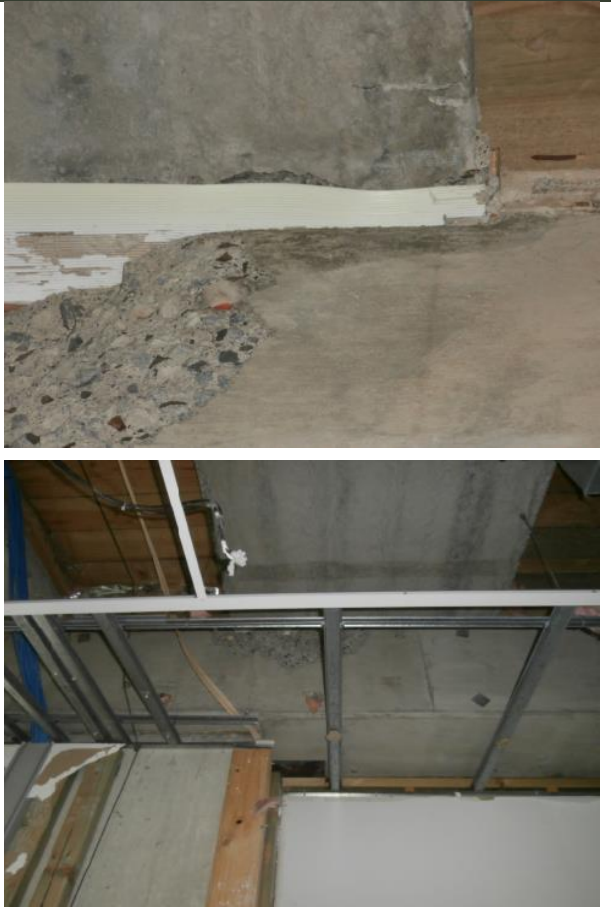
142	Dycore units Underside of level 3. Grid numbers between 10A- 13 and A-B.	A transverse crack. Loss of Dycore unit support. Spalling of cover concrete on beam.

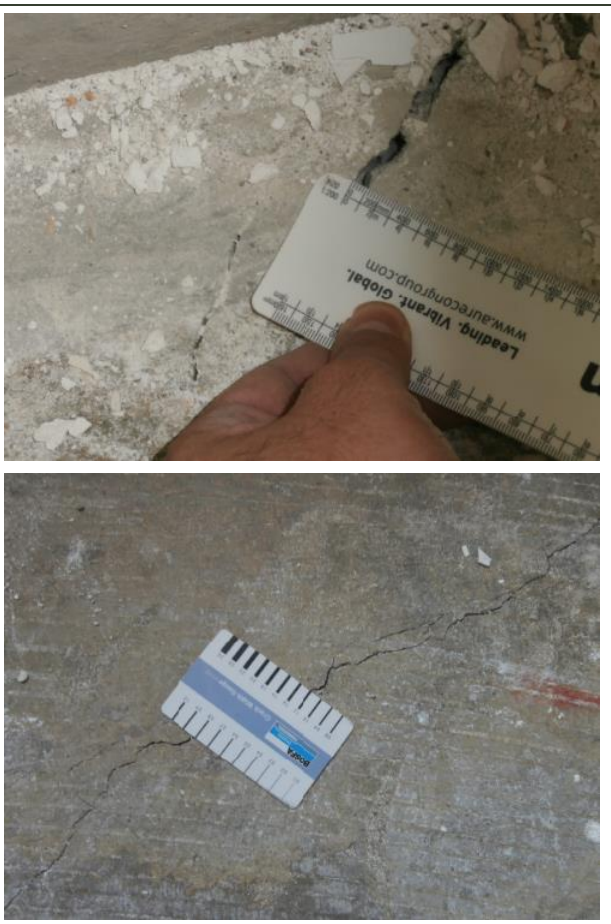
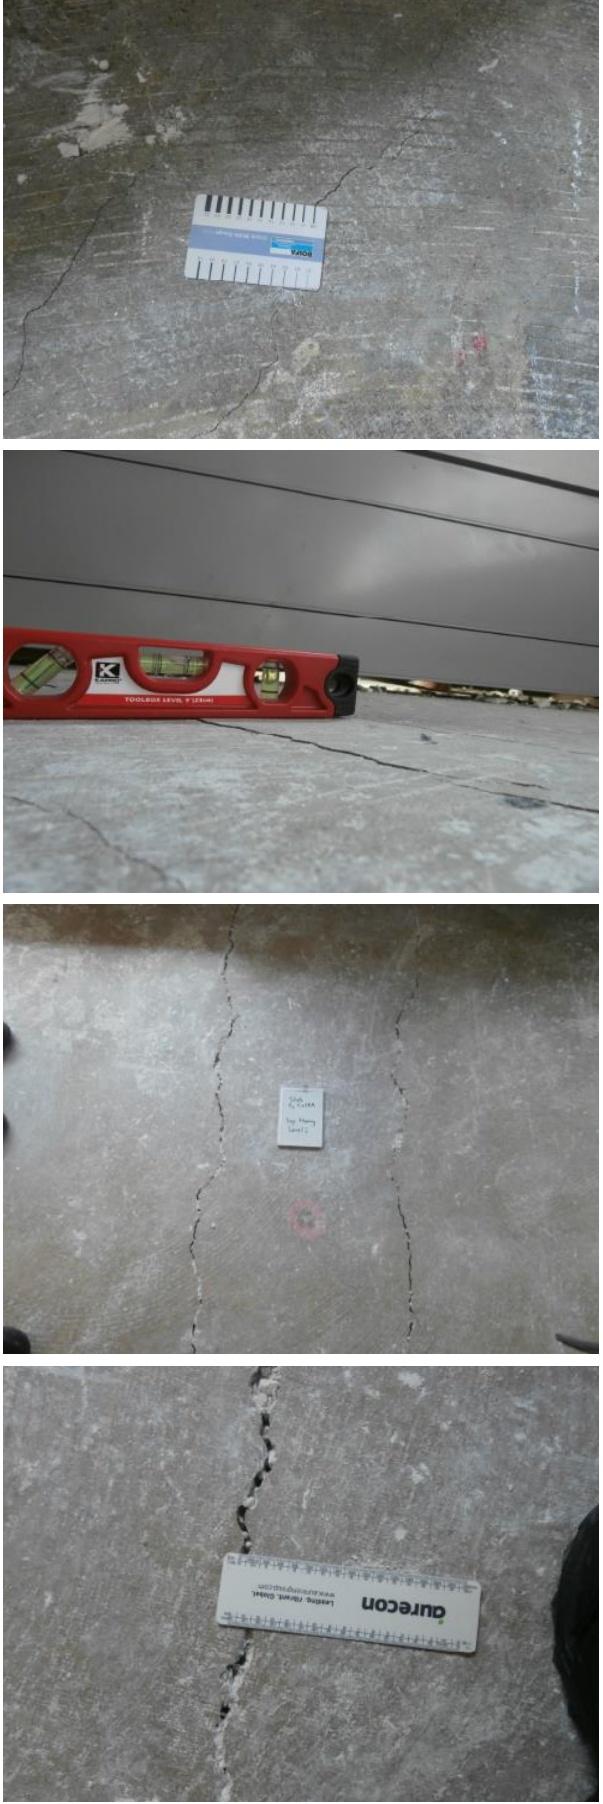
<p>143</p>	<p>Floor slab level 2. Grid numbers between HA-KA and 1-2.</p>	<p>Diagonal cracks on the floor range from 0.8-7 mm wide.</p> <p>Diagonal cracks spread over grid HA/(HA-KA) and 1/2. More cracks around the corner column on grid 1/HA</p> <p>Some of the cracks vertically dislocated.</p> <p>A longitudinal crack 1.8 mm wide along the grid line 2 and between HA to KA.</p> <p>A transverse crack of 7mm wide along the grid line KA and between 1 to 2.</p>

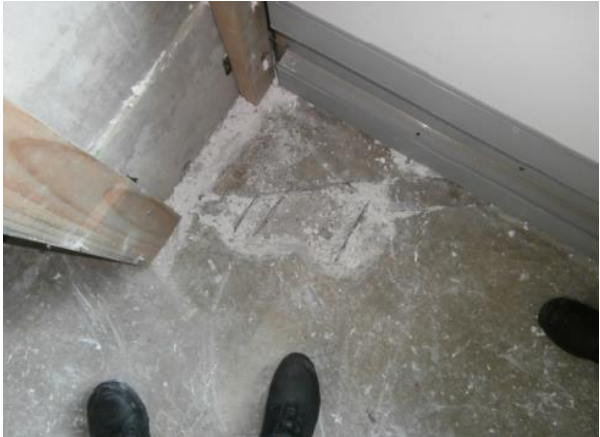
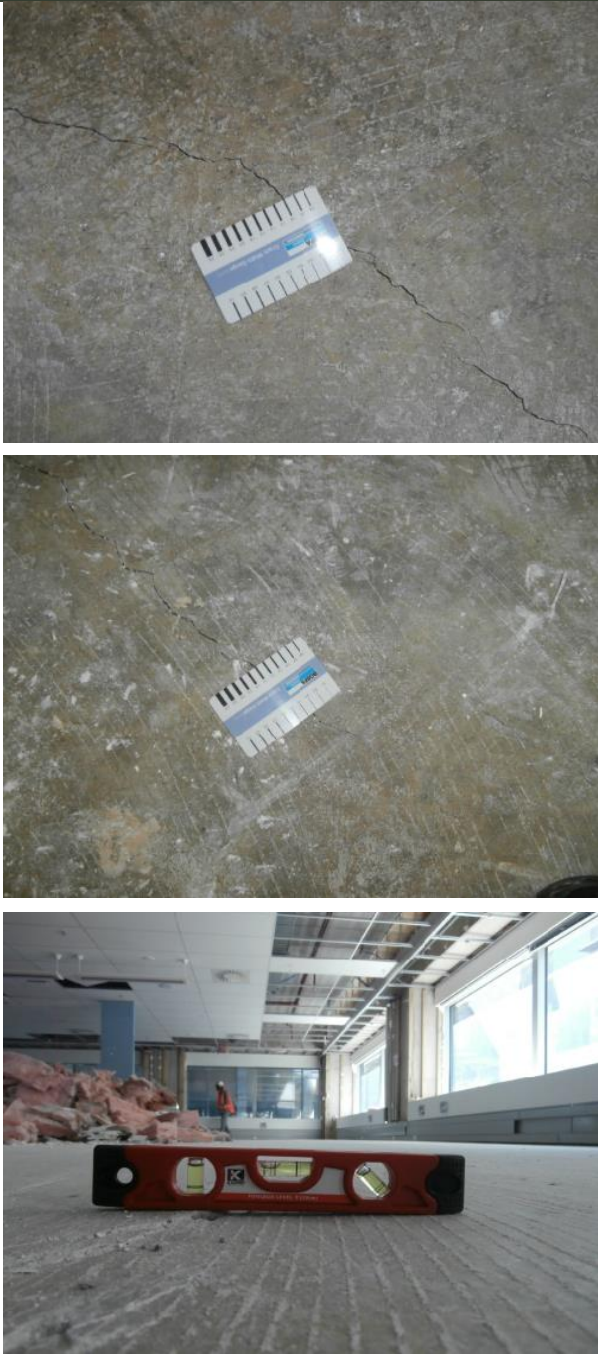
<p>144</p>	<p>Floor slab level 2. Grid numbers between KA-N and 1-2.</p>	<p>Diagonal cracks on the floor range from 1 mm to 1.4 mm wide. More cracks close to the corner column.</p> <p>Cracked concrete topping slab removed to inspect reinforcement. One bar of the mesh was fractured while another mesh bar and one saddle bar were</p>

<p>Some of the cracks vertically dislocated.</p> <p>A longitudinal crack of 5 mm wide along the grid line between KA/N and 2.</p> <p>A transverse crack width of 1.8 mm along the grid KA and between 1 to 2.</p>

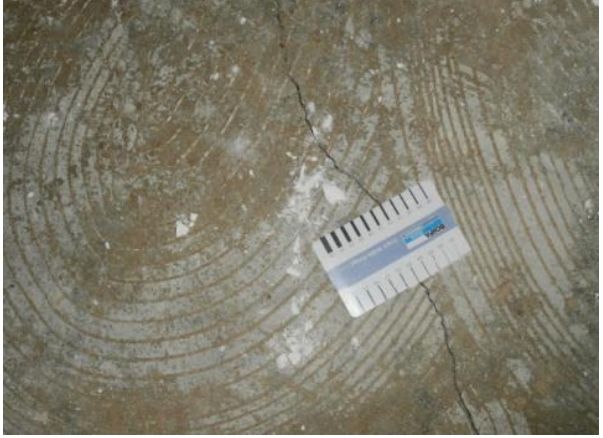
<p>146</p>	<p>Floor slab level 2. Grid numbers between KA-N and 2-3.</p>	<p>Transverse cracks range from 1.2 mm to 2.5 mm wide around the column.</p> <p>A longitudinal crack of 1.4mm wide on the floor along the grid KA/N and between 2/3</p>	 
------------	---	---	---

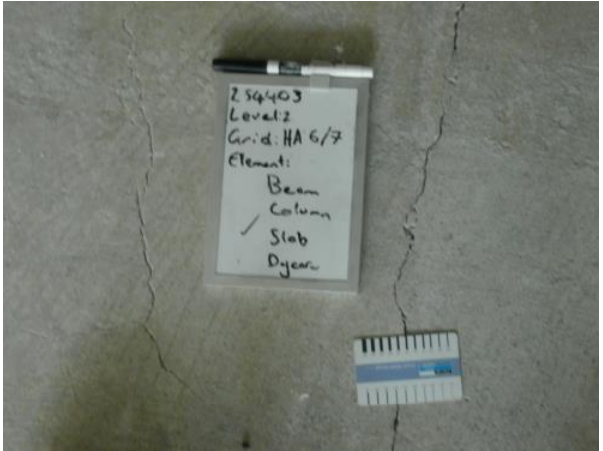
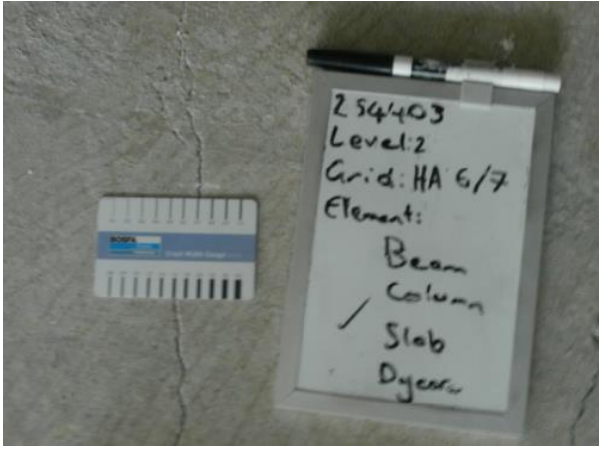
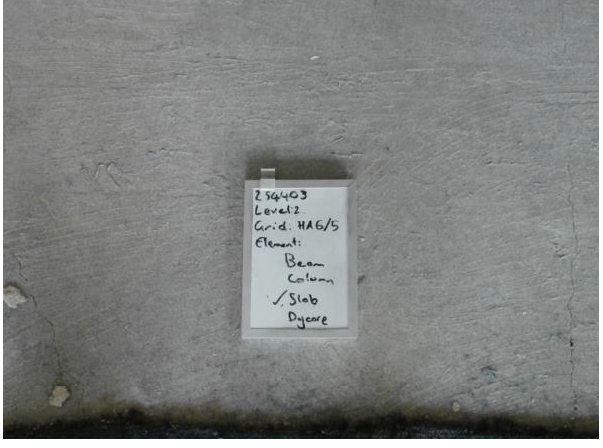
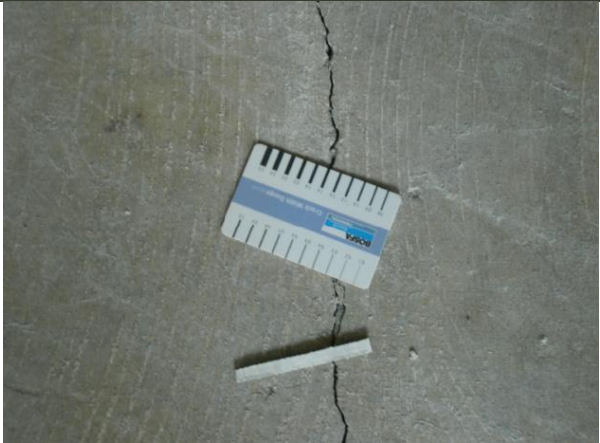
147	Floor slab level 2. Grid numbers between HA-KA and 3-8.	Longitudinal cracks range from 0.7 mm 1.6 mm wide over the grid area between HA/KA and 3/8.

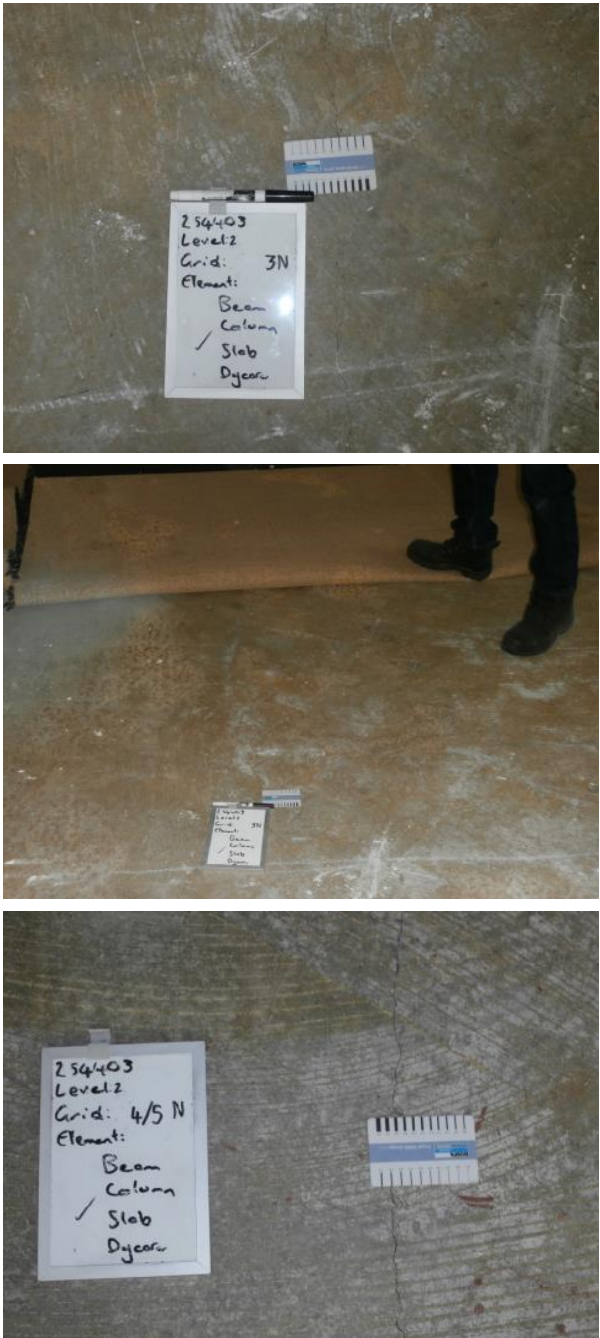
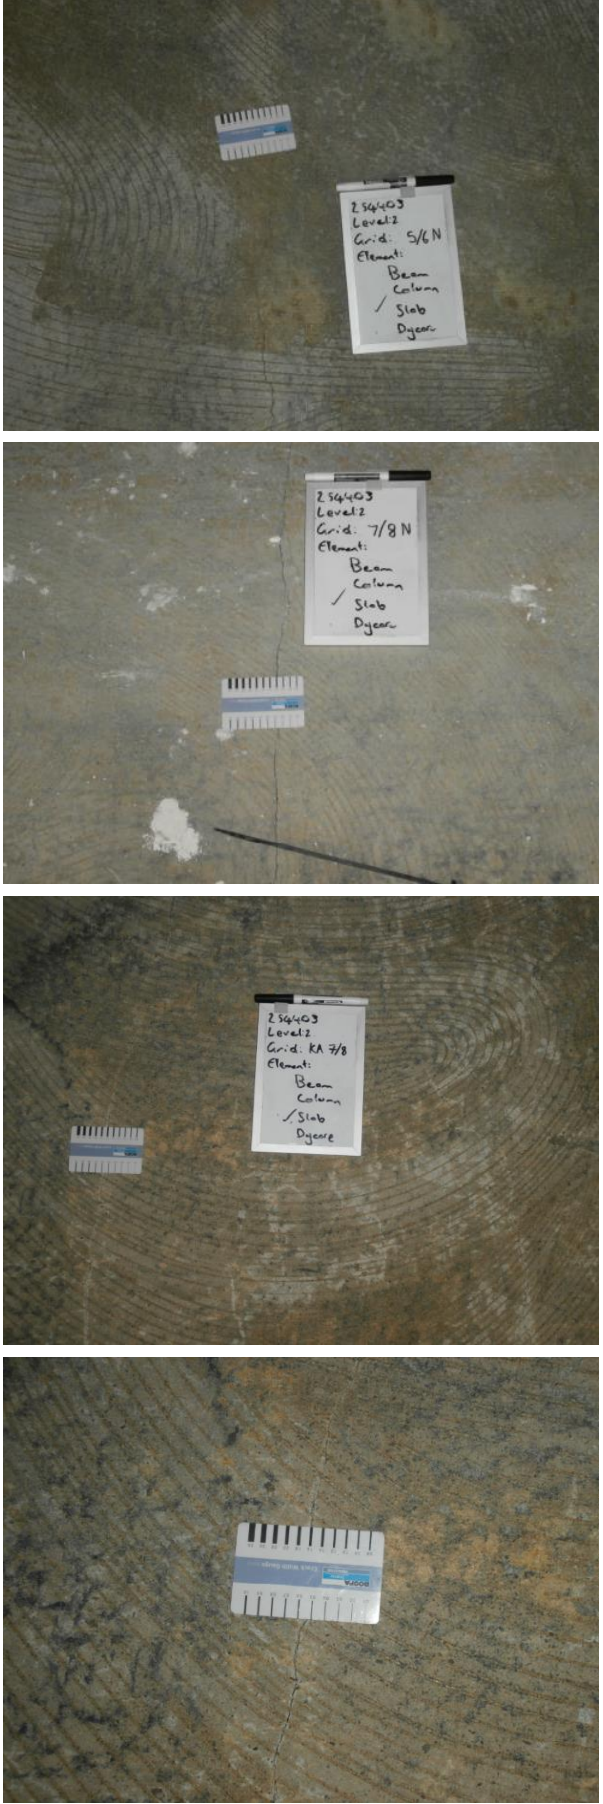
<p>148</p>	<p>Floor slab level 2. Grid numbers between KA-N and 3-8.</p>	<p>Longitudinal cracks range from 0.9 mm 1.6 mm wide over the grid area between KA/N and 3-8.</p>

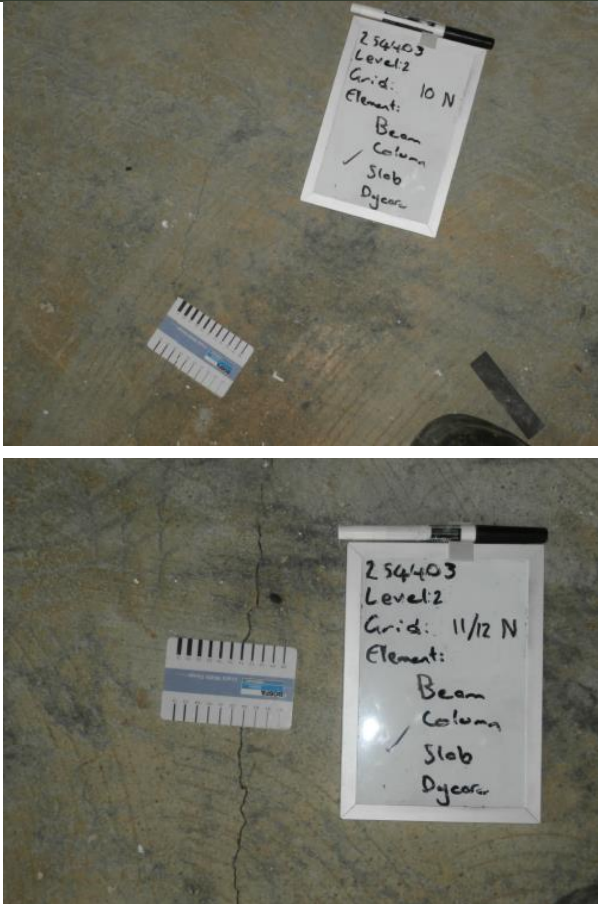
<p>149</p>	<p>Floor slab level 2. Grid numbers between HA-KA and 8-11.</p>	<p>Two longitudinal cracks 3.5 mm and 1.8 mm wide over the grid area between HA/KA and 8-11.</p>	
<p>150</p>	<p>Floor slab level 2. Grid numbers between KA-N and 8-13.</p>	<p>Longitudinal cracks range from 1.2 mm and 1.4 mm wide over the grid area between HA/N and 8/13.</p>

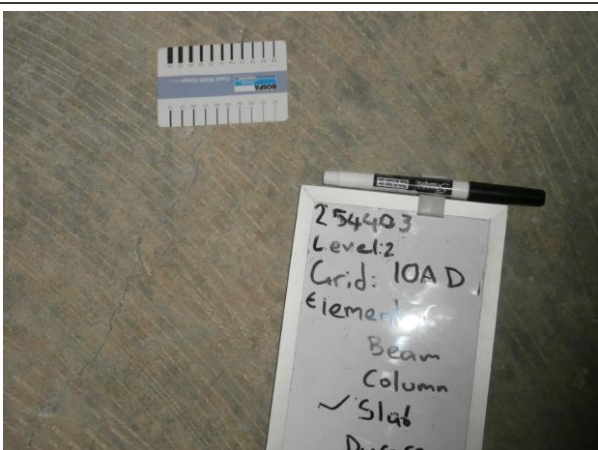
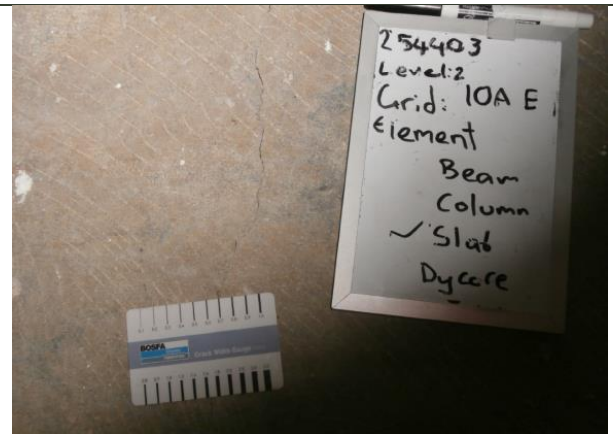
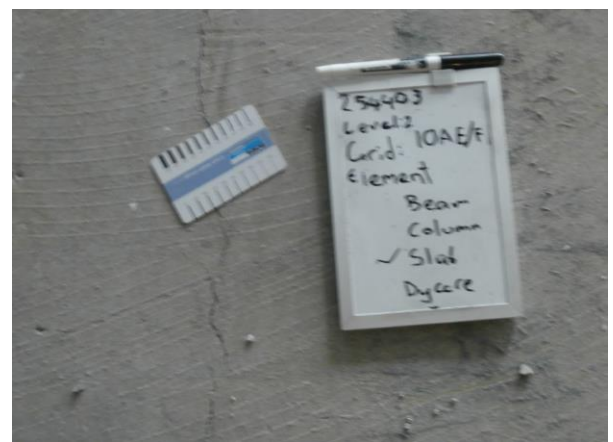
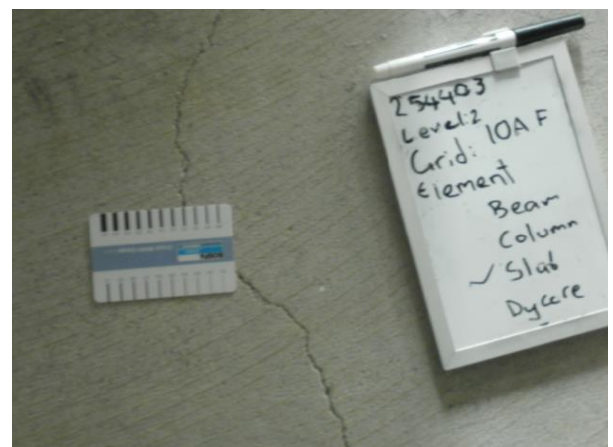
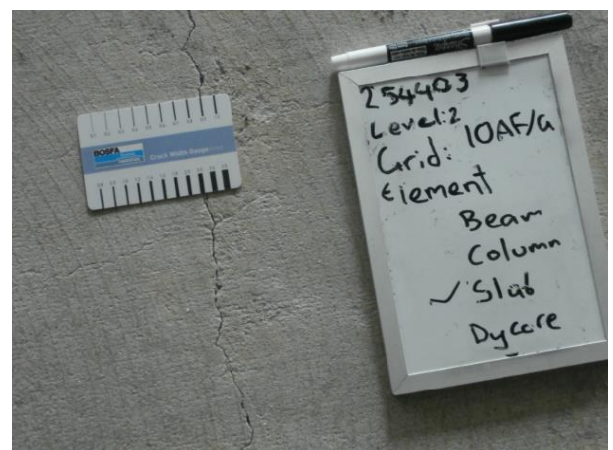
151	Floor slab level 2. Grid numbers between 10A-13 and H-N.	Carpet had not been removed at the time of our inspection.	
152	Floor slab level 2. Grid numbers between 10A-8A and C-H.	Longitudinal cracks range from 1 mm and 3.5 mm wide over the grid area between 10A/8A and C/H.

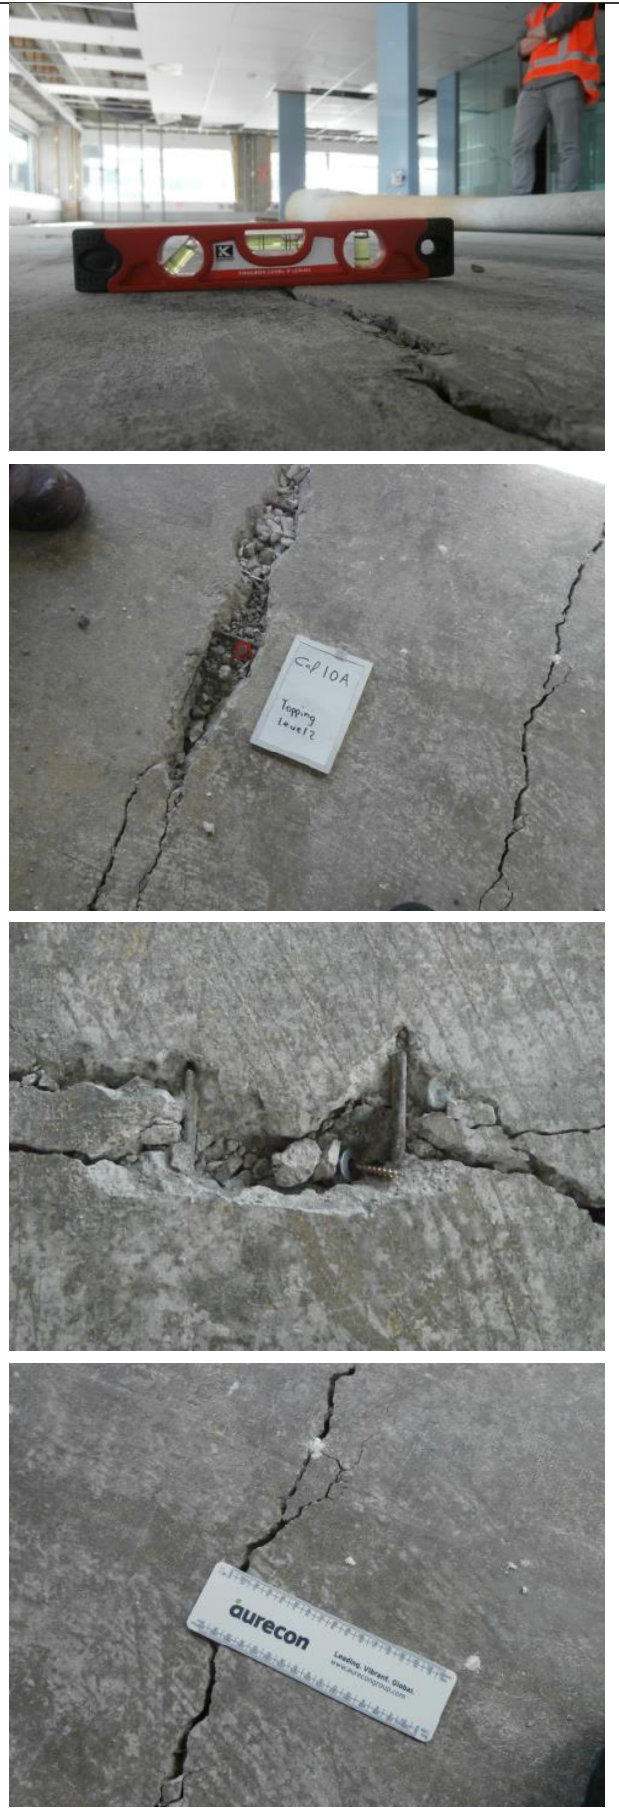
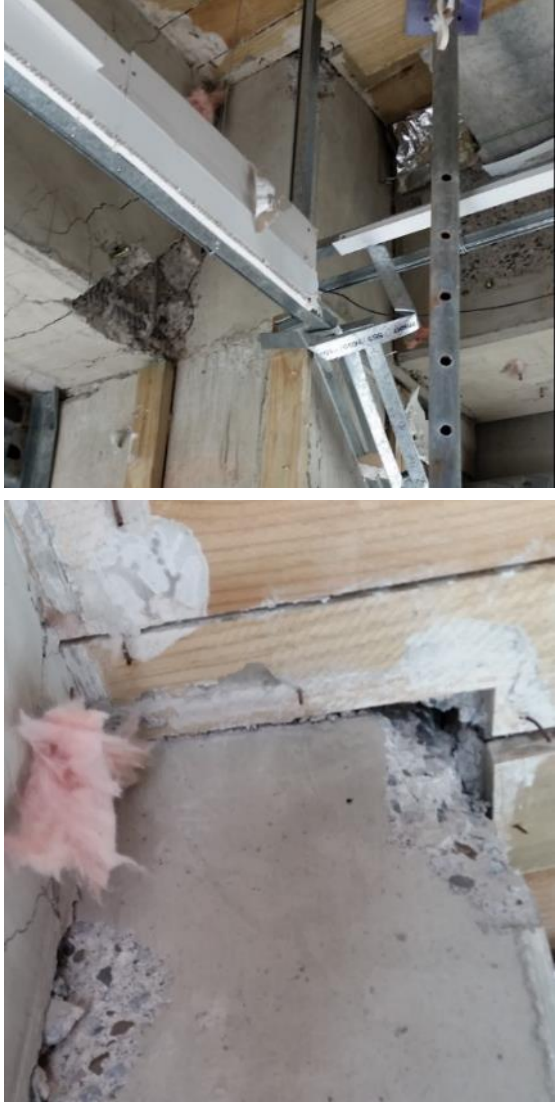
ID.	Location	Comment	Photographs
158	Elevation 8A- Grid A. Beam column joint underside of level 4	<p>Width of vertical crack in the beam column joint is approximately 10 mm.</p> <p>Diagonal cracks on beam continuing to underside of the beam.</p> <p>Loss of concrete in the beam and in the column.</p> <p>Vertical cracks along the beam length. Width of the cracks range from 0.1-0.7 mm</p>

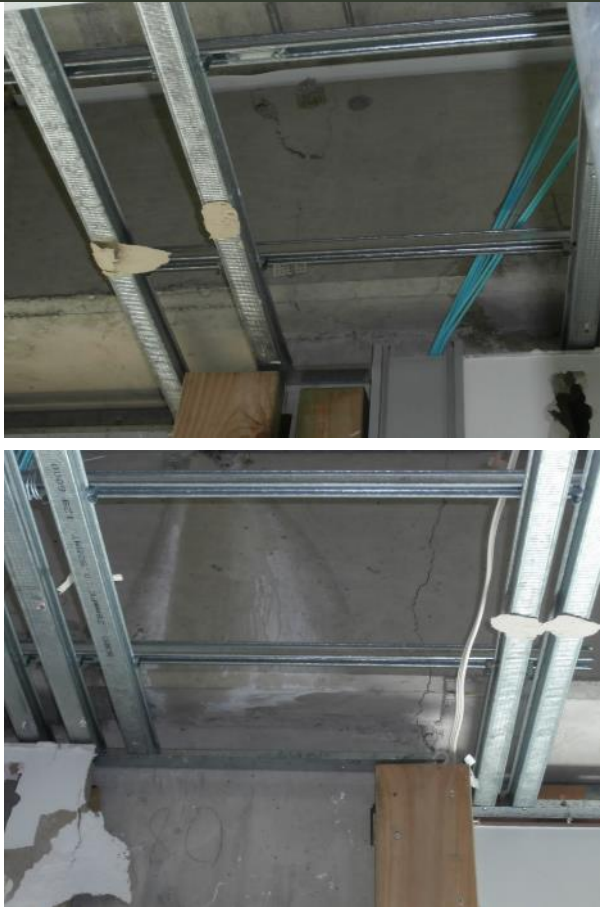
<p>161/162</p>	<p>Elevation 8A-Grid C. Beam column joint underside of level 4</p> <p>DS 1 2.0%</p>	<p>Vertical cracks in the beam column joint are 2.5 mm wide.</p> <p>Damage around the joint and spalling of concrete.</p>

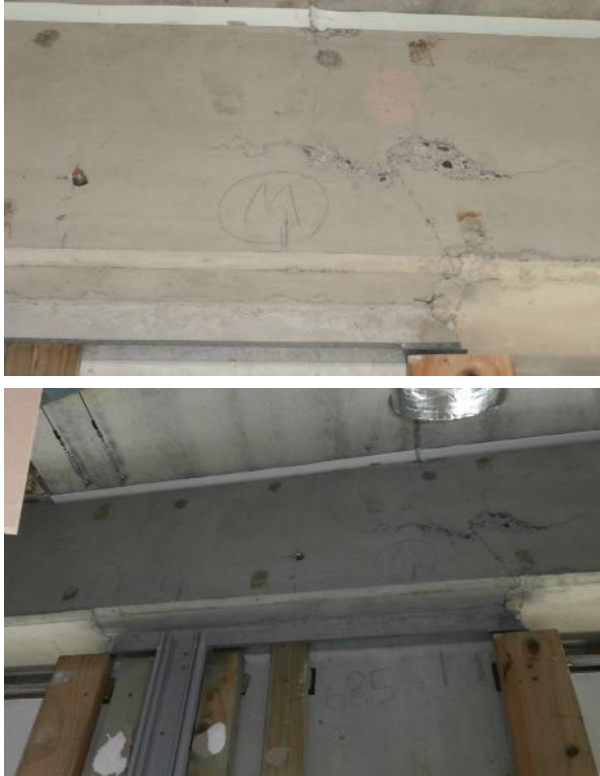
<p>163/164</p>	<p>Elevation 8A- Grid D. Beam column joint underside of level 4</p> <p>DS 1 2.0%</p>	<p>Combination of vertical and diagonal cracks in the beam column joint. Width of the cracks are approximately 2 mm.</p> <p>Diagonal crack in the column.</p> <p>Spalling of concrete in the beam column joint.</p> <p>Vertical cracks along the beam length.</p>
