Resilient Repair Guide Source Report: Case Study Annex

APPLIED TECHNOLOGY COUNCIL
201 Redwood Shores Parkway, Suite 240
Redwood City, California 94065
www.ATCouncil.org

FEDERAL EMERGENCY MANAGEMENT AGENCY
Michael Mahoney, Project Officer
William T. Holmes, Technical Monitor
Washington, D.C.

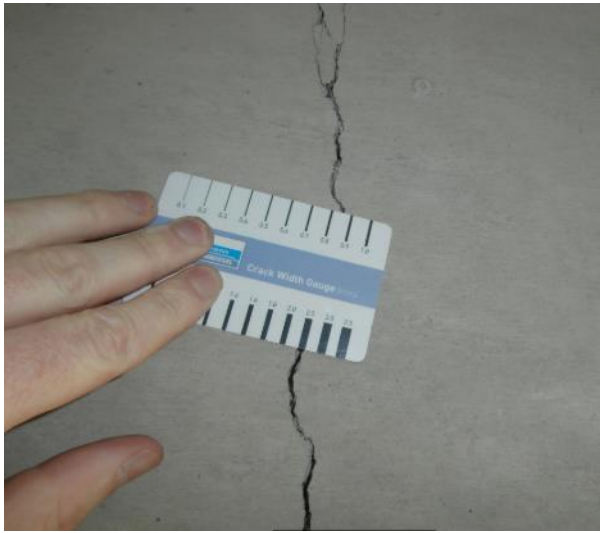
<p>165/166</p>	<p>Elevation 8A-Grid E. Beam column joint underside of level 4 DS 1 2.0%</p>	<p>Width of vertical cracks in the plastic hinge region of the beam range from 2-2.5 mm. Spalling of concrete in the beam column joint. Three vertical cracks along the beam length.</p>

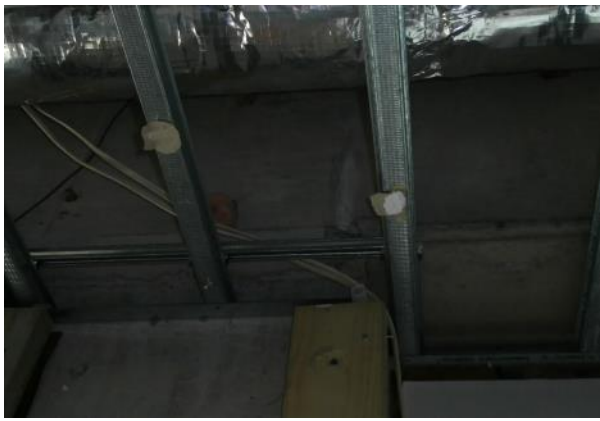
<p>167/168</p>	<p>Elevation 8A-Grid F. Beam column joint underside of level 4 DS 1 2.0%</p>	<p>Vertical cracks at the beam column joint are 2 mm wide. Approximately two vertical cracks along the beam length.</p>

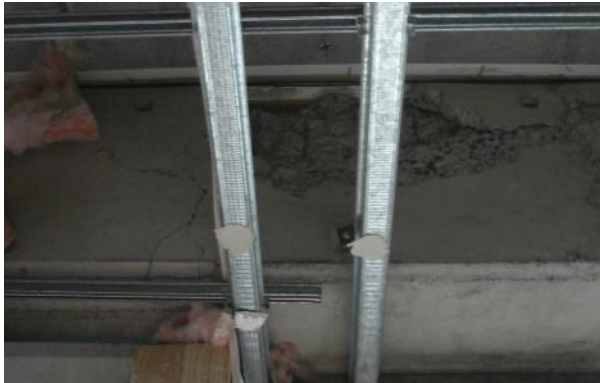
<p>169/170</p>	<p>Elevation 8A-Grid G. Beam column joint underside of level 4 DS 1 2.0%</p>	<p>Vertical cracks at the beam column joint are 2 mm wide. A diagonal crack in the beam column joint. Loss of cover concrete in the beam. Hairline vertical cracks along the beam length.</p>

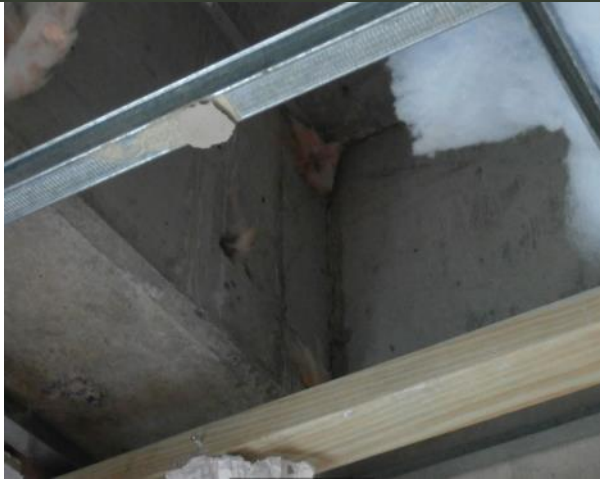
173	Elevation 8A- Grid HA. Beam column joint underside of level 4 DS 1 2.0%	A 2 mm wide vertical crack in the beam column joint.

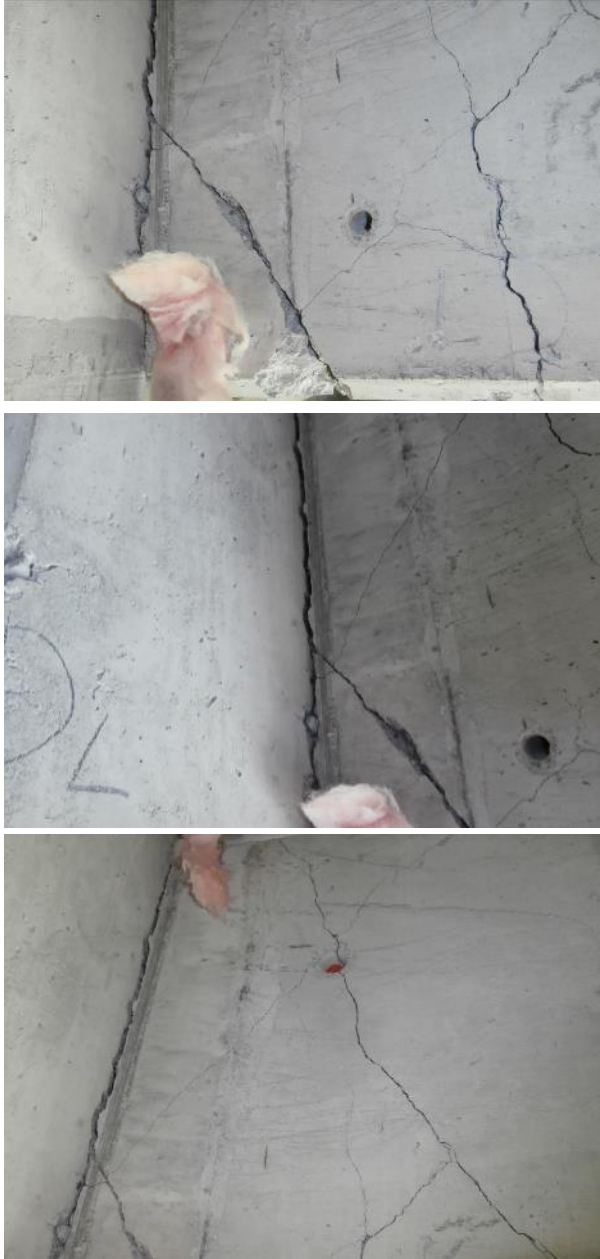
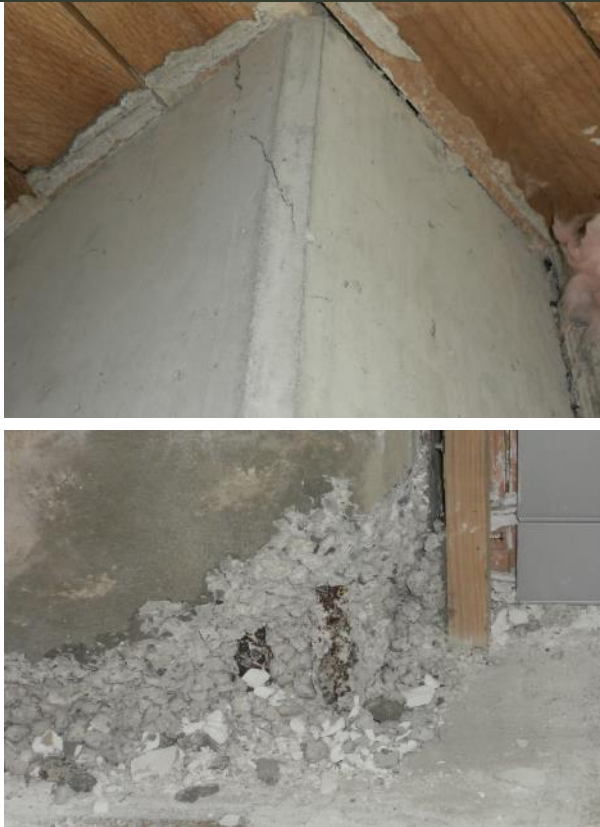
<p>174</p>	<p>Elevation 1- Grid HA. Beam column joint underside of level 4</p> <p>DS 1 2.0%</p>	<p>Combination of vertical and diagonal cracks around the beam column joint. Width of the cracks range from 1-5 mm.</p> <p>Loss of cover concrete in the joint and concrete crushed.</p> <p>Column toe had honey combed concrete.</p> <p>Rusty longitudinal column bars were visible.</p> <p>Combination of diagonal and vertical cracks along the beam length.</p>

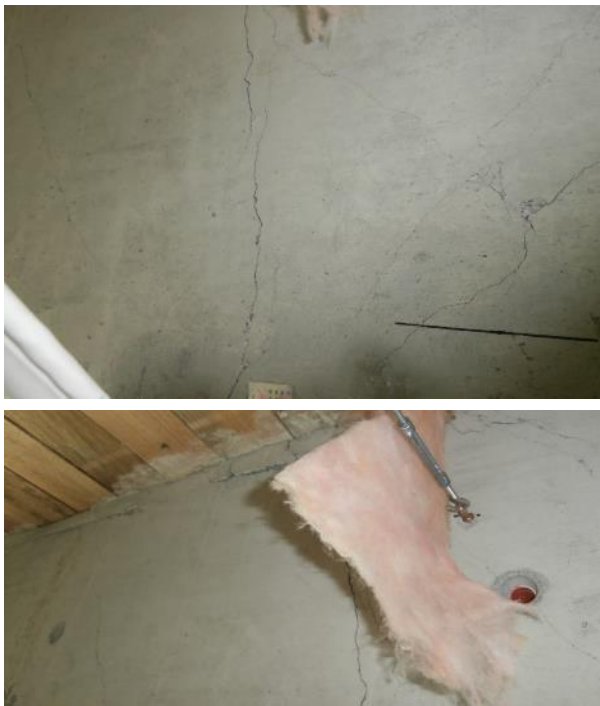
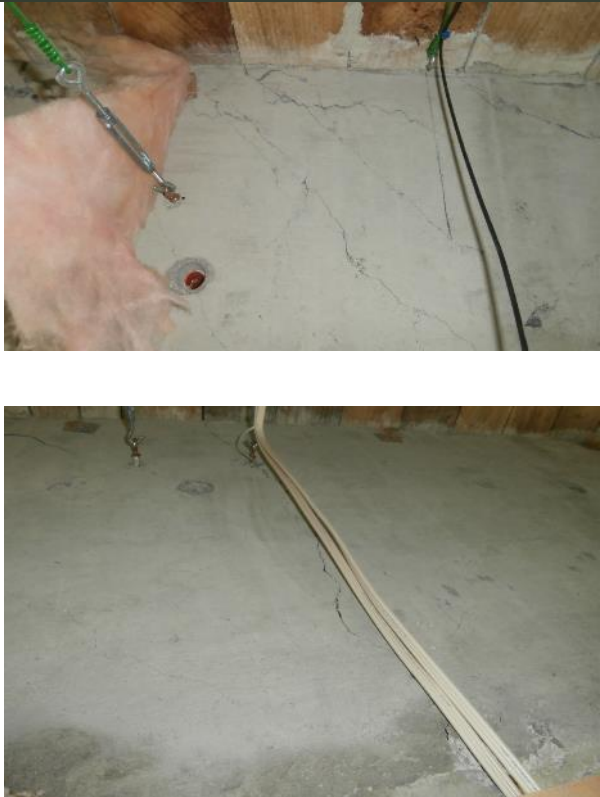
<p>175/176</p>	<p>Elevation 1- Grid HA/KA. Beam column joint underside of level 4</p> <p>DS 1 2.0%</p>	<p>Combination of diagonal and vertical cracks around the beam column joint. Width of the cracks range from 0.6-1.4 mm.</p> <p>Concrete crushed around the joint. Diagonal hairline cracks in the column.</p> <p>Approximately 7 hairline cracks along the beam length.</p>

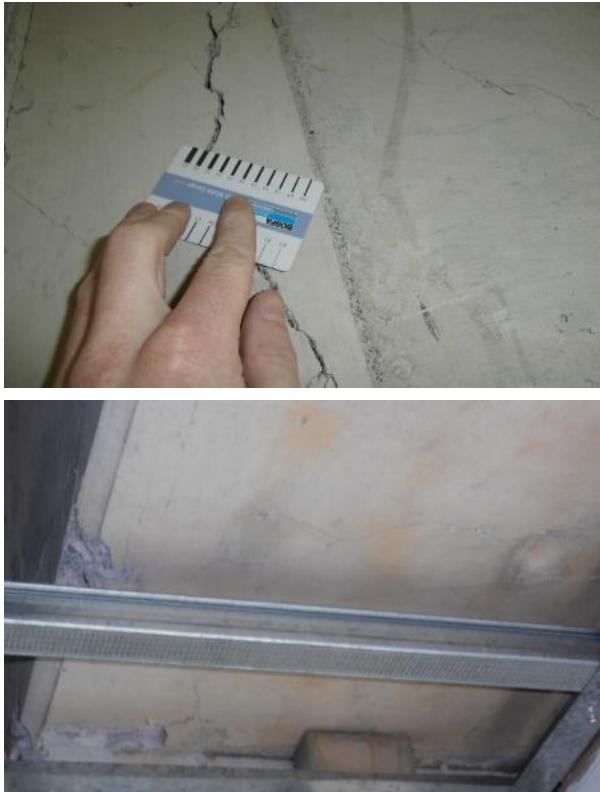
<p>177/178</p>	<p>Elevation 1- Grid KA. Beam column joint underside of level 4</p> <p>DS 1 2.0%</p>	<p>Combination of diagonal and vertical cracks around the B/C joint.</p> <p>Width of the cracks range from 0.6-3 mm.</p> <p>Spalling of concrete around the beam column joint.</p> <p>Diagonal hairline cracks in the column.</p> <p>Approximately 6 hairline cracks along the beam length.</p>

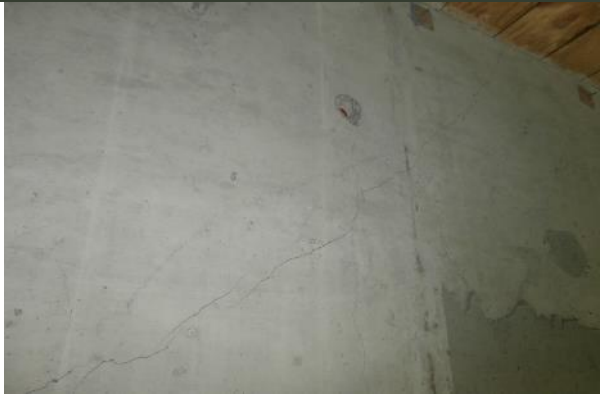
179/180	Elevation 1- Grid KA/N. Beam column joint underside of level 4 DS 0 1 %	Combination of diagonal and vertical cracks around the beam column joint. Width of the cracks range from 0.5-1.2 mm. Diagonal hairline cracks in the column. Approximately 8 hairline cracks along the beam length.

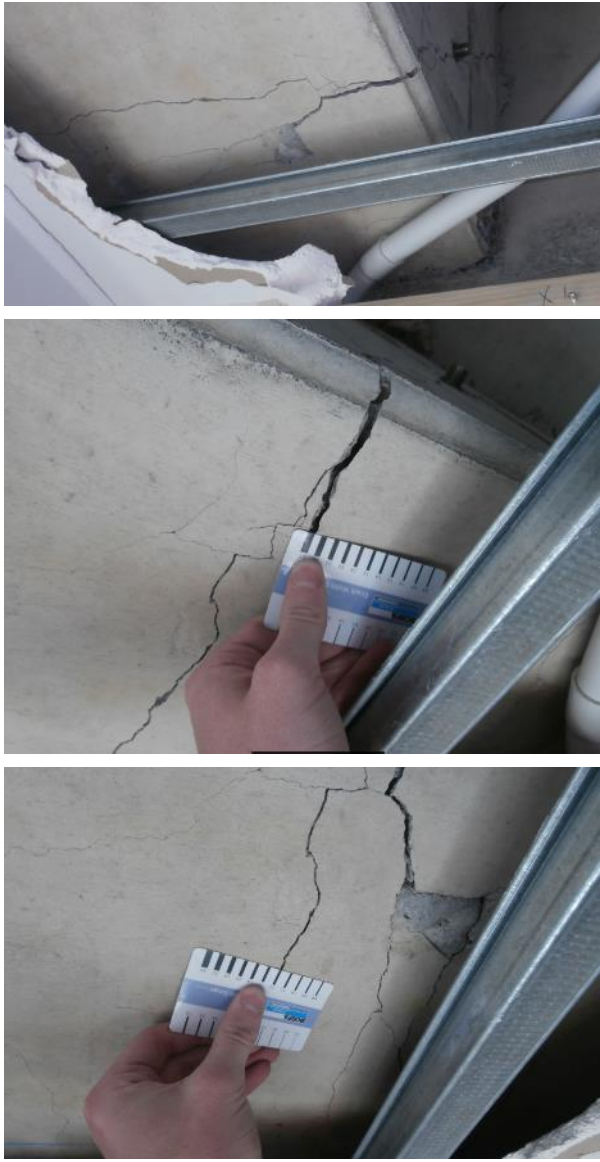
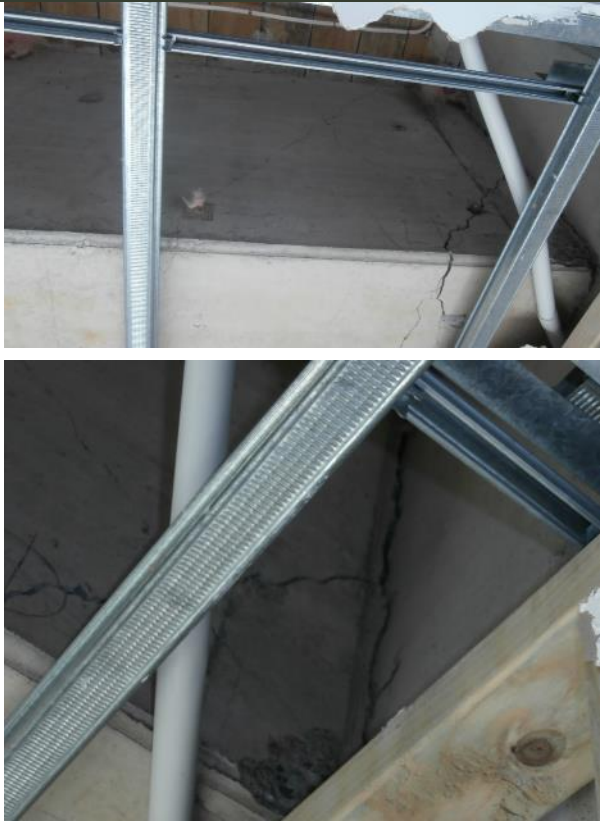
181	Elevation 1- Grid N. Beam column joint underside of level 4 DS 1 2.0%	Combination of diagonal and vertical cracks around the beam column joint. Width of the cracks range from 1.4-3.5 mm. Diagonal hairline cracks in the column. Concrete spalled off in the beam.

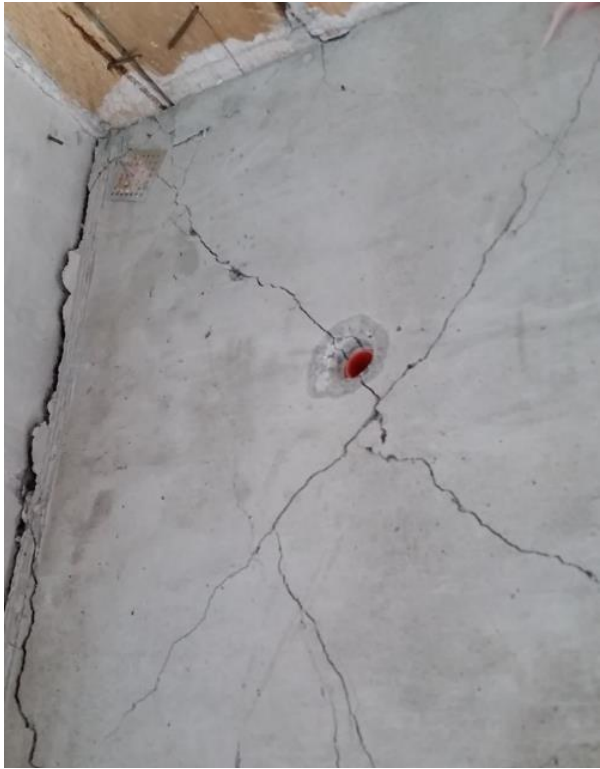
182	Elevation A-Grid 13. Beam column joint underside of level 4 DS 1 2.0%	Combination of diagonal and vertical cracks around the beam column joint. Width of the cracks range from 0.9-3 mm. Diagonal cracks less than 0.5 mm wide along the beam.

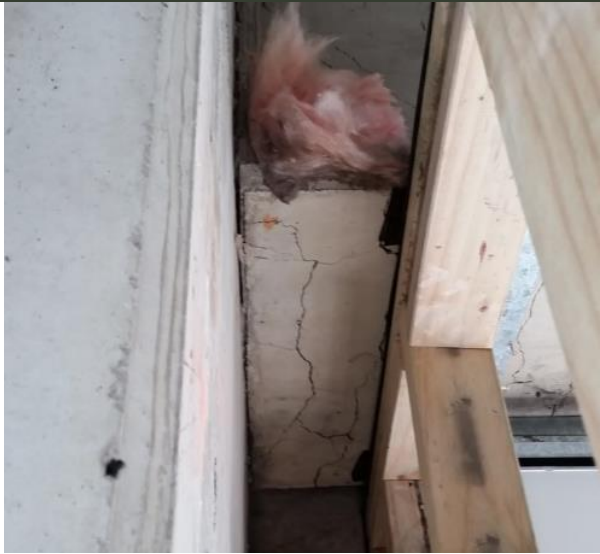
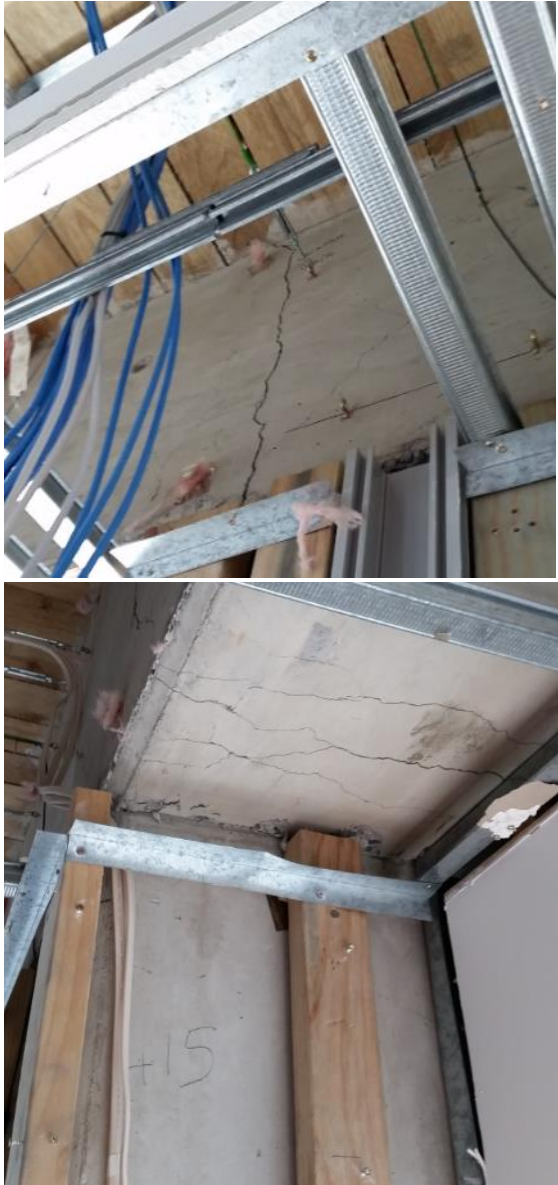
<p>183/184</p>	<p>Elevation A-Grid 13/10A. Beam column joint underside of level 4</p> <p>DS 2 2.75%</p>	<p>Combination of diagonal and vertical cracks around the beam column joint. Width of the cracks range from 1.2-5 mm. Diagonal hairline cracks in the column. Loss of concrete, crushed and spalled off in the beam column joint. Diagonal hairline cracks along the beam length.</p>

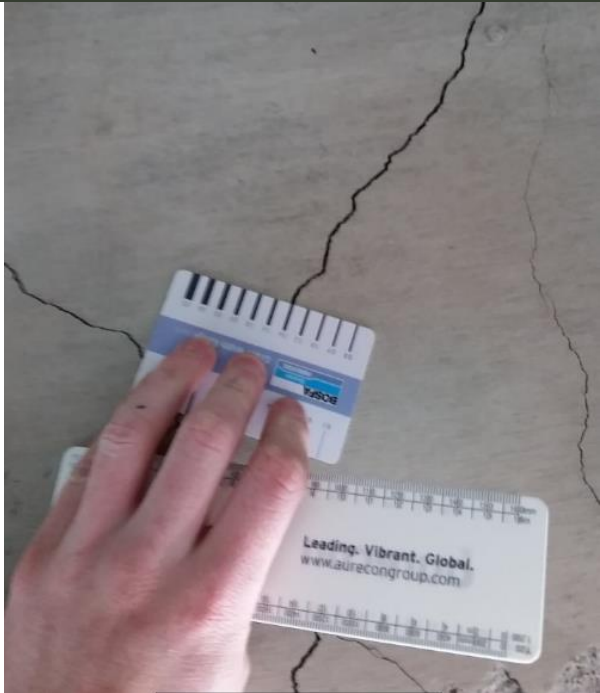
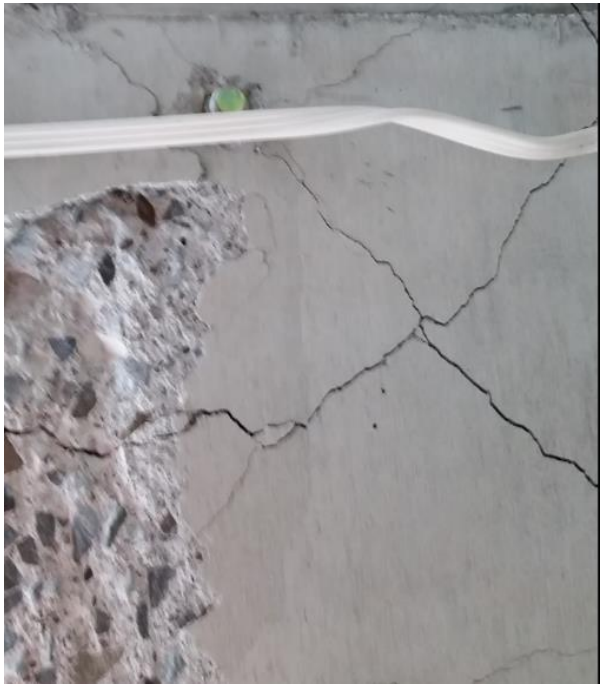
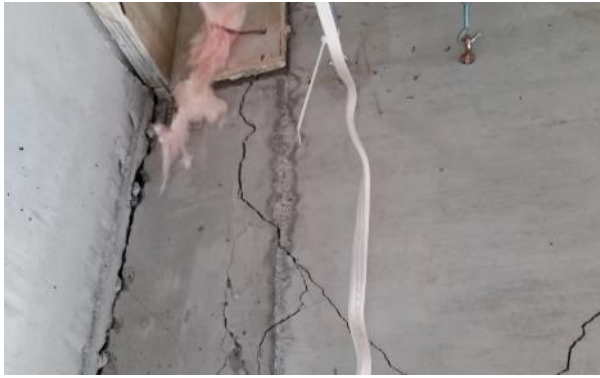
<p>185/186</p>	<p>Elevation A- Grid 10A. Beam column joint underside of level 4</p> <p>DS 1 2.0%</p>	<p>Combination of diagonal and vertical cracks around the beam column joint. Width of the cracks range from 1.4-3 mm. Loss of concrete in the beam column joint. Diagonal hairline cracks in the column.</p>	 
----------------	---	--	---

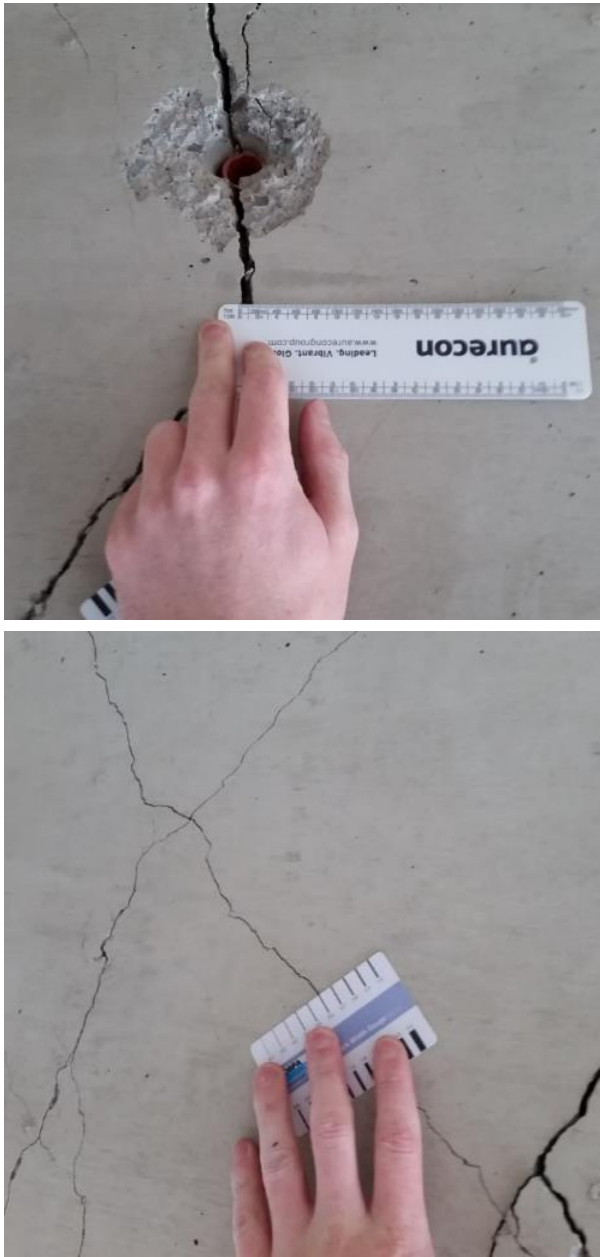
187/188	Elevation A-Grid 10A/8A. Beam column joint underside of level 4	Combination of diagonal and vertical cracks around the beam column joint. Width of the cracks range from 0.6 - 7 mm. Diagonal hairline cracks in the column.

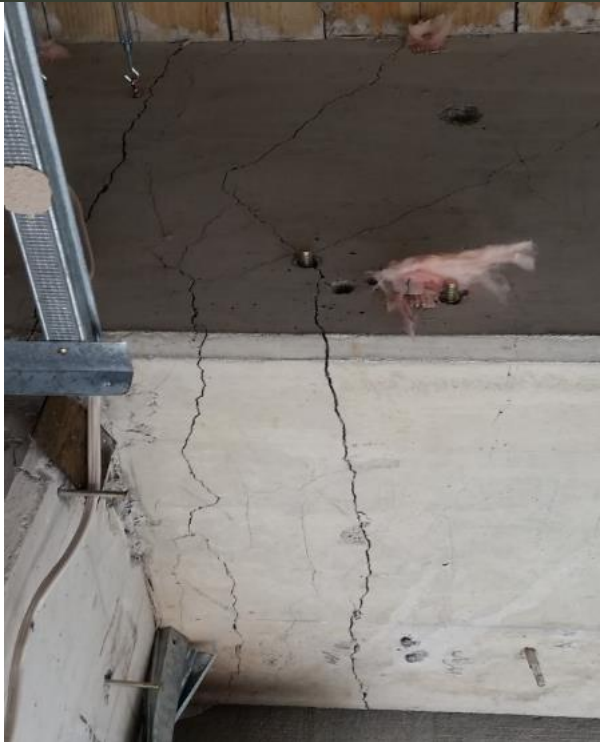
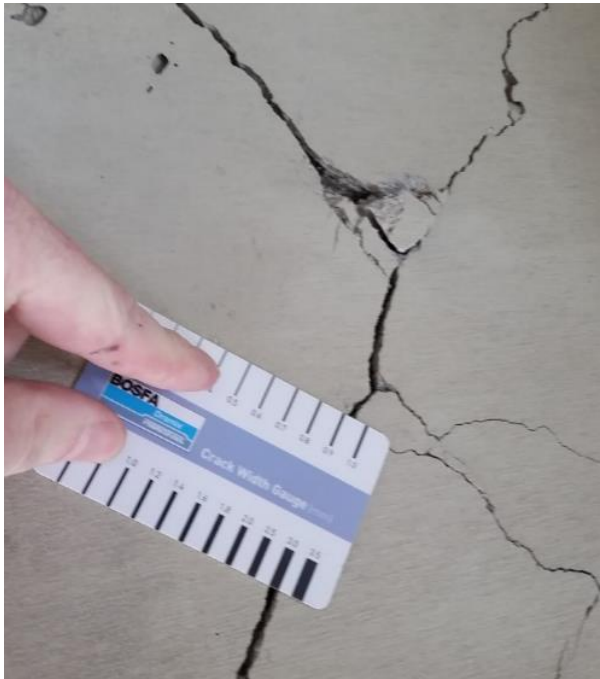
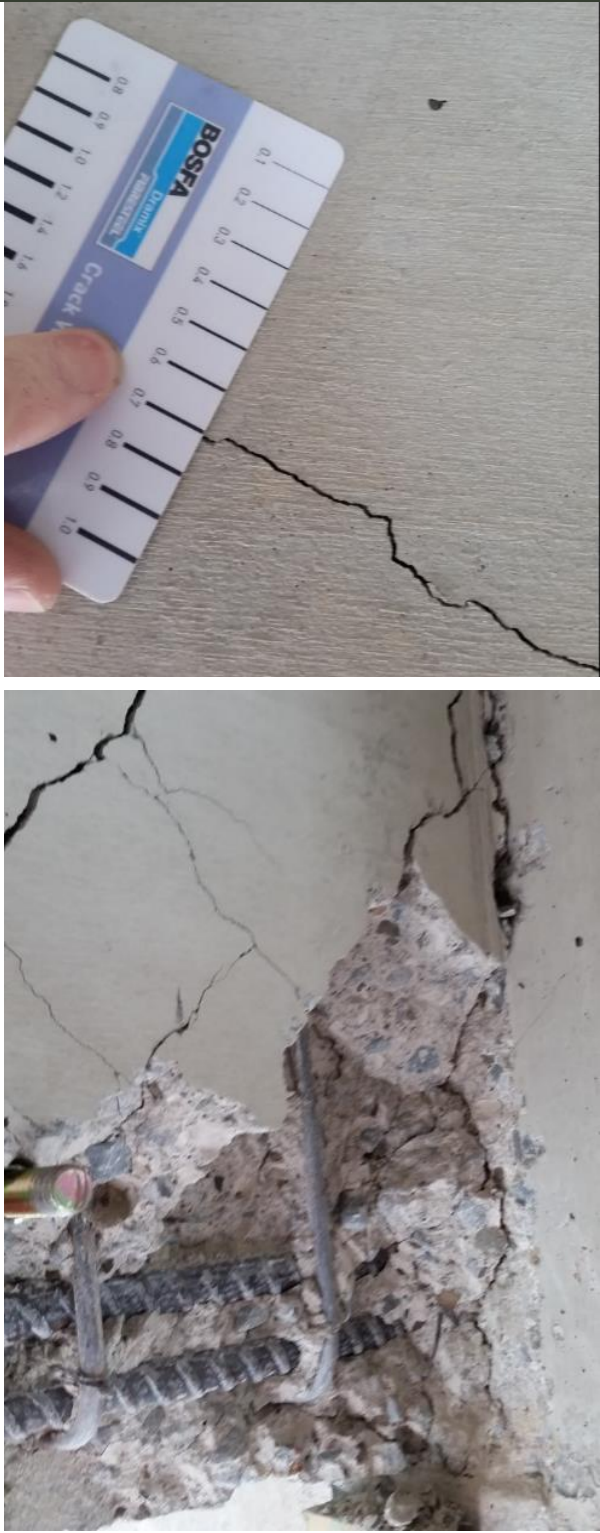
<p>189</p>	<p>Elevation A-Grid 8A. Beam column joint underside of level 4</p> <p>DS 3 5.0%</p> <p>DS 2 2.75%</p>	<p>Combination of diagonal and vertical cracks around the beam column joint. Width of the cracks is approximately 3 mm.</p> <p>Loss of concrete in the beam and the reinforcement is exposed.</p> <p>No fracture in the stirrups observed.</p> <p>Loss of concrete in the column.</p> <p>Conceret crushed in the beam column joint.</p>

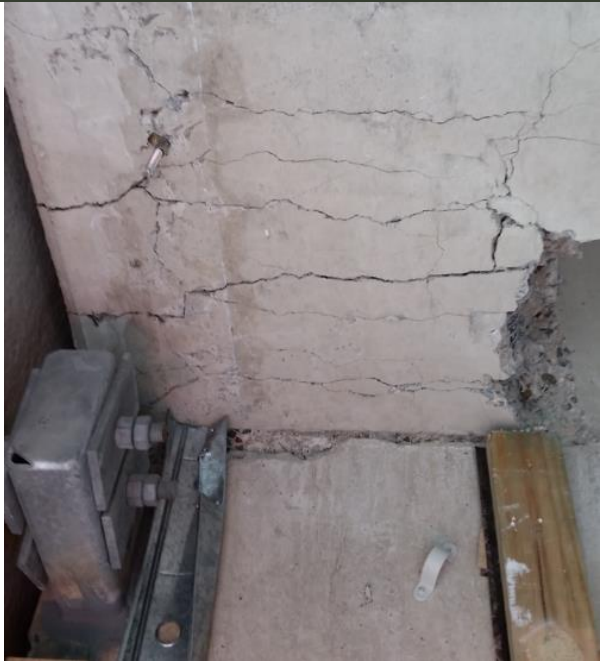
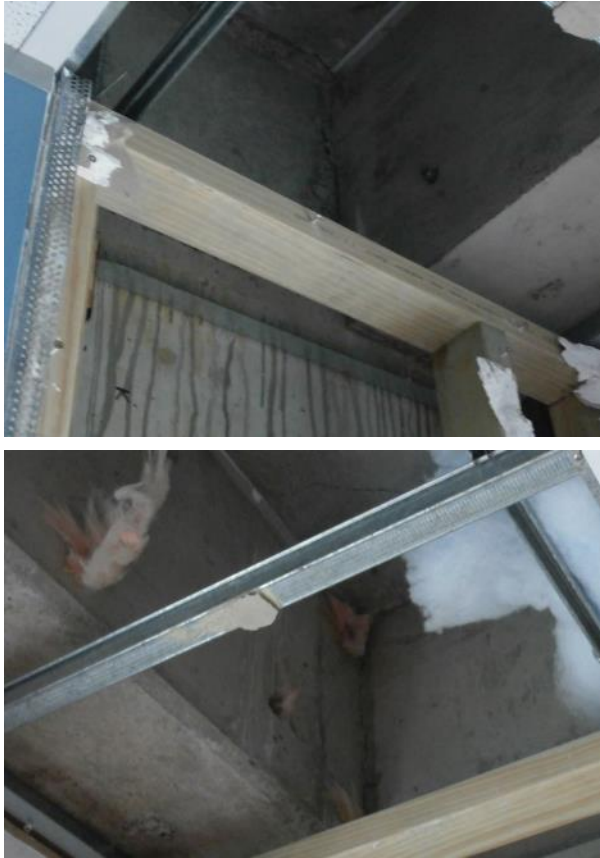
190	Elevation HA-Grid 8A. Beam column joint underside of level 4 DS 1 2.0%	Approximately 5 mm wide vertical crack in the joint.

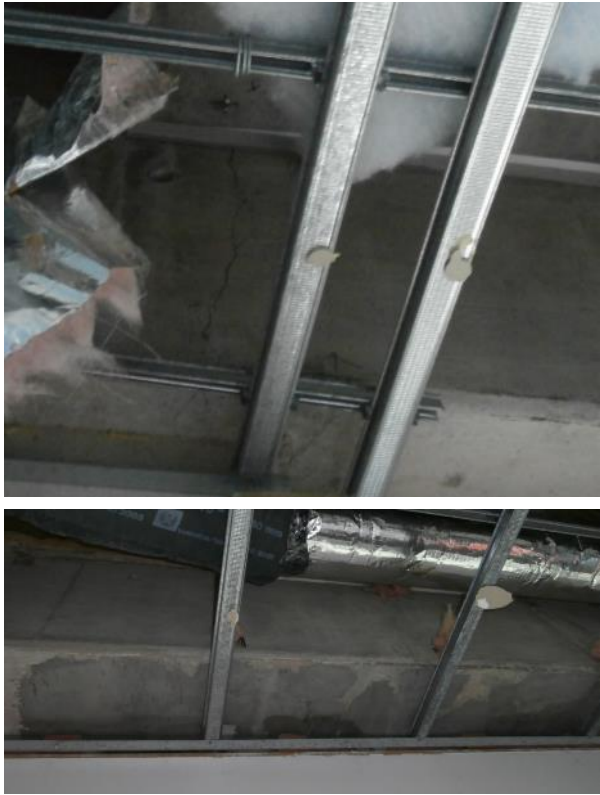
191/192	Elevation HA-Grid 8. Beam column joint underside of level 4 DS 0 1 %	Minor vertical cracks in the beam column joint. Cracks width approximately 0.5 mm. Underside of the beam is patched with concrete.

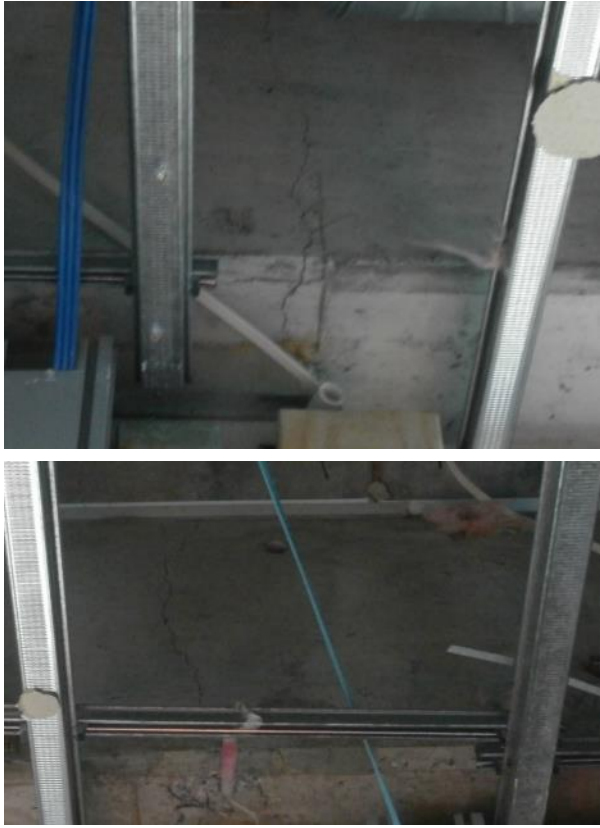
193/194	Elevation HA-Grid 7. Beam column joint underside of level 4 DS 0 1 %	Width of vertical cracks in the beam column are less than 1 mm. Concrete spalled off around the joint. Minor vertical cracks along the beam length.

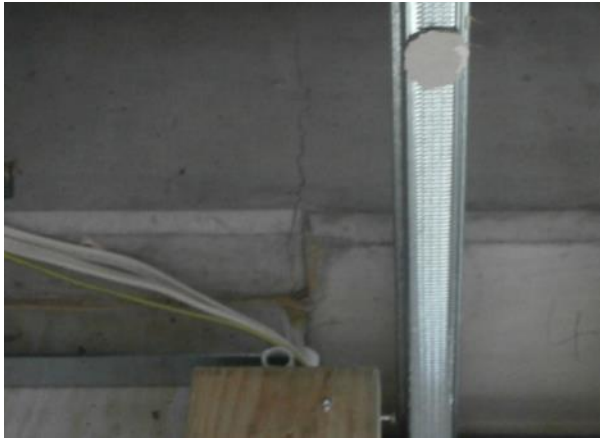
<p>195/195'</p>	<p>Elevation HA-Grid 6. Beam column joint underside of level 4</p> <p>DS 0 1 %</p>	<p>Width of vertical cracks in the beam column are less 1 mm.</p> <p>A minor diagonal crack in the column.</p> <p>Approximately 2 hairline cracks along the beam width.</p>

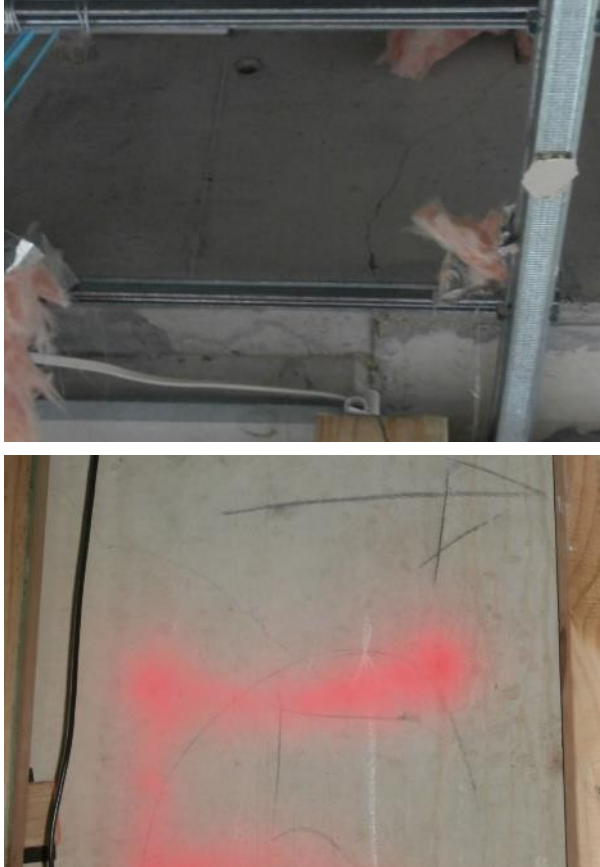
<p>196/197</p>	<p>Elevation HA-Grid 5. Beam column joint underside of level 4</p> <p>DS 0 1 %</p>	<p>Width of vertical cracks in the beam column are less than 1 mm.</p> <p>A minor diagonal crack in the column.</p> <p>A hairline crack in the beam.</p>

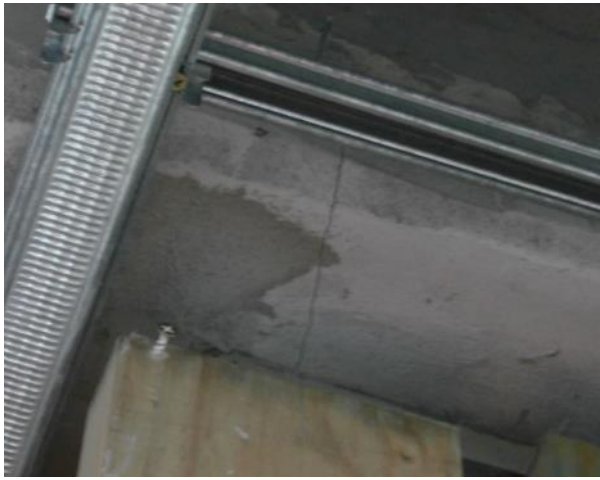
<p>198/199</p>	<p>Elevation HA-Grid 4. Beam column joint underside of level 4</p> <p>DS 0 1 %</p>	<p>Crack width of 0.2 mm under side of the beam in the joint.</p> <p>Underside of the beam is patched with concrete.</p> <p>A minor diagonal crack in the column.</p> <p>Minor cracks along the beam length</p>

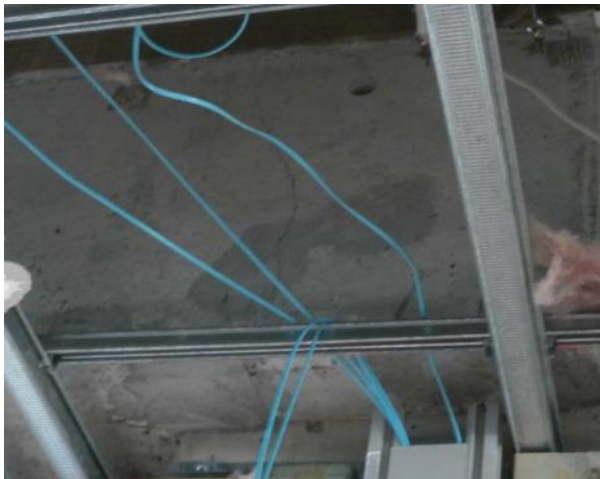
<p>200/201</p>	<p>Elevation HA-Grid 3. Beam column joint underside of level 4</p> <p>DS 0 1 %</p>	<p>Width of vertical crack in the beam column are less than 1 mm.</p> <p>A minor diagonal crack in the column.</p> <p>Underside of the beam is patched with concrete.</p> <p>Minor cracks along the beam length.</p>

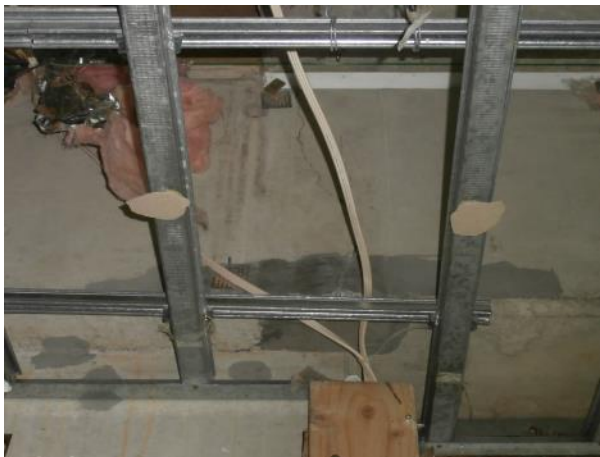
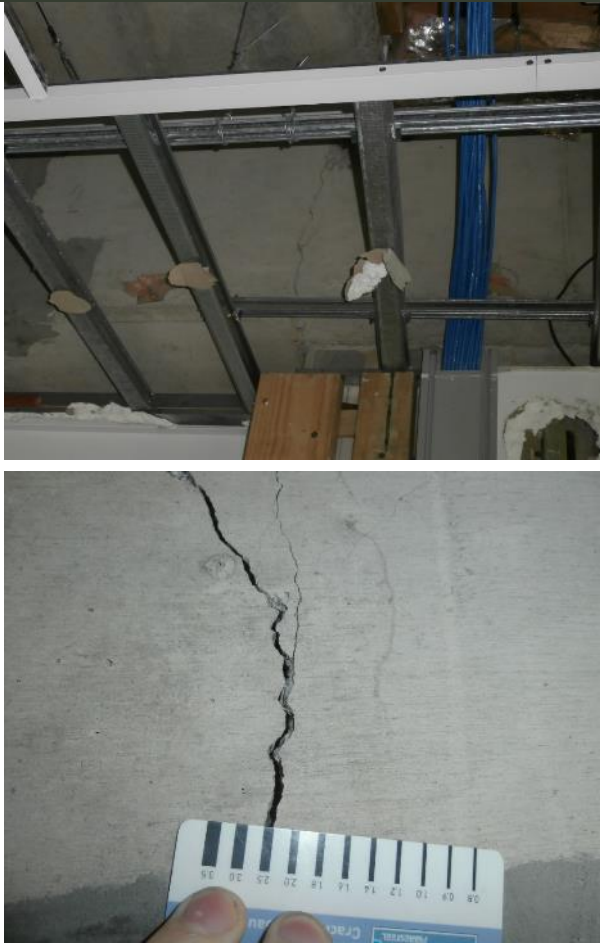
<p>202/203</p>	<p>Elevation HA-Grid 2. Beam column joint underside of level 4</p> <p>DS 1 2.0%</p>	<p>Vertical cracks in the beam column are 2.5 mm wide.</p> <p>Minor cracks along the beam length range from 0.2 - 0.5 mm.</p>

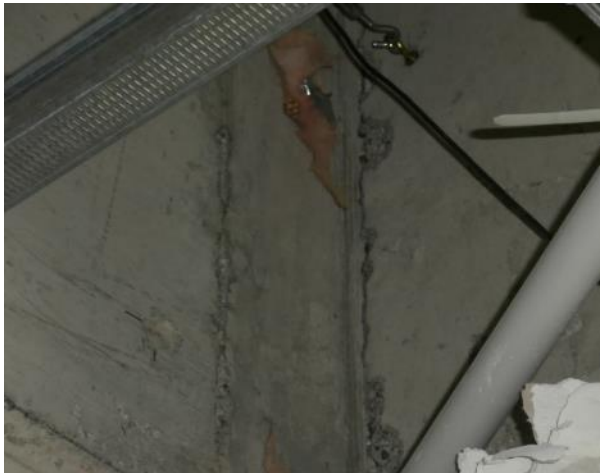
204	Elevation HA-Grid 1. Beam column joint underside of level 4 DS 1 2.0%	A vertical crack in the beam column joint approximately 4 mm wide.

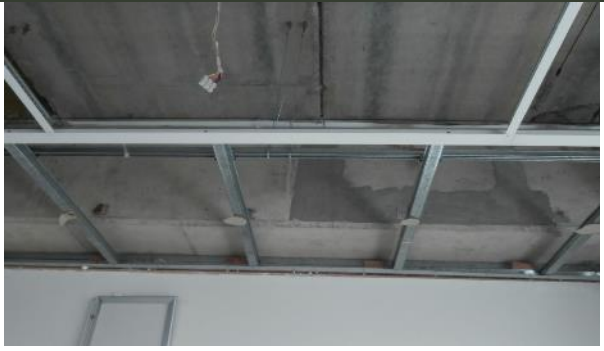
205	<p>Elevation 13-Grid N. Beam column joint underside of level 4</p> <p>DS 0 1 %</p>	<p>A vertical crack in the beam column joint less than 1 mm wide.</p> <p>Approximately 4 vertical hairline cracks along the beam length.</p>

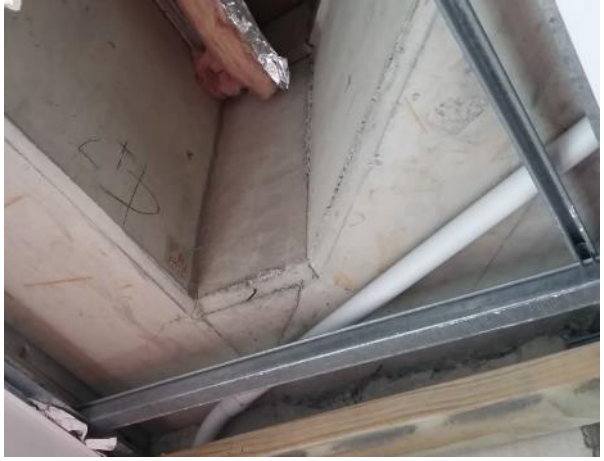
206/207	<p>Elevation 13-Grid M. Beam column joint underside of level 4</p> <p>DS 0 1 %</p>	<p>Vertical cracks in the beam column joint 0.6 wide.</p> <p>Approximately 4 vertical hairline cracks along the beam length.</p>

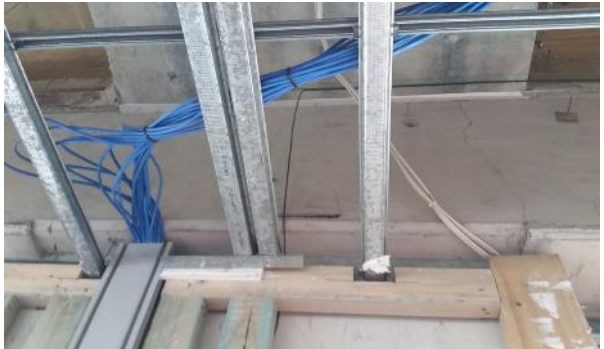
208/209	<p>Elevation 13-Grid L. Beam column joint underside of level 4</p> <p>DS 0 1 %</p>	<p>A vertical crack in the beam column joint less than 1 mm wide.</p> <p>Approximately 4 vertical hairline cracks along the beam length.</p>

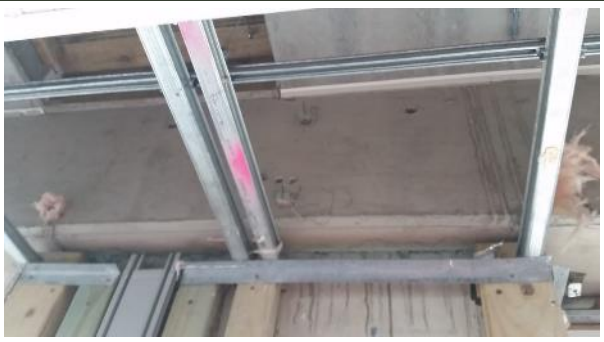
<p>210/211</p>	<p>Elevation 13-Grid K. Beam column joint underside of level 4</p> <p>DS 0 1 %</p>	<p>A vertical crack in the beam column joint less than 1 mm wide.</p> <p>Approximately 4 vertical hairline cracks along the beam length.</p>

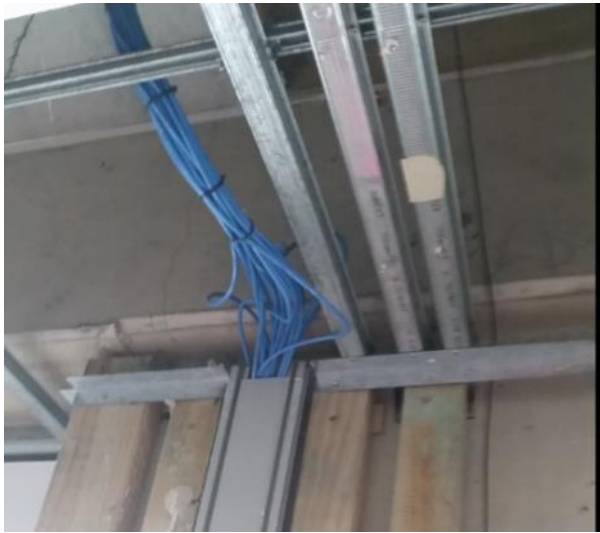
<p>212/213</p>	<p>Elevation 13-Grid J. Beam column joint underside of level 4</p> <p>DS 0 1 %</p>	<p>A vertical crack in the beam column joint less than 0.5 mm wide.</p> <p>Approximately 3 vertical hairline cracks along the beam length.</p>

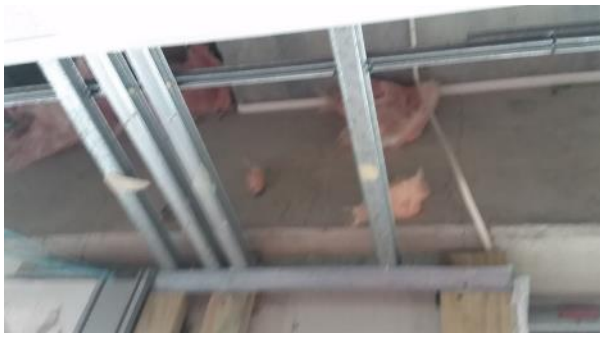
<p>214/215</p>	<p>Elevation 13-Grid H. Beam column joint underside of level 4</p> <p>DS 1 2 %</p>	<p>A vertical crack in the beam column joint approximately 0.3 mm wide.</p> <p>Approximately 2 vertical hairline cracks along the beam length.</p> <p>Loss of concrete in two locations along the beam length.</p>

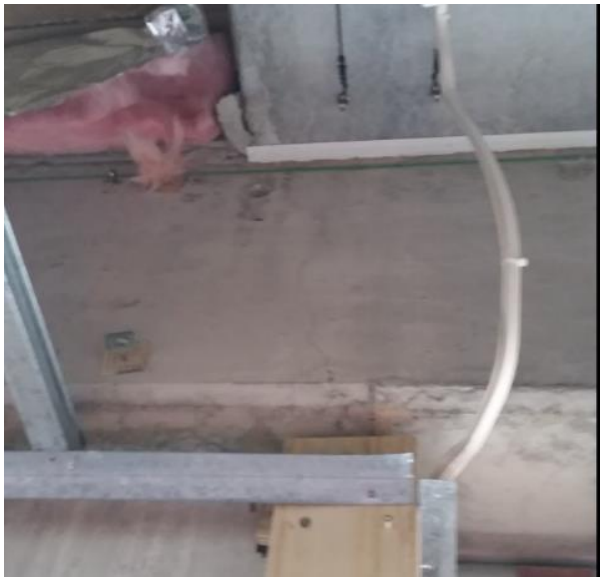
<p>216/217</p>	<p>Elevation 13- Grid G. Beam column joint underside of level 4</p> <p>DS 1 2 %</p>	<p>Combination of diagonal and vertical cracks in the beam column joint approximately 0.6 mm wide.</p> <p>Loss of concrete in the joint.</p> <p>Approximately 5 vertical hairline cracks along the beam length.</p>

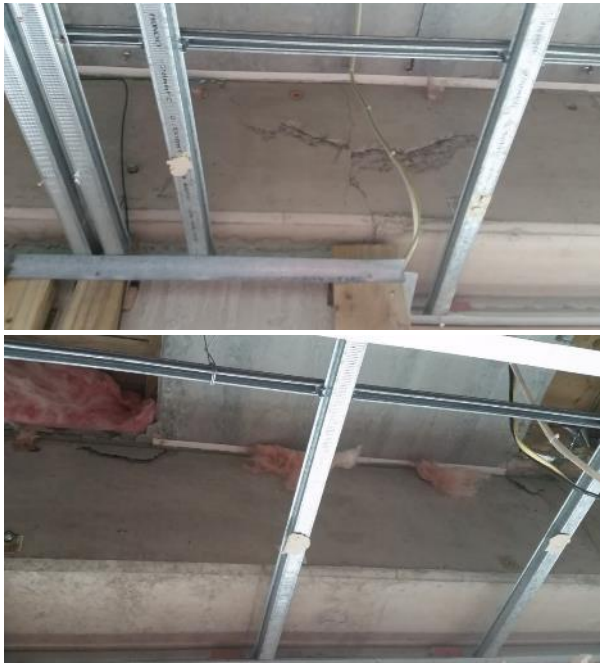
<p>218/219</p>	<p>Elevation 13- Grid F. Beam column joint underside of level 4</p> <p>DS 0 1 %</p>	<p>Vertical cracks in the beam column joint approximately 0.6 mm wide.</p> <p>Approximately 5 vertical hairline cracks along the beam length.</p>

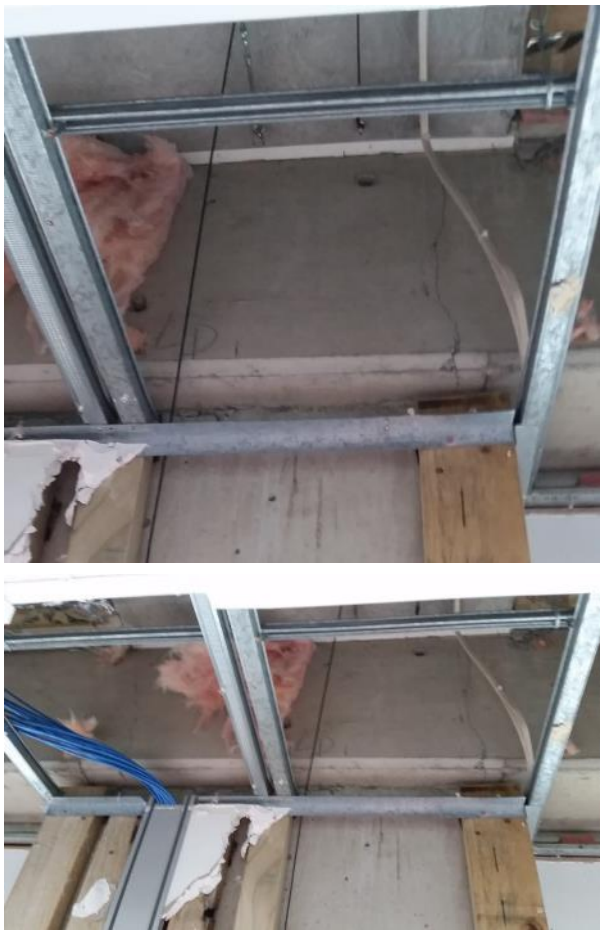
<p>220/221</p>	<p>Elevation 13-Grid E. Beam column joint underside of level 4</p> <p>DS 1 2 %</p>	<p>Vertical cracks in the beam column joint approximately 1 mm wide.</p> <p>Loss of concrete and concrete spalled off in the beam.</p> <p>Approximately 2 vertical hairline cracks along the beam length.</p>

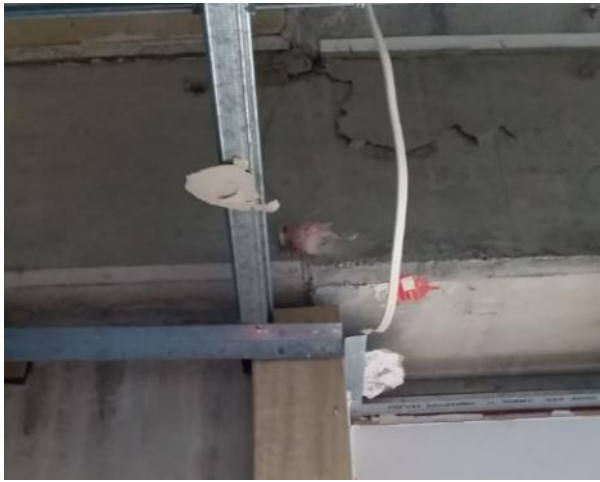
<p>222/223</p>	<p>Elevation 13-Grid D. Beam column joint underside of level 4</p> <p>DS 0 1 %</p>	<p>Vertical cracks in the beam column joint less than 0.5 mm wide.</p> <p>Approximately 5 vertical hairline cracks along the beam length.</p>

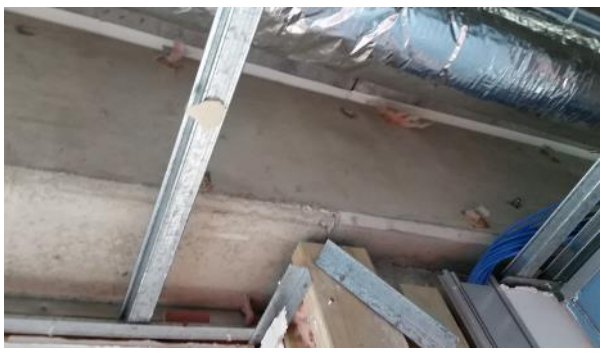
<p>224/225</p>	<p>Elevation 13-Grid C. Beam column joint underside of level 4</p> <p>DS 1 2 %</p>	<p>Vertical cracks in the beam column joint less than 0.5 mm wide.</p> <p>Approximately 8 vertical hairline cracks along the beam length.</p> <p>Concrete crushed close to the beam column joint and spalling of concrete in the beam.</p>

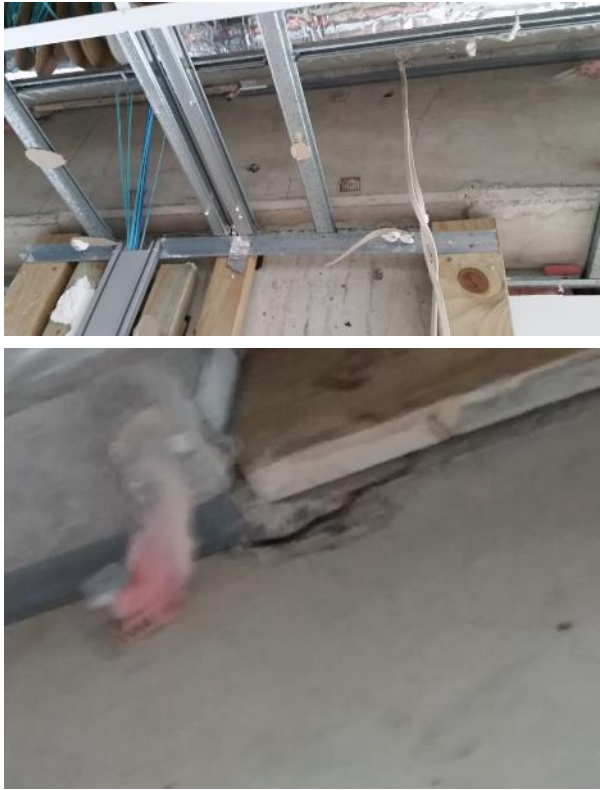
226/227	Elevation 13- Grid B. Beam column joint underside of level 4 DS 1 2 %	Vertical cracks in the beam column joint approximately 1 mm wide. A hairline crack in the column. Approximately 11 vertical cracks along the length of the beam range from 0.1 - 0.4 mm wide. Concrete spalled off.

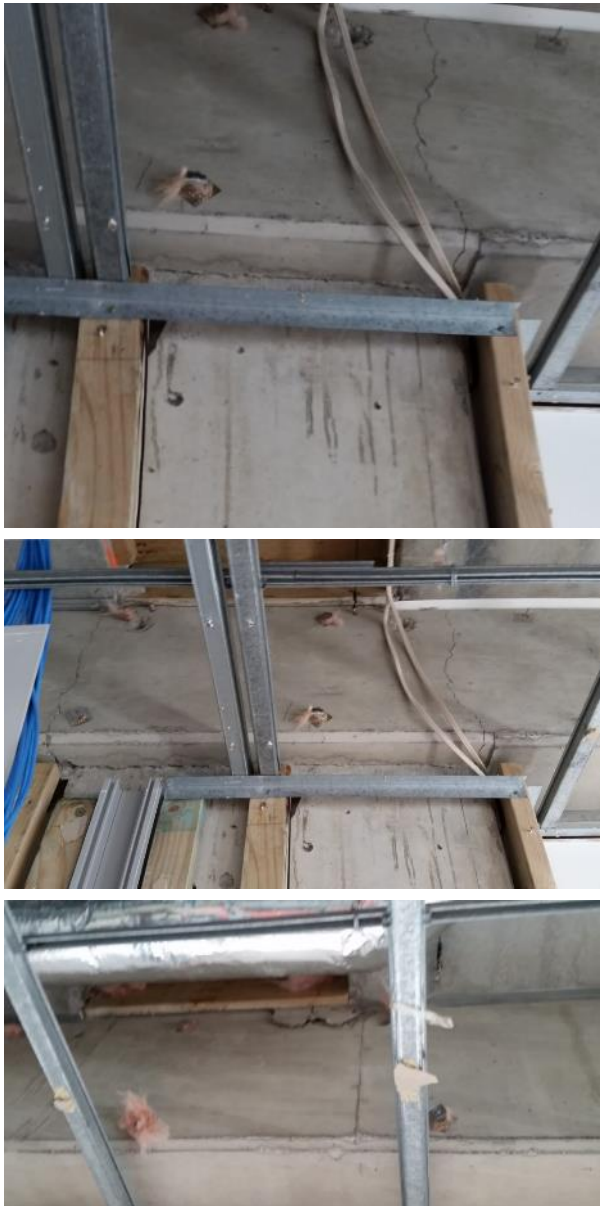
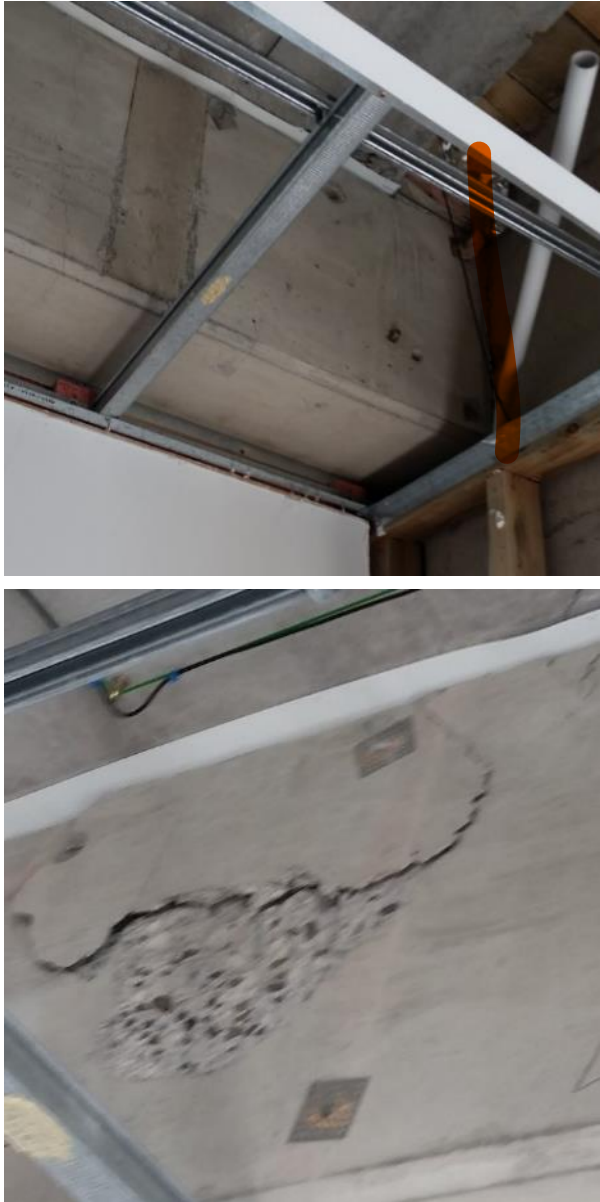
228	Elevation 13- Grid A. Beam column joint underside of level 4 DS 2 2.75% DS 1 2.0%	<p>A vertical crack of 10 mm wide in the beam column joint.</p> <p>Loss of concrete in the beam.</p> <p>transverse frame drift</p>	<p>opening up of pin connection to column (likely)</p>
