Resilient Repair Guide Source Report: Case Study Annex

APPLIED TECHNOLOGY COUNCIL
201 Redwood Shores Parkway, Suite 240
Redwood City, California 94065
www.ATCouncil.org

FEDERAL EMERGENCY MANAGEMENT AGENCY
Michael Mahoney, Project Officer
William T. Holmes, Technical Monitor
Washington, D.C.

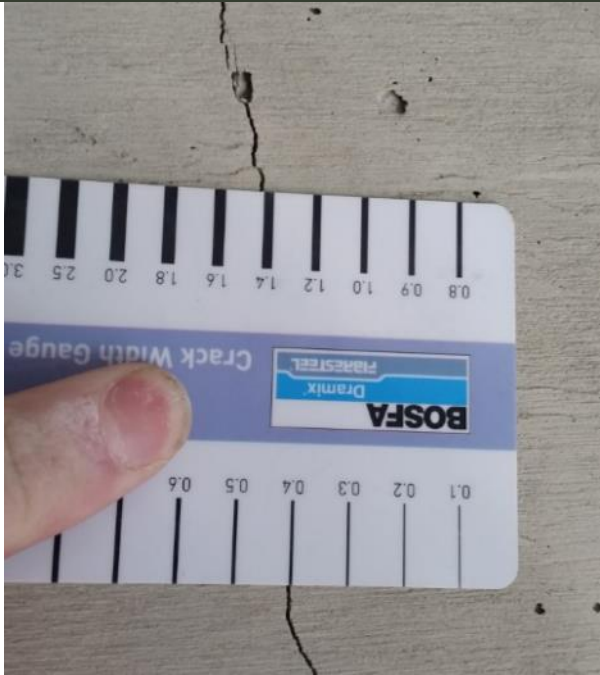
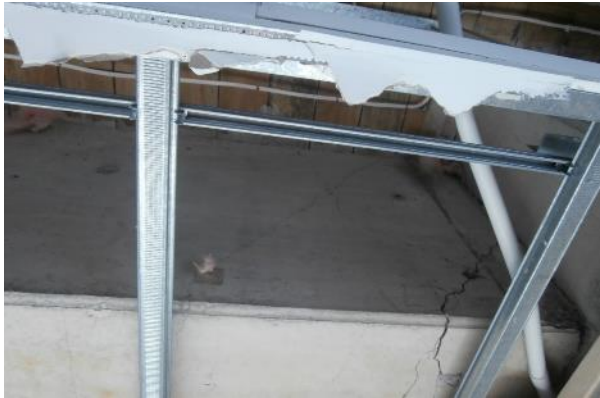
229	Elevation N-Grid 1. Beam column joint underside of level 4 DS 1 2.0%	Combination of diagonal and vertical cracks in the beam column joint. Width of the cracks range from 1.4 - 3.5 mm. Concrete spalling off in the joint. Approximately 3 vertical hairline cracks along the beam length.

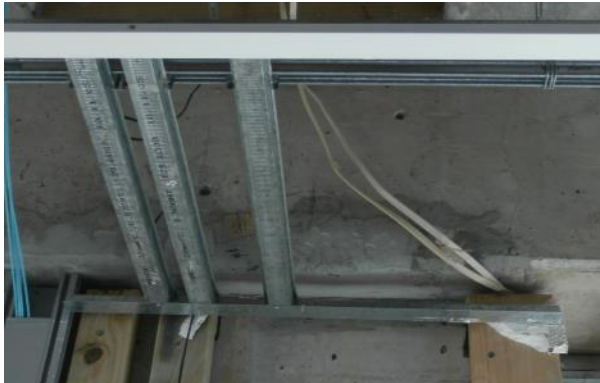
230/231	Elevation N-Grid 2. Beam column joint underside of level 4 DS 0 1 %	Vertical cracks in the beam column joint approximately 1 mm wide. Concrete spalling in the beam. Approximately 3 vertical hairline cracks along the beam length.

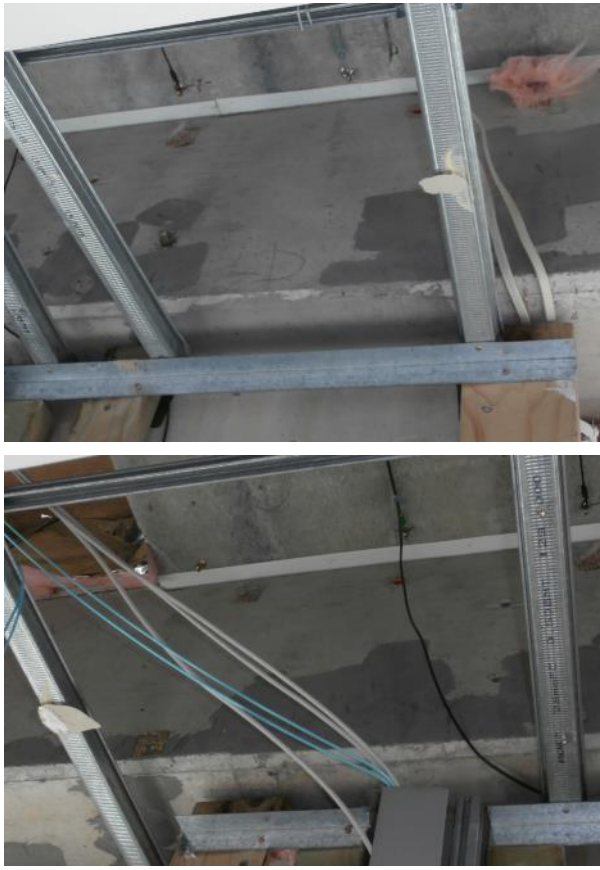
<p>234/235</p>	<p>Elevation N-Grid 4. Beam column joint underside of level 4</p> <p>DS 0 1 %</p>	<p>Vertical cracks in the beam column joint less than 0.3 mm wide.</p> <p>Approximately 7 vertical hairline cracks along the beam length.</p>

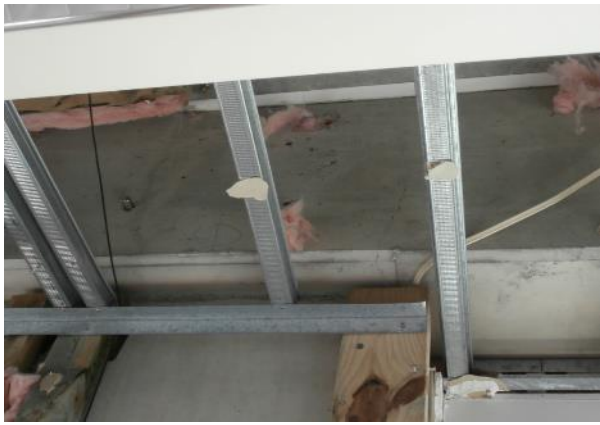
<p>236/237</p>	<p>Elevation N-Grid 5. Beam column joint underside of level 4</p> <p>DS 0 1 %</p>	<p>Vertical cracks in the Bbeam column joint less than 0.3 mm wide.</p> <p>Approximately 5 vertical hairline cracks along the beam length.</p>

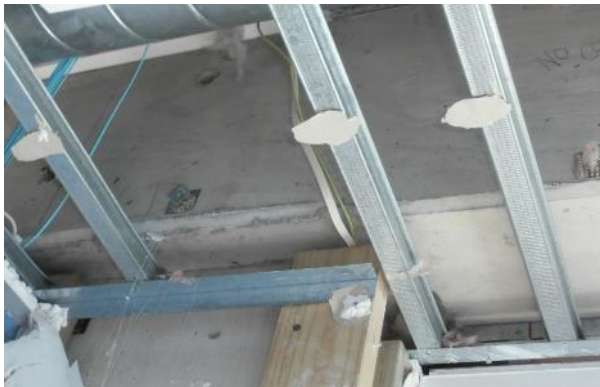
<p>238/239</p>	<p>Elevation N-Grid 6. Beam column joint underside of level 4</p> <p>DS 0 1 %</p>	<p>Vertical cracks in the beam column joint less than 0.5 mm wide.</p> <p>Vertical cracks along the beam length.</p> <p>Width of the cracks range from 0.1 - 0.5 mm.</p>

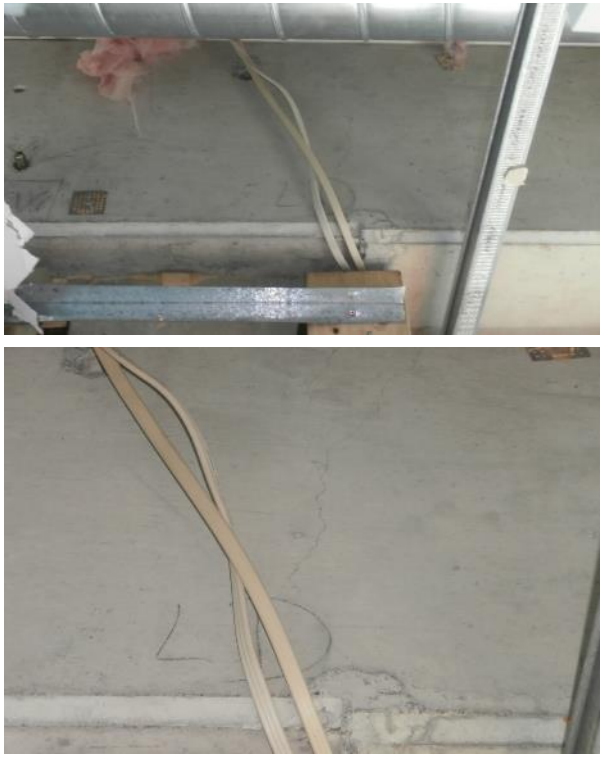
<p>240/241</p>	<p>Elevation N-Grid 7. Beam column joint underside of level 4</p> <p>DS 0 1 %</p>	<p>Vertical cracks in the beam column joint less than 0.3 mm wide.</p> <p>Approximately 6 vertical cracks along the beam length.</p>

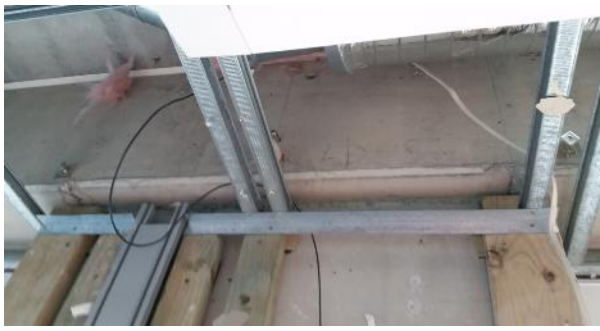
<p>242/243</p>	<p>Elevation N-Grid 8. Beam column joint underside of level 4</p> <p>DS 0 1 %</p>	<p>A vertical crack in the beam column joint less than 0.2 mm wide.</p> <p>Approximately 5 vertical cracks along the beam length.</p>

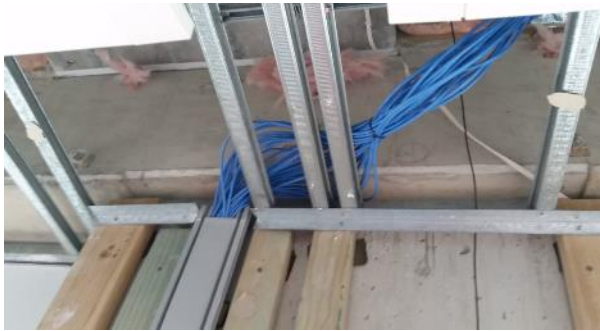
<p>244/245</p>	<p>Elevation N-Grid 9. Beam column joint underside of level 4</p> <p>DS 0 1 %</p>	<p>Vertical cracks in the beam column joint approximately 0.3 mm wide.</p> <p>Approximately 8 vertical cracks along the beam length.</p>

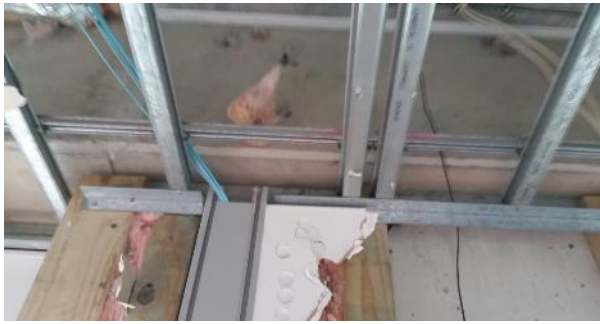
<p>246/247</p>	<p>Elevation N-Grid 10. Beam column joint underside of level 4</p> <p>DS 0 1 %</p>	<p>Vertical cracks in the beam column joint approximately 0.2 mm wide.</p> <p>Approximately 10 vertical cracks along the beam length.</p>

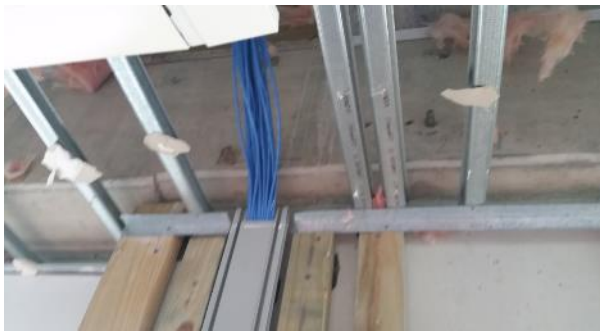
<p>248/249</p>	<p>Elevation N-Grid 11. Beam column joint underside of level 4</p> <p>DS 0 1 %</p>	<p>Vertical cracks in the beam column joint approximately 0.2 mm wide.</p> <p>Approximately 5 vertical cracks along the beam length.</p>

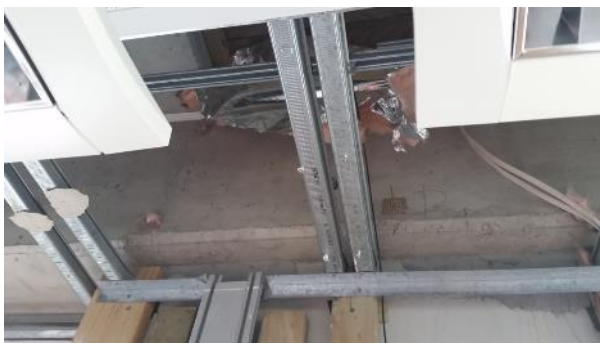
<p>250/251</p>	<p>Elevation N-Grid 12. Beam column joint underside of level 4</p> <p>DS 0 1 %</p>	<p>Vertical cracks in the beam column joint approximately 0.3 mm wide.</p> <p>Approximately 3 vertical hairline cracks and a 1 mm wide crack along the beam length.</p>

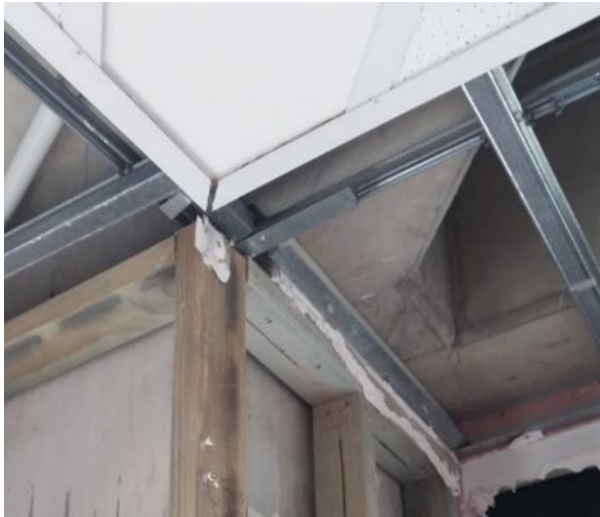
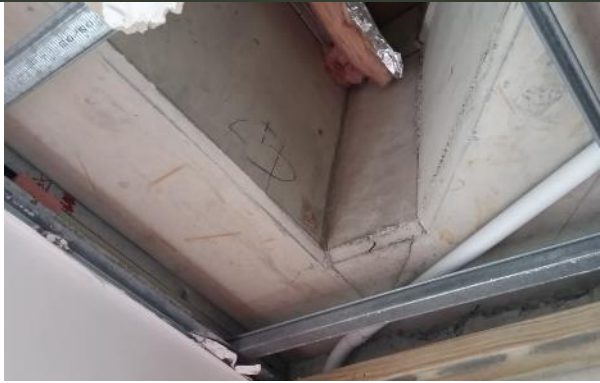
<p>252</p>	<p>Elevation N-Grid 13. Beam column joint underside of level 4</p> <p>DS 1 2.0%</p>	<p>No crack observed in the joint.</p> <p>Spalling of concrete close to the beam column joint.</p>

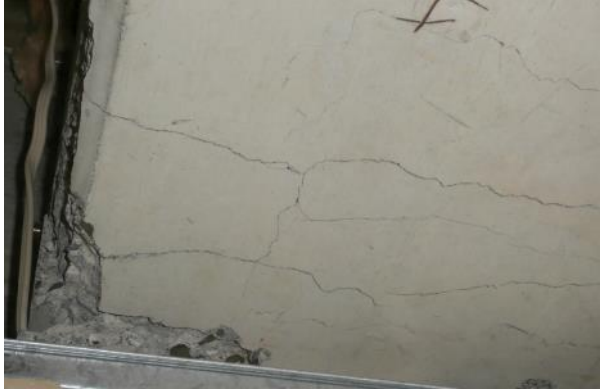
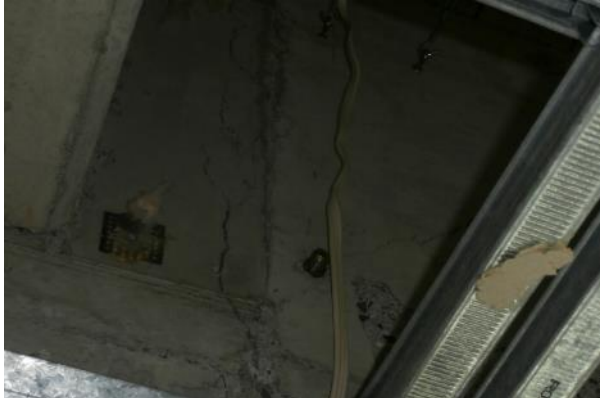
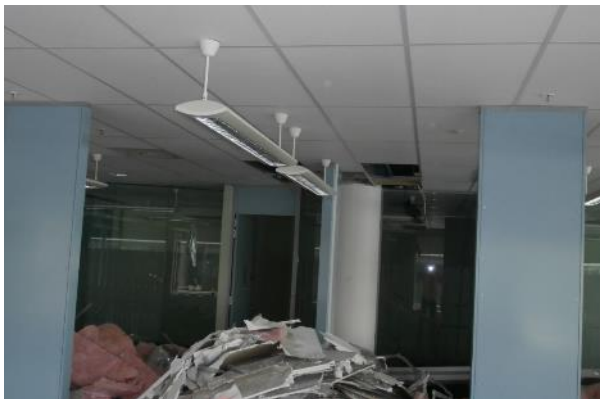
253	Elevation 10A-Grid A. Beam column joint underside of level 4	Combination of vertical and diagonal cracks in the beam column joint range from 1.5 - 5 mm wide. Approximately 4 minor cracks along the beam length.

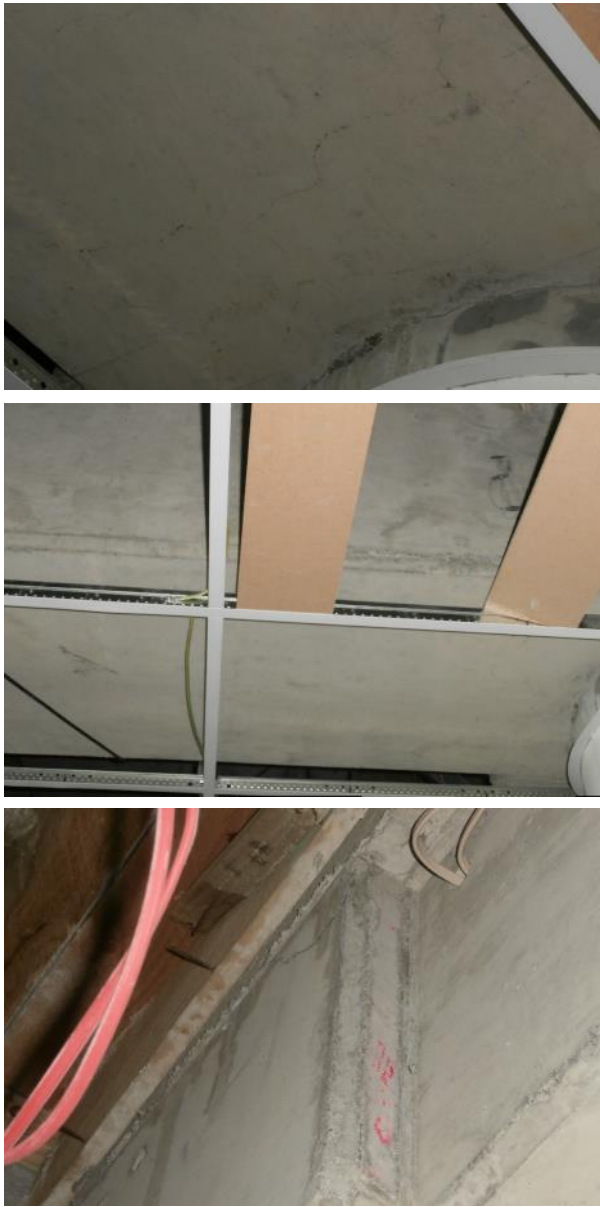
254/255	Elevation 10A-Grid B'. Beam column joint underside of level 4	<p>Cracks each side of the beam column joint. Width of cracks less than 2 mm.</p> <p>Approximately 5 vertical cracks including a 0.3 mm wide crack along the beam length.</p> <p>Concrete spalled off in the beam.</p>

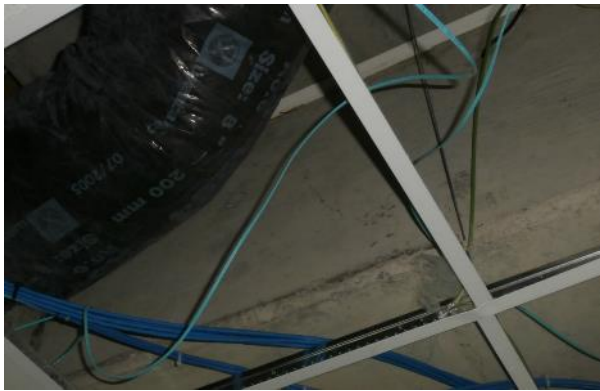
262/263	Elevation 10A-Grid H'. Beam column joint underside of level 4	A diagonal crack width of 0.3 mm on the beam face and underside of the beam. Minor hairline cracks along the beam length.

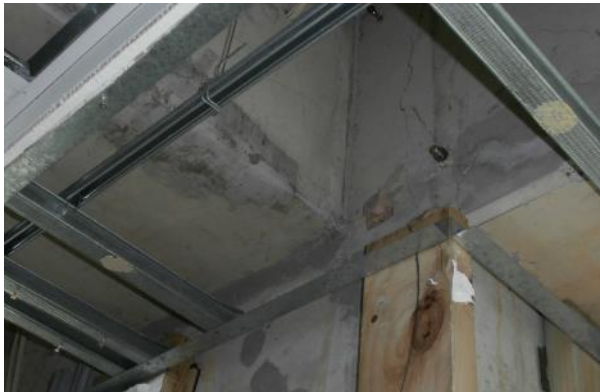
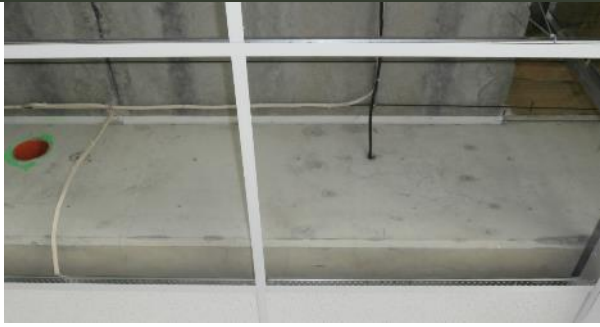
264	Elevation KA-Grid 1. Beam column joint underside of level 4	Minor vertical crack less than 1 mm in the beam column joint. Approximately 8 vertical cracks less than 0.5 mm wide along the beam length.

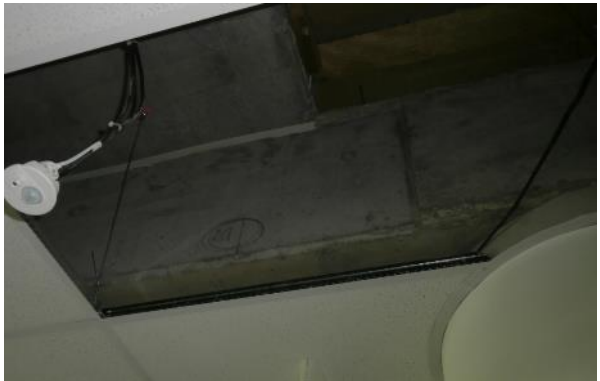
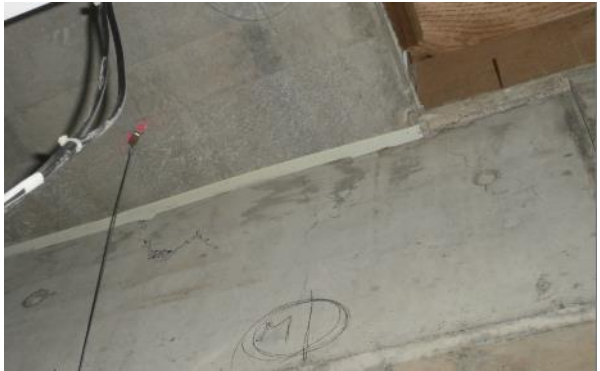
265/266	Elevation KA-Grid 2'. Beam column joint underside of level 4	Combination of vertical and diagonal cracks less than 1 mm wide in the beam column joint. Concrete spalling in the beam.

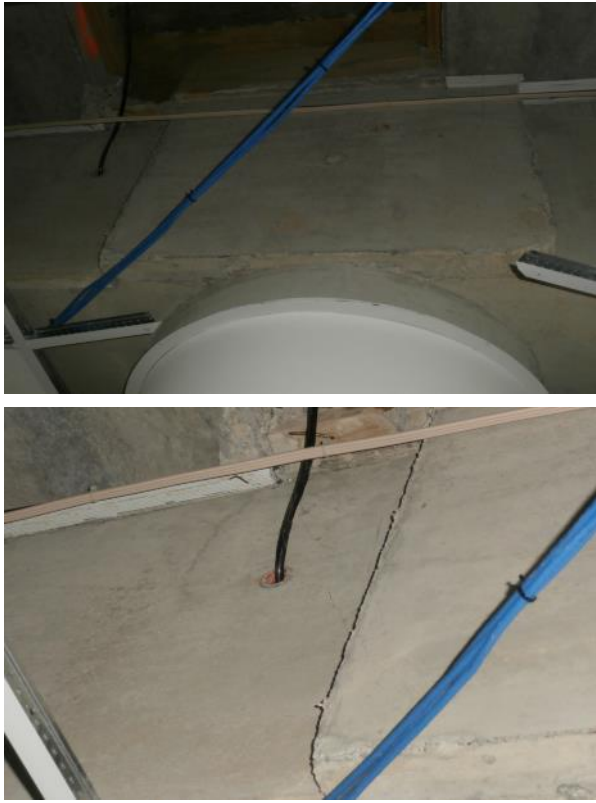
271/272	Elevation KA-Grid 6'. Beam column joint underside of level 4	This area has since been exposed however, we have not been back to inspect	
273/274	Elevation KA-Grid 8'. Beam column joint underside of level 4	Cracks less than 0.5 mm wide in the beam column joint.

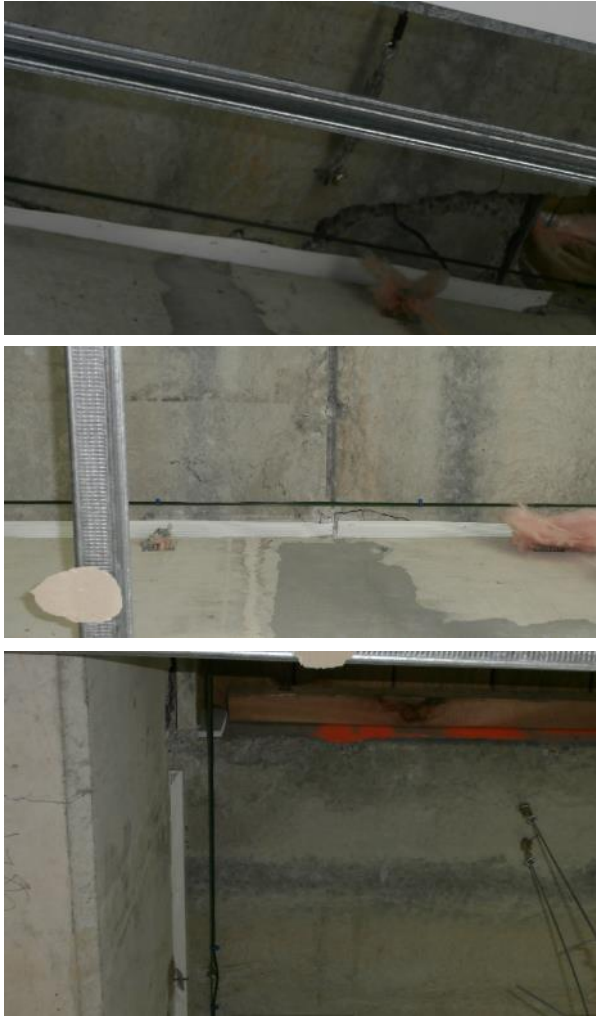
<p>283 (b&c)</p>	<p>Elevation 13'- Grids between N to J'. B/C joints and beams underside of level 4. (Refer to Dycore plan for the reference)</p>	<p>This area has since been exposed however, we have not been back to inspect</p>	
<p>284</p>	<p>Dycore units Underside of level 4. Grid numbers between HA- KA and 1-2.</p>	<p>Minor diagonal crack, underside of the Dycore unit at location 1/HA. Spalling of concrete around the crack. Minor longitudinal crack close to the perimeter beam.</p>

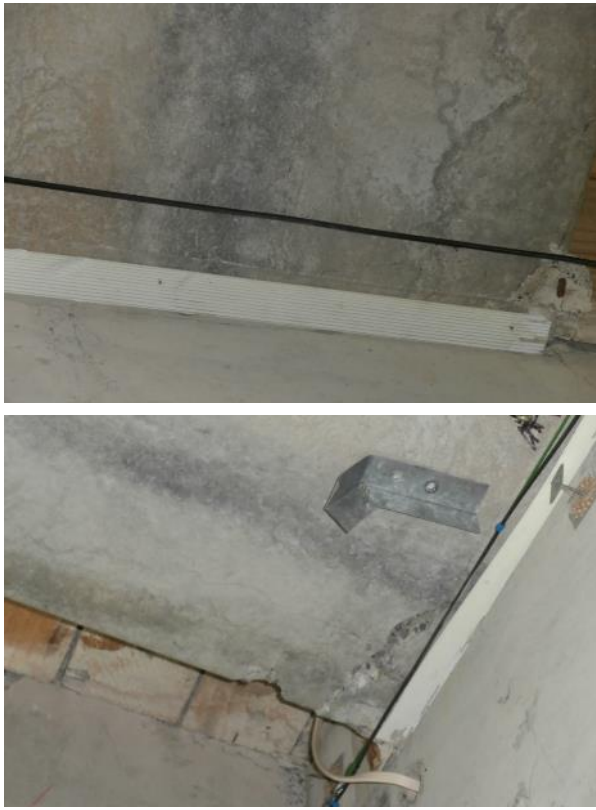
285	Dycore units Underside of level 4. Grid numbers between KA-N and 1-2.	<p>Minor diagonal crack, underside of the Dycore unit at location 1/KA. Width of the cracks less than 0.5 mm.</p> <p>A combination of diagonal and longitudinal cracks underside of the Dycore unit at location 1/N.</p> <p>Loss of concrete and crushed at the corner.</p>

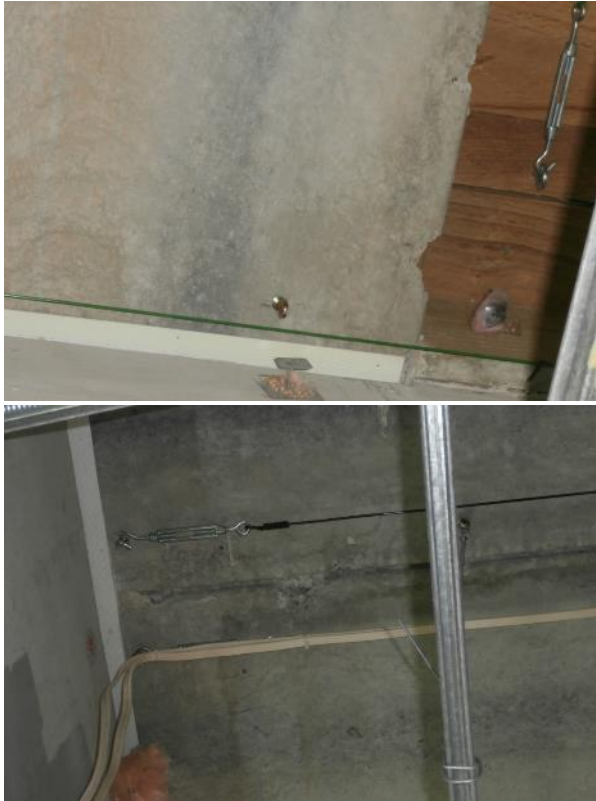
287	Dycore units Underside of level 4. Grid numbers between KA-N and 2-3.	A longitudinal crack underside of the Dycore unit close to the grid location 2/N.

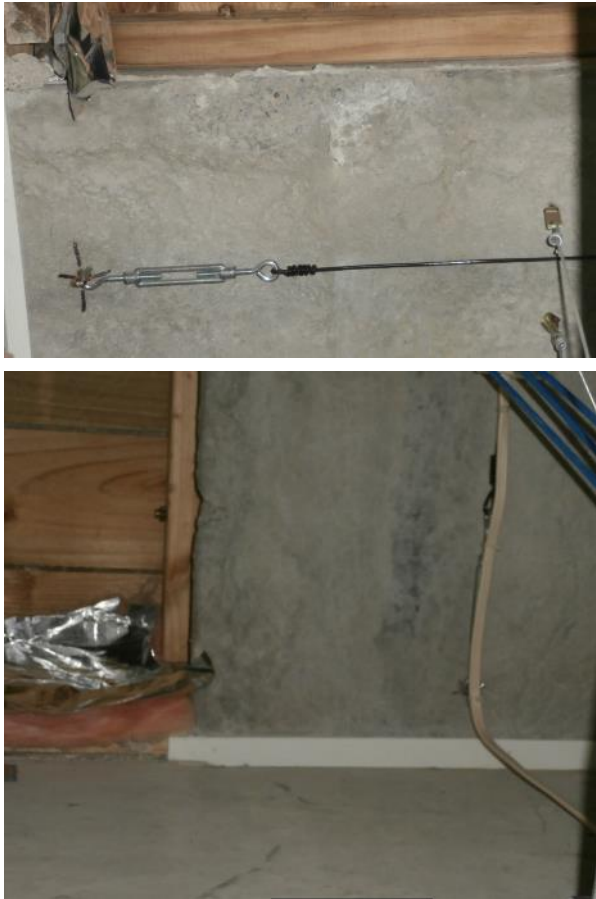
288	Dycore units Underside of level 4. Grid numbers between HA- KA and 3-8.	A crack underside of the Dycore unit close to the grid location 5/HA. Concrete spalled off (suspected at the time of installation) on grid location 3/HA.

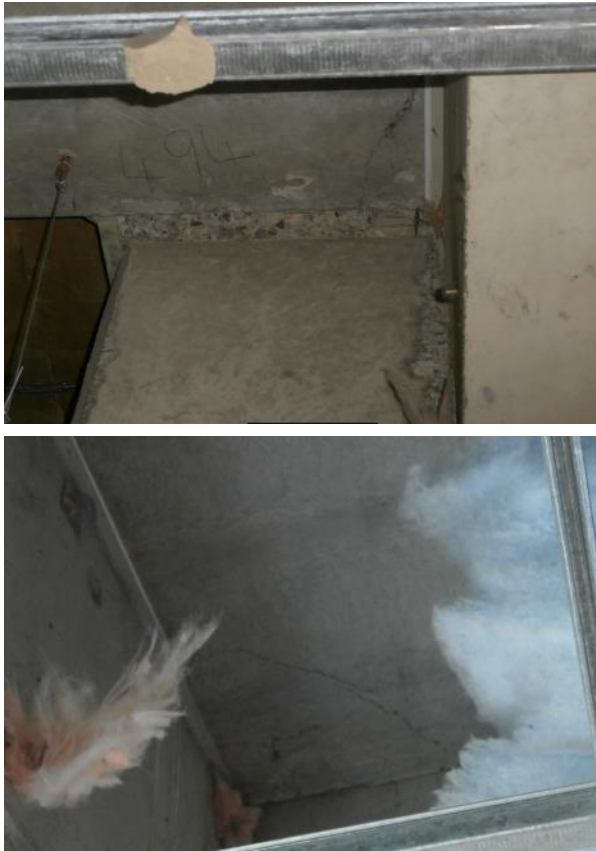
289	Dycore units Underside of level 4. Grid numbers between KA-N and 3-8.	Concrete spalled off in the Dycore units close to the grid location 4/N, suspected at the time of installation.	
290	Dycore units Underside of level 4. Grid numbers between 8-11 and H-KA.	Combination of diagonal and longitudinal cracks underside of the Dycore units around the corner column located on grid HA/8A. Diagonal cracks range from minor to 2 mm wide.

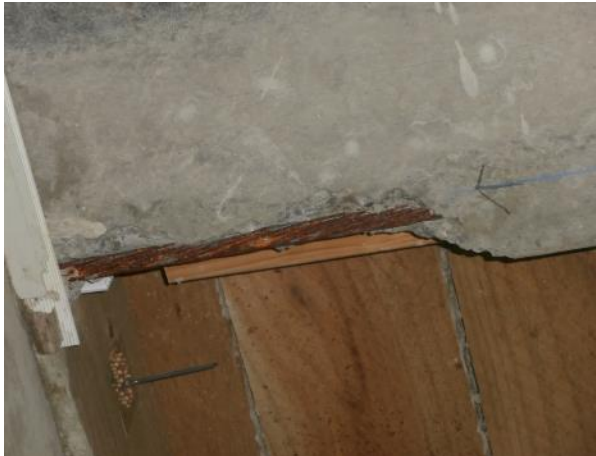
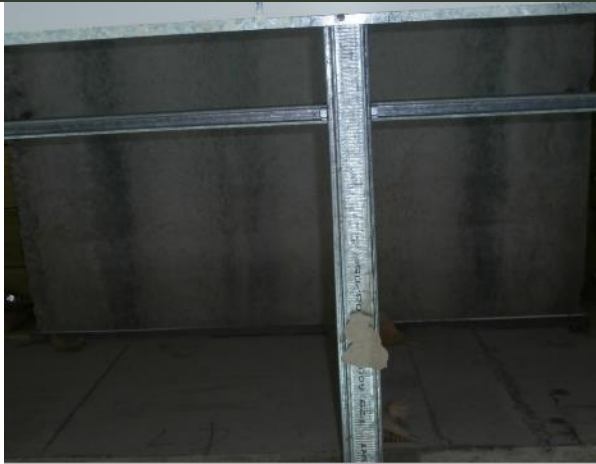
292	Dycore units Underside of level 4. Grid numbers between H-N and 11-13.	A longitudinal crack with loss of concrete and tendon exposed close to the grid 13/J. A minor crack with concrete spalled off.

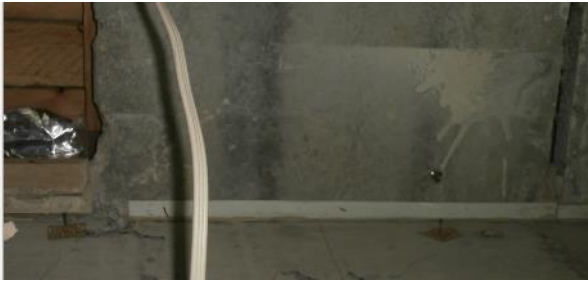
<p>293</p>	<p>Dycore units Underside of level 4. Grid numbers between 13- 10A and C-H.</p>	<p>Minor damage to corner of Dycore</p>

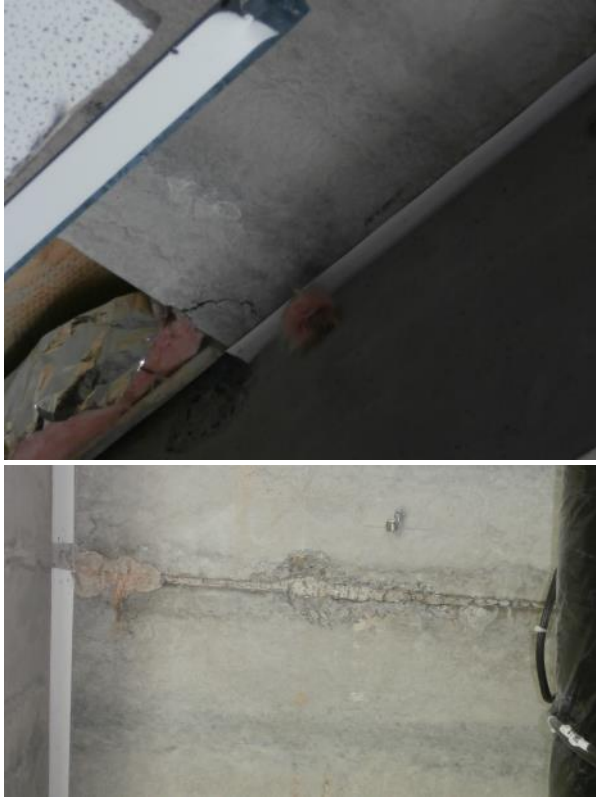
<p>294</p>	<p>Dycore units Underside of level 4. Grid numbers between 8A- 10A and C-H</p>	<p>Diagonal corner cracking in 4 slabs, Grids D, E and F. Longitudinal crack in member at Grid E</p>

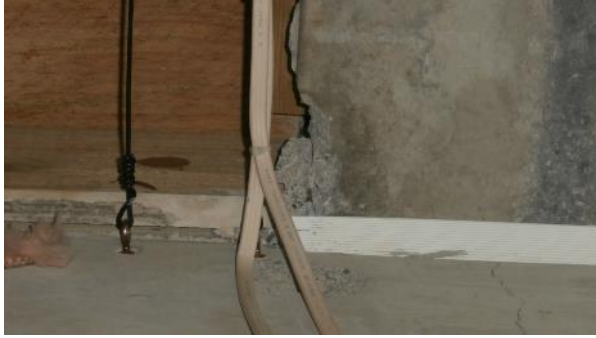
295	Dycore units Underside of level 4. Grid numbers between 8A-10A and B-C	Minor damage to corner of Dycore unit

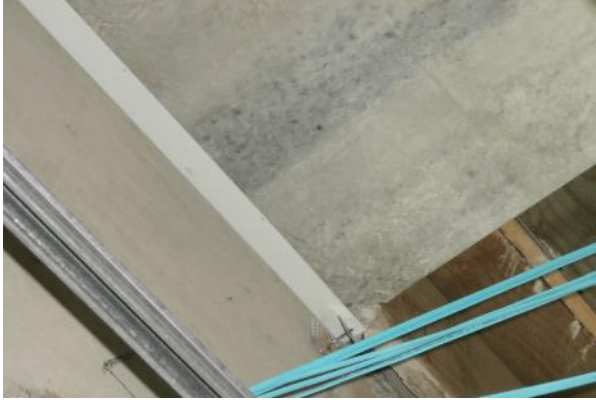
296	Dycore units Underside of level 4. Grid numbers between 10A-13 and A-B	Minor damage to corner of Dycore unit

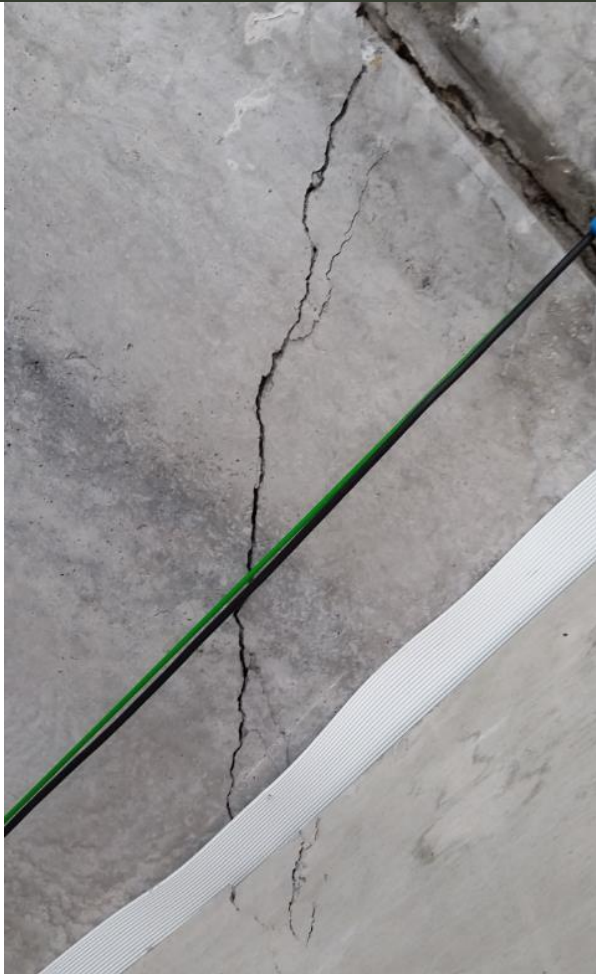
297	Dycore units Underside of level 4. Grid numbers between 10A - 13 and A-B	Diagonal crack of Dycore unit, crack width approx 1.8 mm. Loss of concrete at end of Dycore unit.

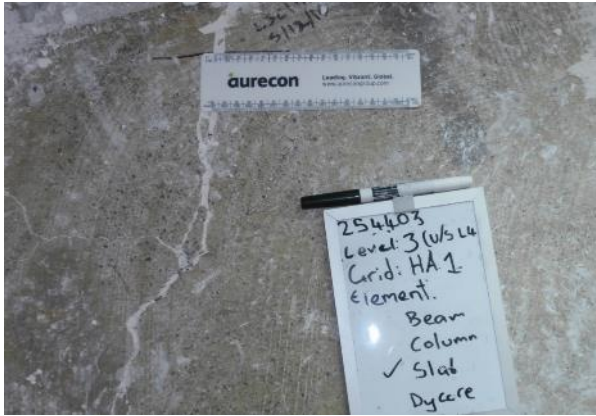
298	Dycore units Underside of level 4. Grid numbers between 8A-10A and A-B.	Minor cracking, less than 0.3 mm	
299	Floor slab level 3. Grid numbers between HA-KA and 1-2.	<p>Diagonal cracking spreading from corner column on grid 1HA.</p> <p>Crack at column 1HA 7 mm wide with vertical dislocation.</p> <p>Cracking spreading out from column range between 2 - 0.8 mm</p> <p>Longitudinal crack along gridline 2 approx 4 mm wide.</p>

<p>Transverse crack along grid line KA approx 12 mm</p>	 
--	--	---	---

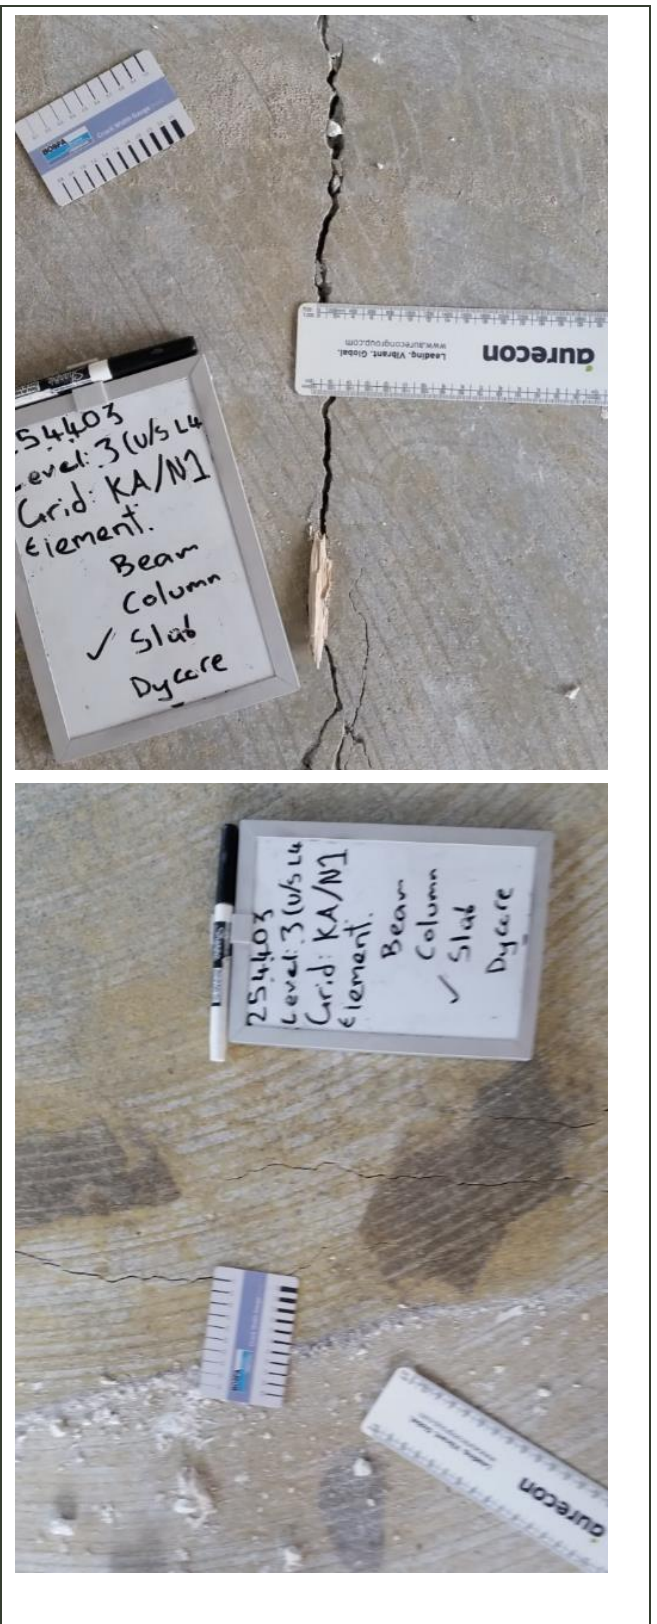
300	Floor slab level 3. Grid numbers between KA-N and 1-2.	Transverse crack along grid line KA approx 5 mm wide. Longitudinal crack along grid line 2, 2.5 - 5 mm wide. Cracking at base of column 1N approx 7 mm wide.

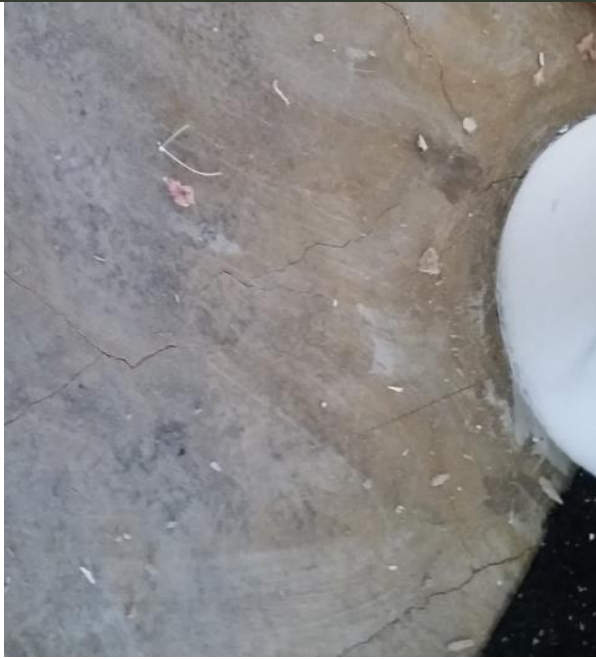
301	Floor slab level 3. Grid numbers between HA-KA and 2-3.	This area has since been exposed however, we have not been back to inspect.	
302	Floor slab level 3. Grid numbers between KA-N and 2-3.	<p>Longitudinal crack near grid line 3 approx 1.4 mm wide.</p> <p>Transverse crack along grid line KA approx 0.6 mm wide.</p>

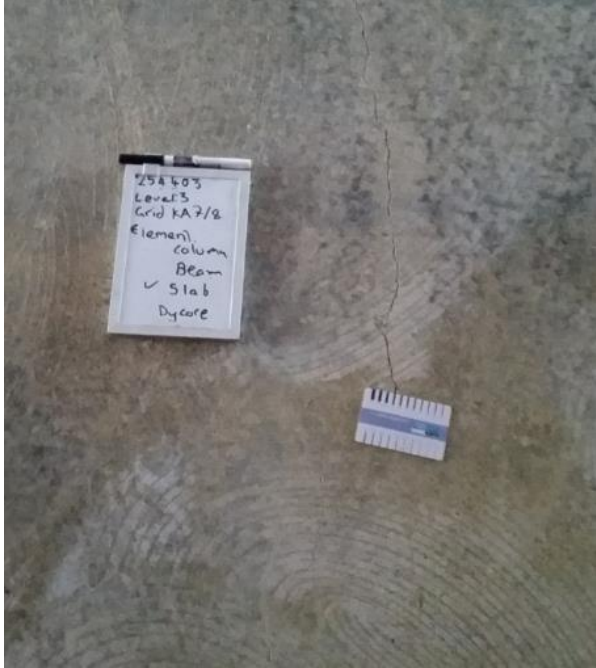
303	Floor slab level 3. Grid numbers between HA-KA and 3-8.	Longitudinal crack in between grid lines 5-6 approx 2.5 mm. Transverse cracking along frame KA at grid 7 approx 1.2 mm wide.

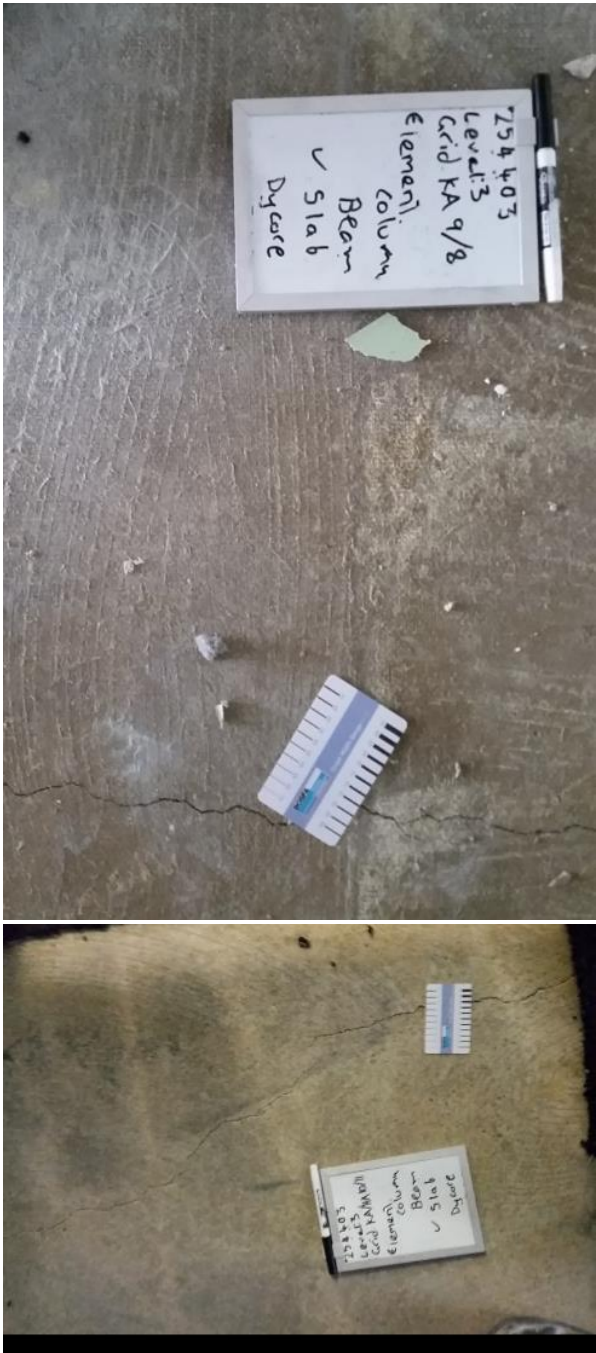
306	Floor slab level 3. Grid numbers between KA-N and 8-13.	Minor longitudinal cracks between grids 8 and 9 approx 1.4 mm wide.

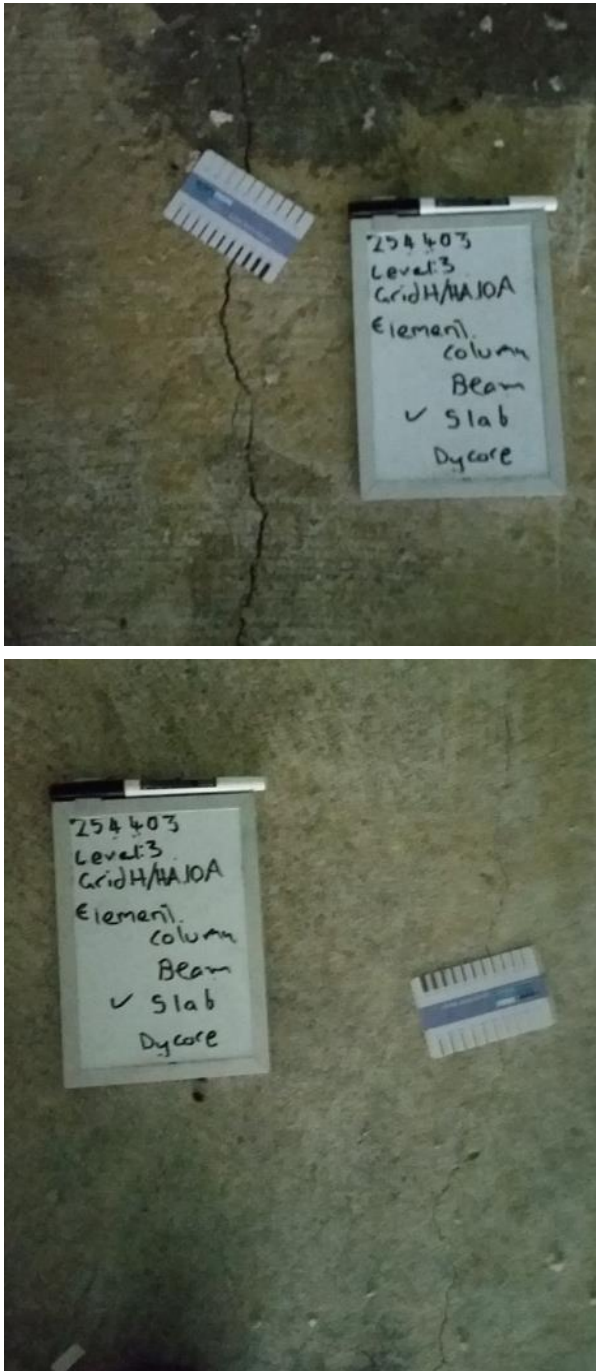
307	Floor slab level 3. Grid numbers between 10A-13 and H-N.	Longitudinal cracks spreading from central column between grids H and J, cracks range from 2 – 0.8 mm wide.

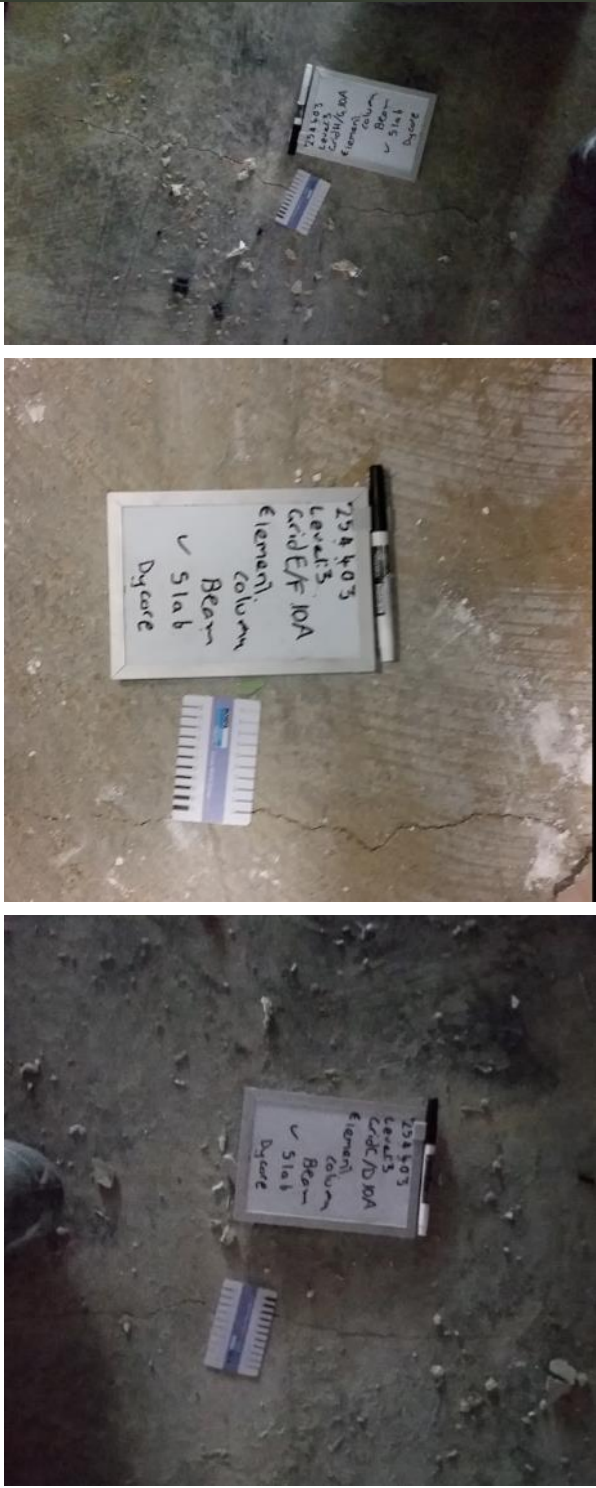
<p>308</p>	<p>Floor slab level 3. Grid numbers between 10A-8A and C-H.</p>	<p>Transverse cracks along inner frame on grid 10A between Grids G-H, E-F and C-D widths ranging 1-1.4 mm.</p> <p>Longitudinal cracks from Grid C-D with widths ranging from 0.6-1 mm.</p>	  <p>The three photographs show different views of a concrete floor slab with a vertical crack. Each image includes a ruler for scale and a handwritten note with the following text: '254403 Level: 3 Grid: D8A Element: Beam Column ✓ Slab Dycere'. The crack is clearly visible in all three images, running vertically through the concrete.</p>
------------	---	--	--

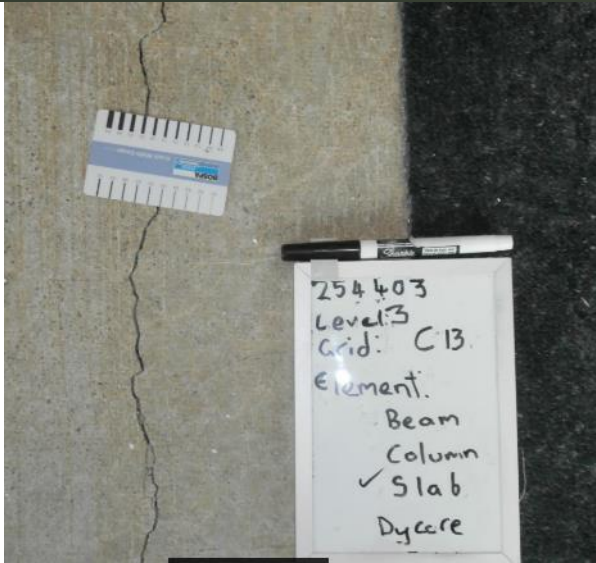
<p>The three photographs show a floor slab with a crack. The top photo shows a crack with a ruler and a label. The middle photo shows a crack with a ruler and a label. The bottom photo shows a crack with a ruler and a label.</p>
309	Floor slab level 3. Grid numbers between 10A-13 and C-H.	<p>Longitudinal crack along grid C approx 2 mm wide.</p> <p>Transverse crack along grid line 10A at point D approx 1.2 mm.</p>

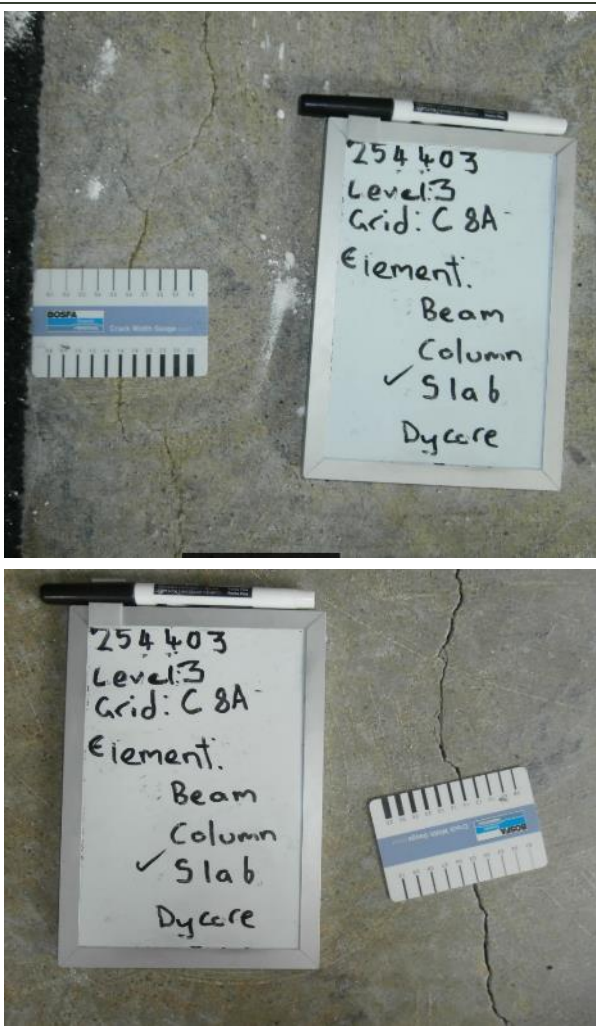
<p>310</p>	<p>Floor slab level 3. Grid numbers between 10A-8A and B-C.</p>	<p>Longitudinal cracks along grid line C and B approx 1.4 mm wide. Transverse cracking around column in inner frame width ranging 1.6-2.5 mm.</p>

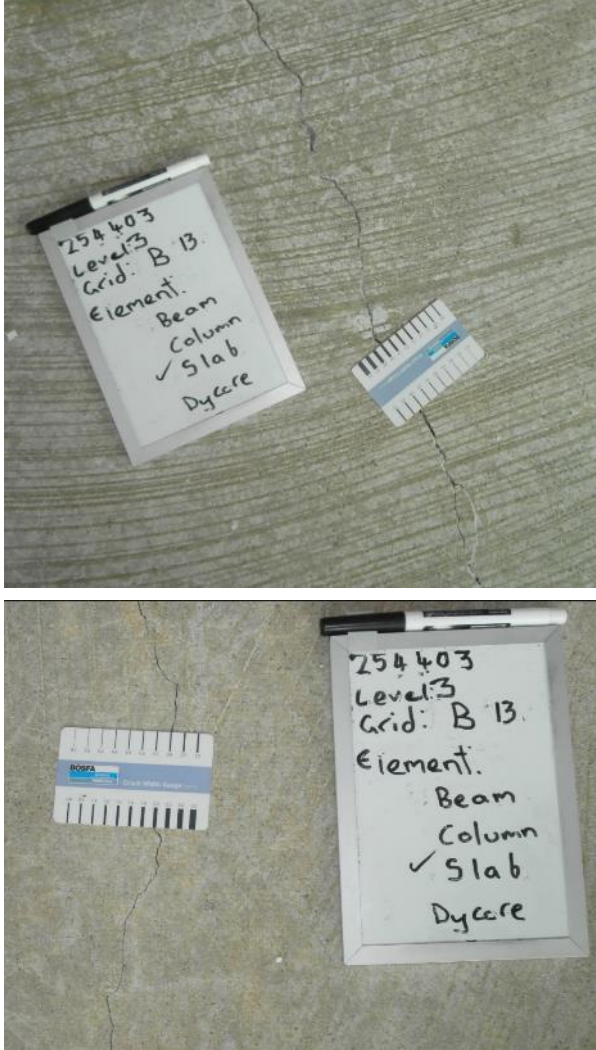
<p>311</p>	<p>Floor slab level 3. Grid numbers between 10A-13 and B-C.</p>	<p>Longitudinal cracking between along slab widths ranging 0.8-2 mm.</p>

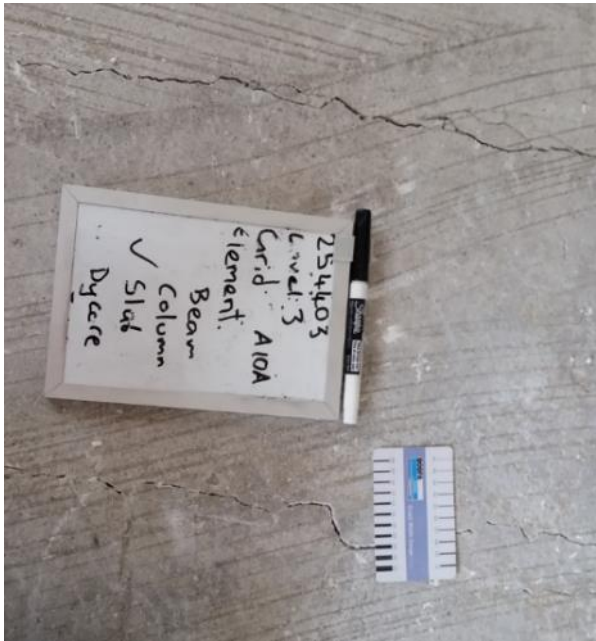
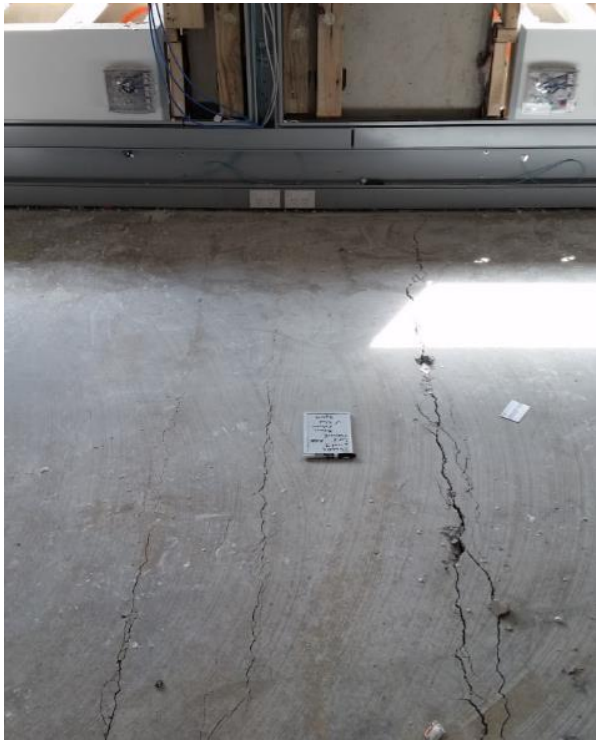
312	Floor slab level 3. Grid numbers between 10A-8A and A-B.	<p>Diagonal cracking spreading from corner column A8A width ranges from 4 – 1.2 mm.</p> <p>Cracking at column base at A8A.</p> <p>Longitudinal crack along the span of the floor approx 2 mm width.</p> <p>Transverse crack along gridline 10A approx 8 mm.</p> <p>Longitudinal crack along perimeter frame at grid A approx 4 mm wide.</p>

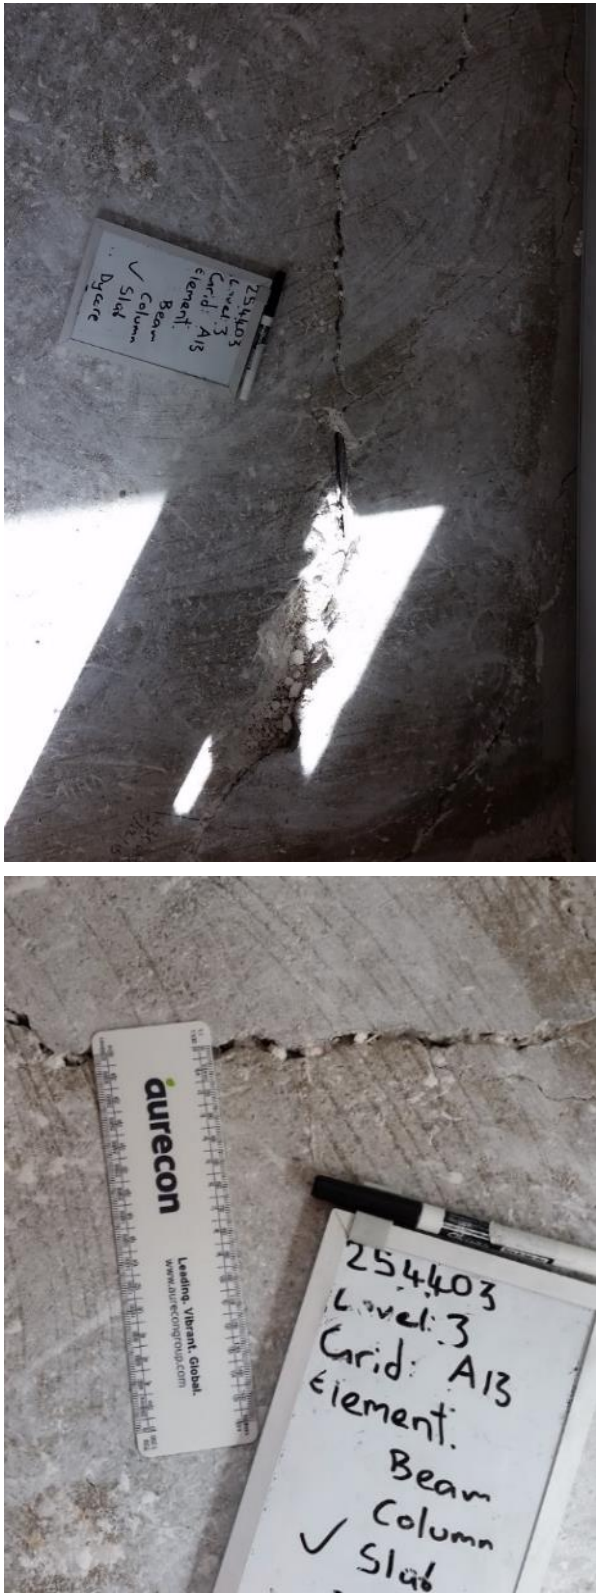
<p>313</p>	<p>Floor slab level 3. Grid numbers between 10A-13 and A-B.</p>	<p>Diagonal cracking spreading from corner column at A13 widths ranging 7-1.8 mm. Mesh exposed at places.</p> <p>Loss of concrete at toe of column A13.</p> <p>Longitudinal crack along the span of the floor approx 0.9 mm width.</p> <p>Transverse crack along gridline 10A approx 2.5 mm.</p>
