Resilient Repair Guide Source Report: Case Study Annex

APPLIED TECHNOLOGY COUNCIL
201 Redwood Shores Parkway, Suite 240
Redwood City, California 94065
www.ATCouncil.org

FEDERAL EMERGENCY MANAGEMENT AGENCY
Michael Mahoney, Project Officer
William T. Holmes, Technical Monitor
Washington, D.C.

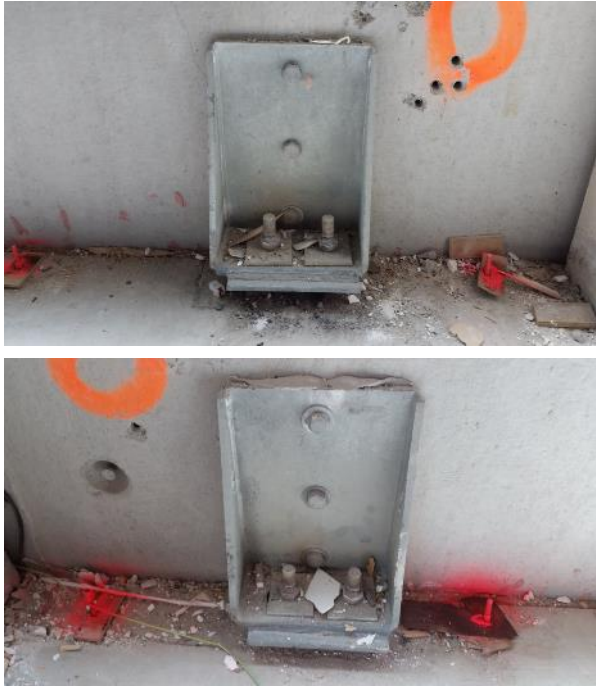
314	Elevation 8A, Grids between A-B. Precast façade panels in level 3.	Diagonal cracks approximately 3mm wide around the bottom connection of the precast panel.

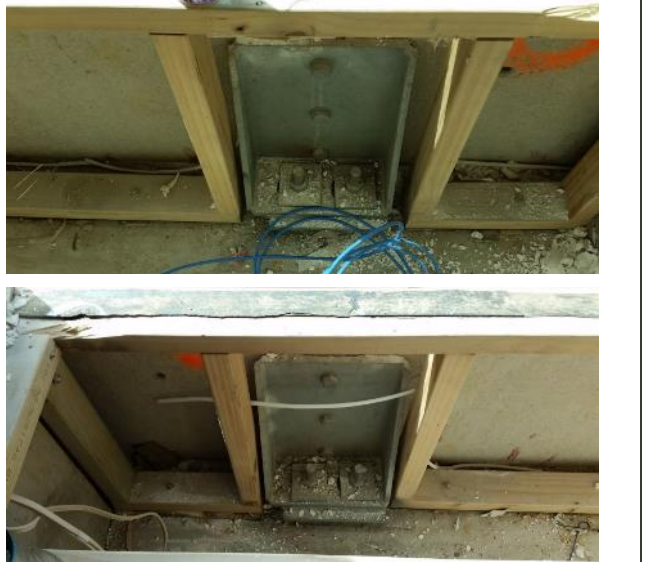
315	Elevation 8A, Grids between B-C. Precast façade panels in level 3.	Diagonal cracks approximately 3mm wide around the bottom connection of the precast panel.

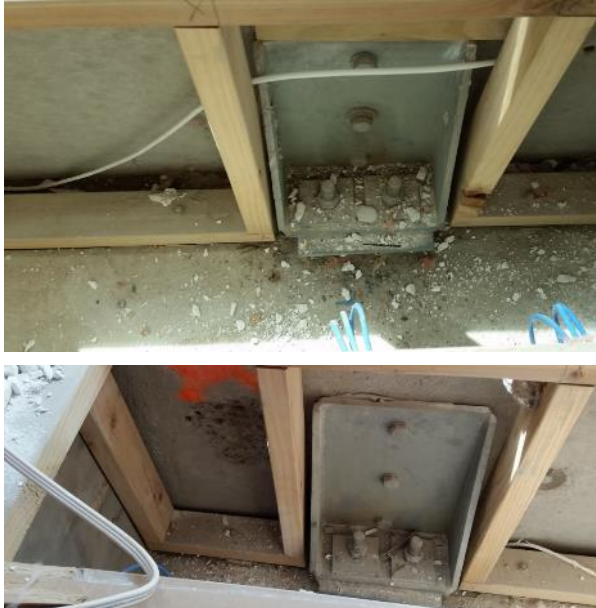
318	Elevation 8A, Grids between E-F. Precast façade panels in level 3.	Panel damaged, likely not related with the earthquake. No crack seen in the panel.

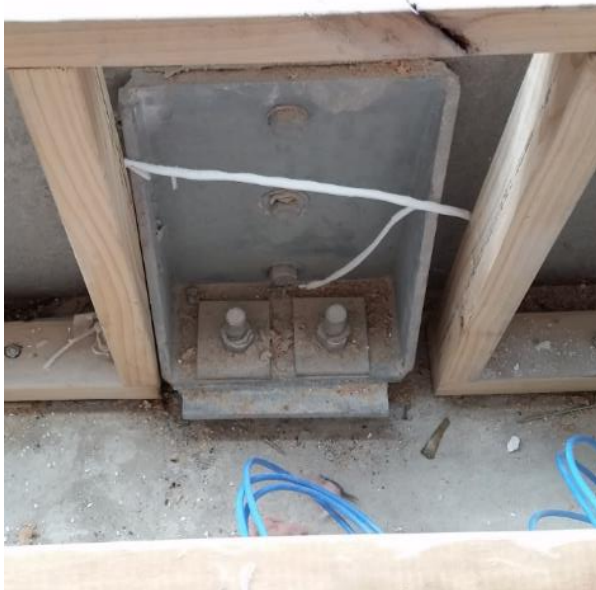
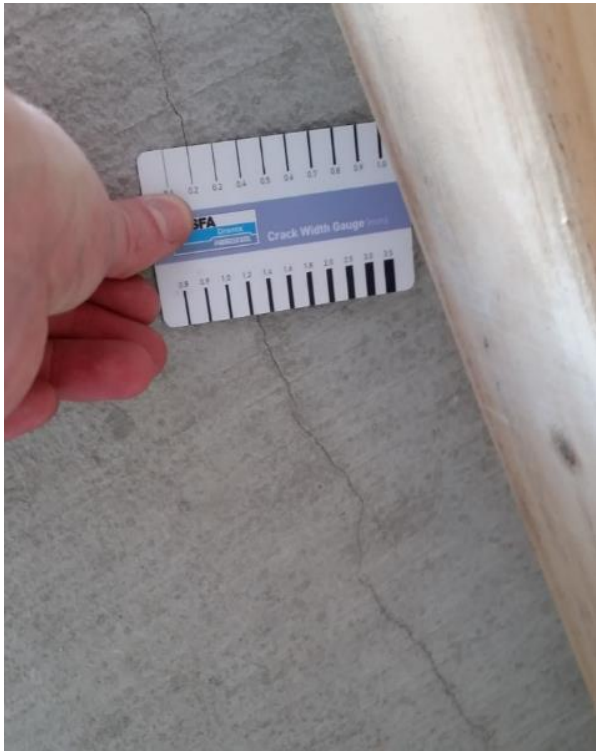
319	Elevation 8A, Grids between F-G. Precast façade panels in level 3.	A 2mm wide vertical crack in the center of the panel. No cracks around the connections.

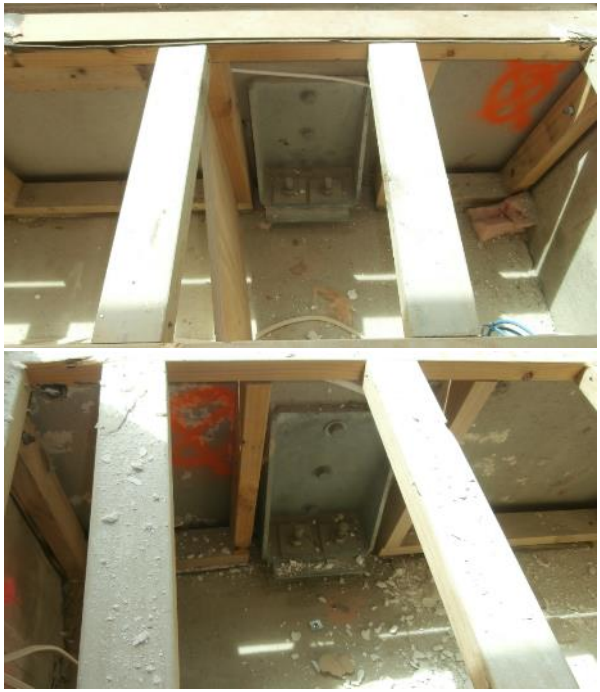
323	Elevation 1, Grids between HA/KA-KA. Precast façade panels in level 3.	Combination of vertical and diagonal cracks between 0.3mm to 0.2mm wide around the connection and in the precast panel.

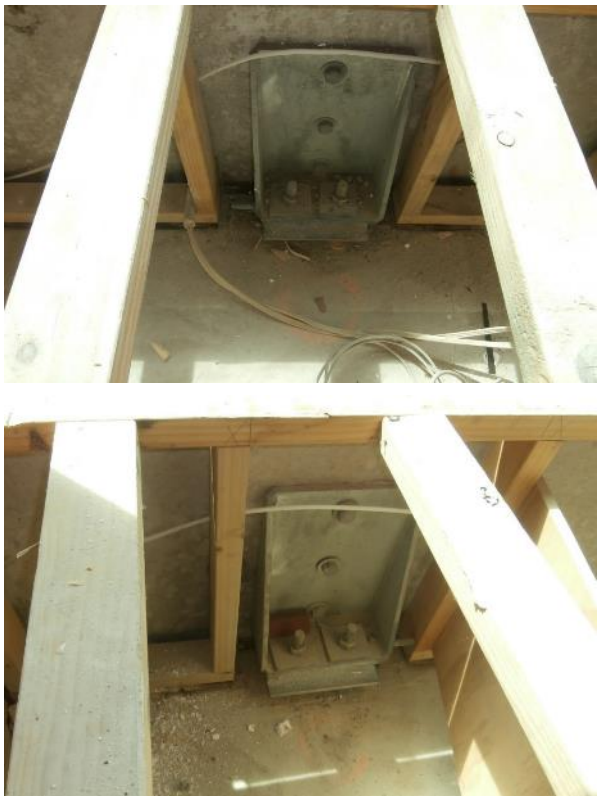
The top photograph shows a close-up of a precast concrete panel's connection to a steel beam. A vertical crack is visible on the left side of the panel, and a diagonal crack runs from the top edge towards the center. The bottom photograph shows a similar view from a slightly different angle, highlighting the diagonal crack more prominently.
324	Elevation 1, Grids between KA-KA/N. Precast façade panels in level 3.	Diagonal cracks in upper pannel approx 0.2 mm wide.

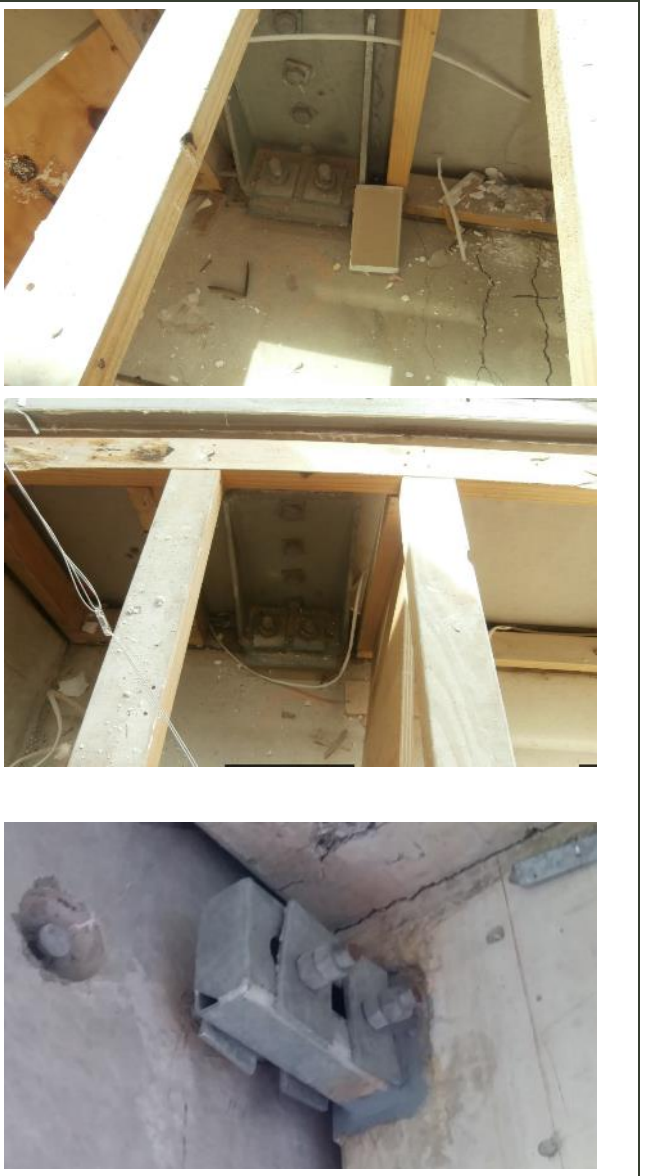
325	Elevation 1, Grids between KA/N-N. Precast façade panels in level 3.	Diagonal cracks between 0.3mm to 0.2mm wide around the connection and in the precast panel. Diagonal cracks approximately 0.2mm wide in the top of the precast panel. Top fixing plates were bent.

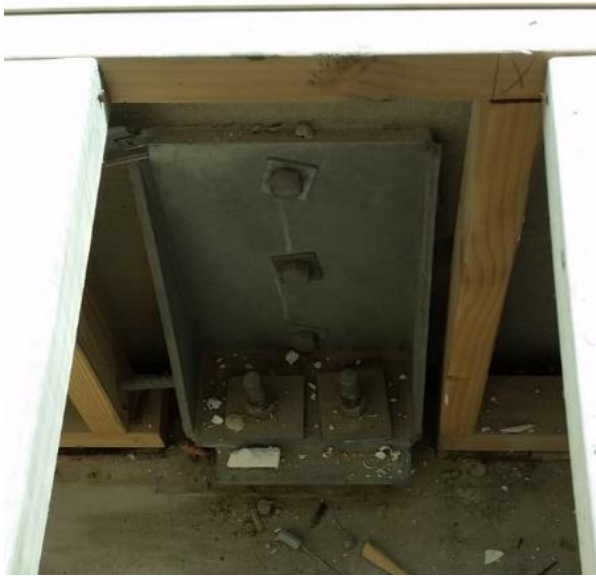
326	Elevation A, Grids between 13-13/10A. Precast façade panels in level 3.	No crack was observed in the bottom of the panel at the time of inspection. A hairline crack in the top of the panel.

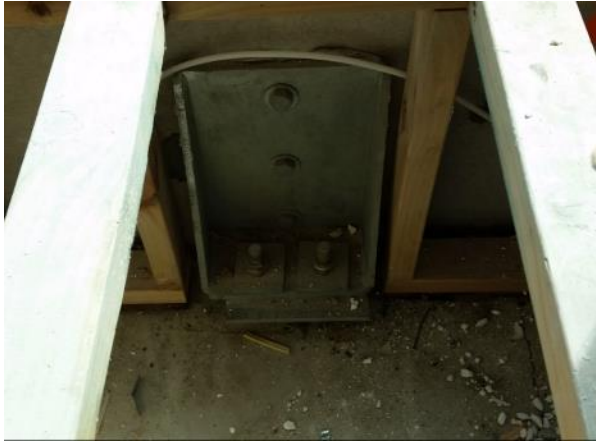
327	Elevation A, Grids between 13/10A-10A. Precast façade panels in level 3.	No crack was observed around the bottom connection. Minor damage/dislocation of concrete around the top connection. Top connection plates are bent.

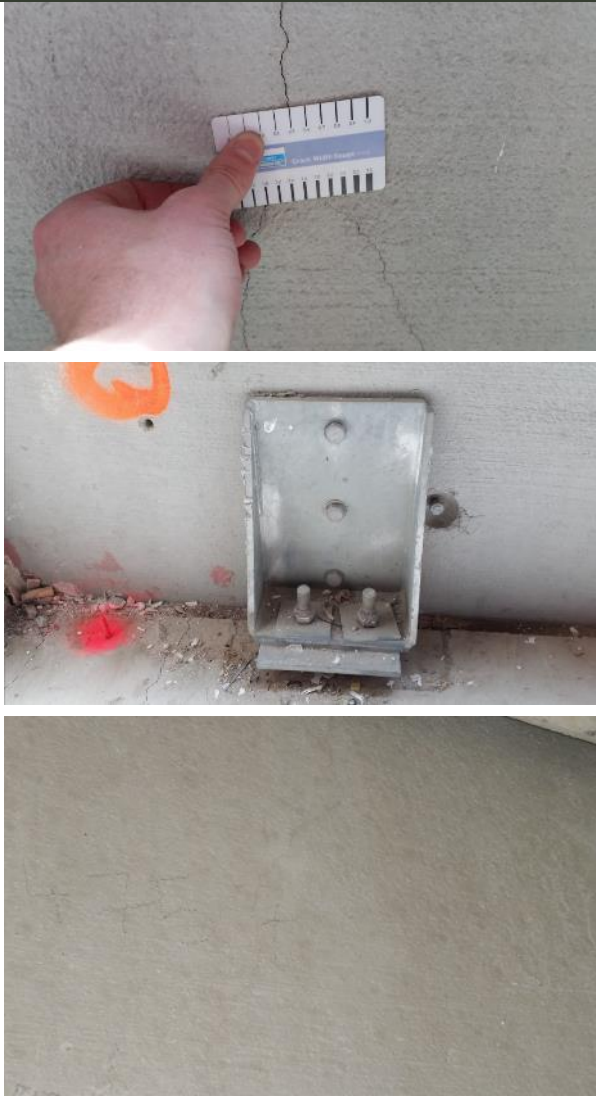
328	Elevation A, Grids between 10A-10A/8A. Precast façade panels in level 3.	Diagonal cracks approximately 0.3mm wide close to the bottom connection of the precast panel. Vertical crack in upper pannel approx 0.2 mm.

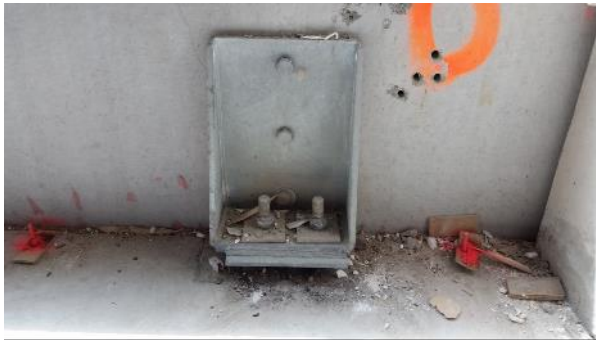
<p>329</p>	<p>Elevation A, Grids between 10A/8A-8A. Precast façade panels in level 3.</p>	<p>Vertical cracks between 0.5mm to 0.2mm wide in the bottom of the precast panel. Concrete spalling and a width of 0.2mm crack in the top of the panel. Top connection bolts are bent.</p>

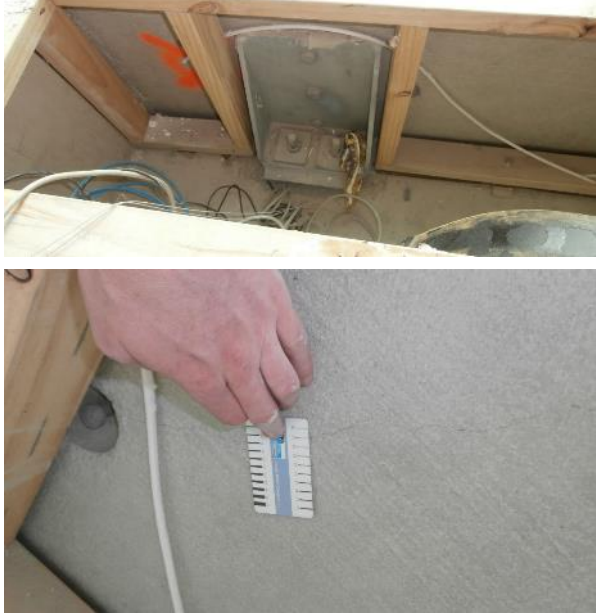
330	Elevation HA, Grids between 8A-8. Precast façade panels in level 3.	No crack/damage was observed in the panel at the time of inspection.	 
331	Elevation HA, Grids between 8-7. Precast façade panels in level 3.	A diagonal crack 0.2mm wide around the bottom connection of the precast panel.

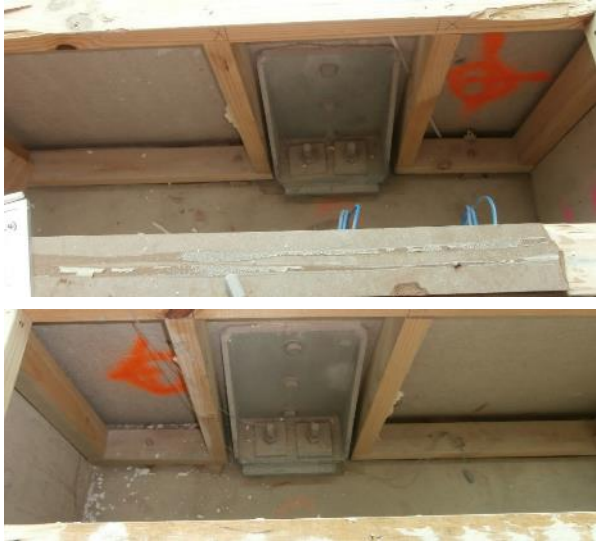
332	Elevation HA, Grids between 7-6. Precast façade panels in level 3.	No crack/damage was observed in the panel at the time of inspection.

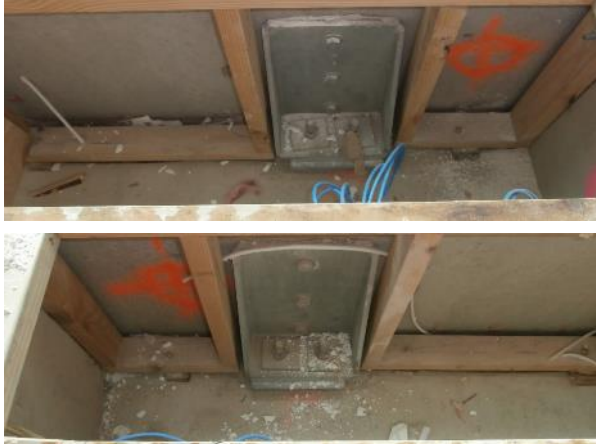
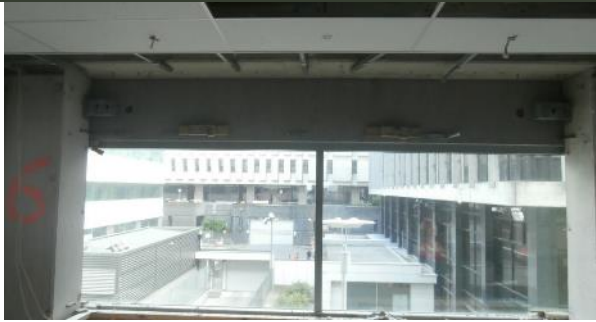
333	Elevation HA, Grids between 6-5. Precast façade panels in level 3.	No crack/damage was observed in the panel at the time of inspection.

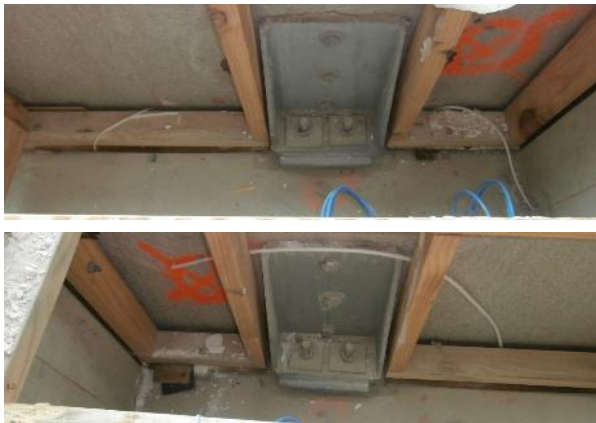
334	Elevation HA, Grids between 5-4. Precast façade panels in level 3.	No crack/damage was observed in the panel at the time of inspection.

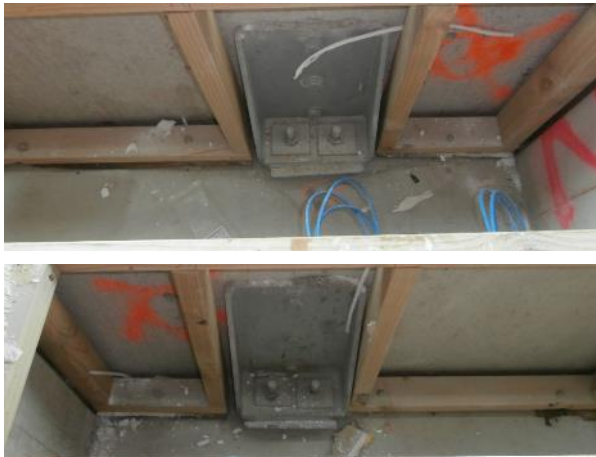
335	Elevation HA, Grids between 4-3. Precast façade panels in level 3.	No crack/damage was observed in the panel at the time of inspection.

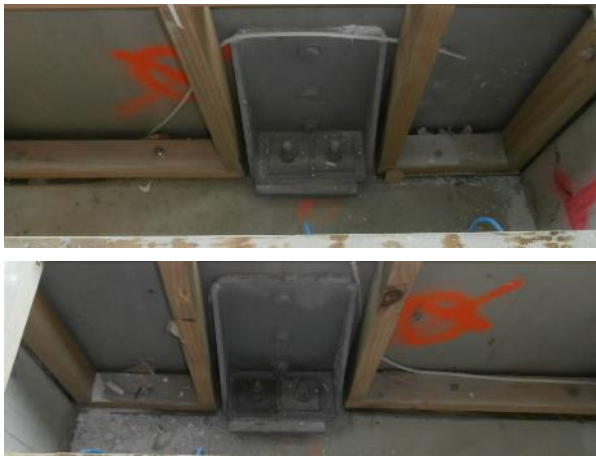
336	Elevation HA, Grids between 3-2. Precast façade panels in level 3.	No crack/damage was observed in the panel at the time of inspection.

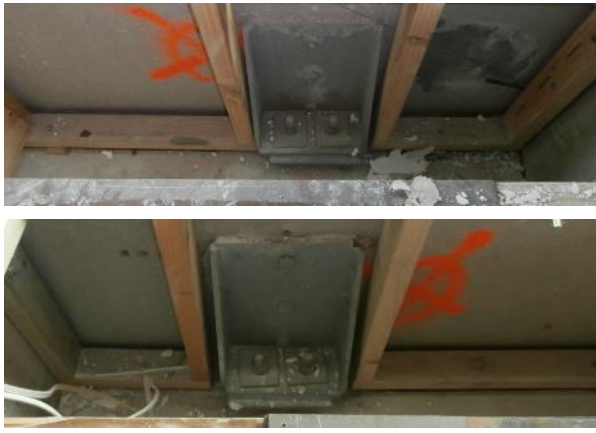
337	Elevation HA, Grids between 2-1. Precast façade panels in level 3.	No crack/damage was observed in the panel at the time of inspection.

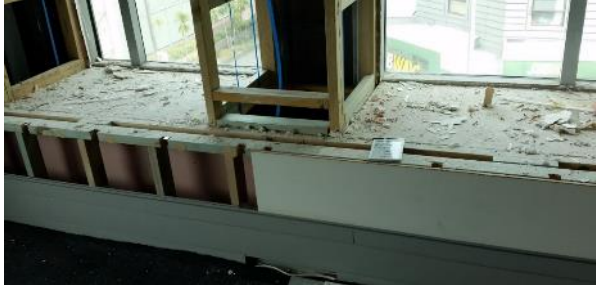
338	Elevation 13, Grids between N-M. Precast façade panels in level 3.	Bulkhead not removed at the time of inspection

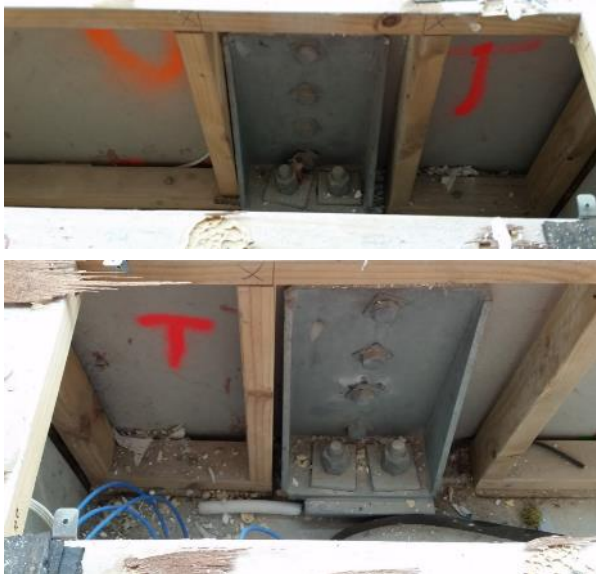
339	Elevation 13, Grids between M-L. Precast façade panels in level 3.	Diagonal cracks approximately 0.3mm wide around the bottom connection of the precast panel. Diagonal crack approx 0.8 mm.

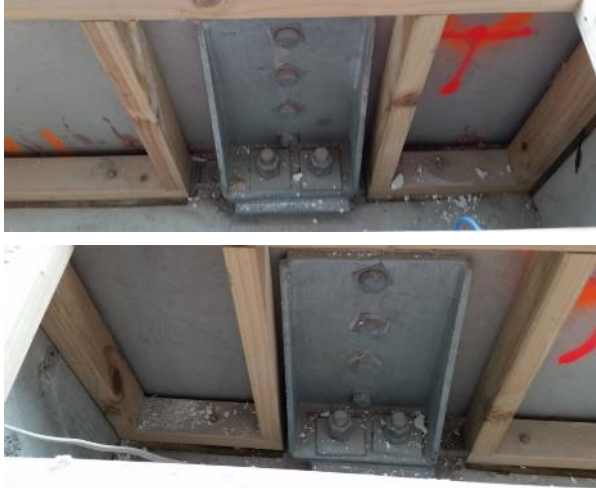
340	Elevation 13, Grids between L-K. Precast façade panels in level 3.	<p>Diagonal cracks between 0.3mm to 0.5mm wide around the bottom connections of the precast panel.</p> <p>Top connection bolts are bent.</p> <p>0.2 mm diagonal crack in upper pannel.</p>

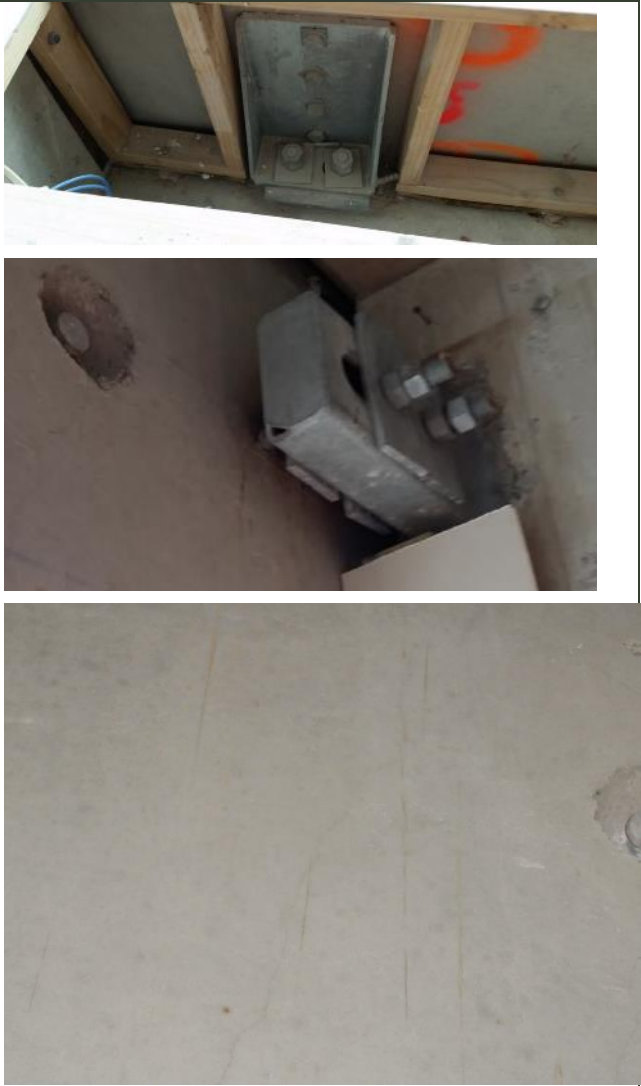
<p>342</p>	<p>Elevation 13, Grids between J-H. Precast façade panels in level 3.</p>	<p>Diagonal cracks approximately 0.4mm wide around the bottom connections of the precast panel.</p> <p>Right side plate bent.</p>

<p>0.3 mm diagonal cracking on left side of upper panel.</p>

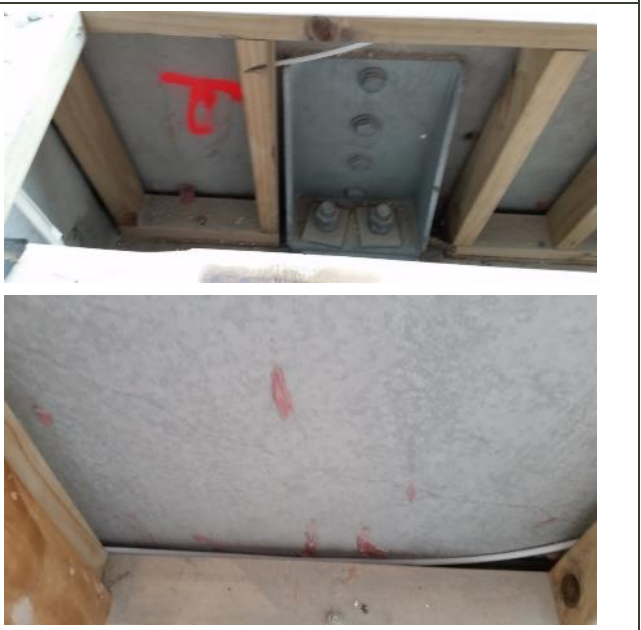
<p>343</p>	<p>Elevation 13, Grids between H-G. Precast façade panels in level 3.</p>	<p>Diagonal and horizontal cracks between 0.3mm to 0.5mm wide in the precast panel. Bolts and plates of the top connections are bent. 0.2 mm diagonal cracking on left of panel 0.3 mm on right side in upper connection.</p>

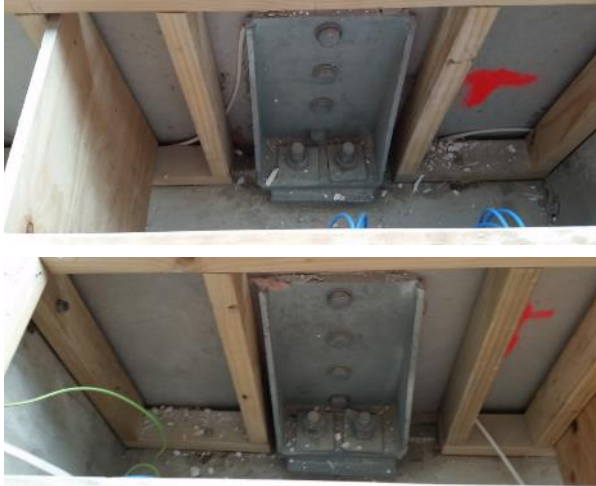
<p>344</p>	<p>Elevation 13, Grids between G-F. Precast façade panels in level 3.</p>	<p>Diagonal cracks range between 0.3mm to 0.5mm wide around the bottom connections. 0.2 mm diagonal cracking on left of panel 0.3 mm on right side in upper connection.</p>

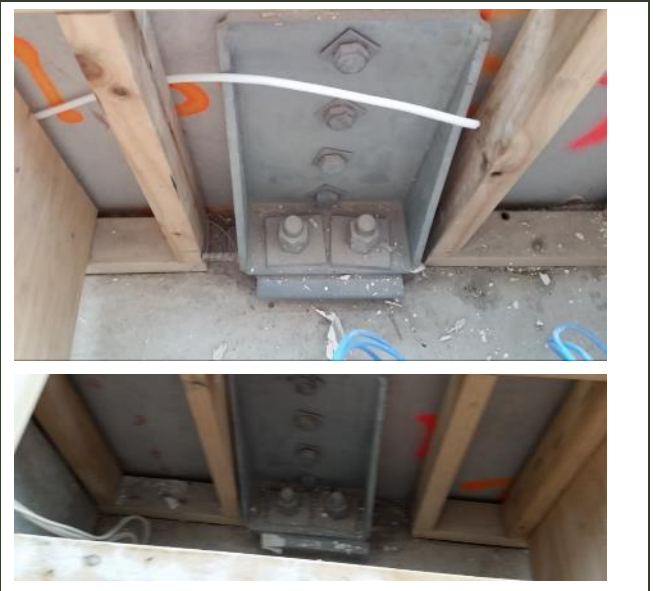
345	Elevation 13, Grids between F-E. Precast façade panels in level 3.	Diagonal cracks approximately 0.4mm wide around the bottom connections. 0.5 mm diagonal cracking on left of panel 0.2 mm on right side in upper panel.

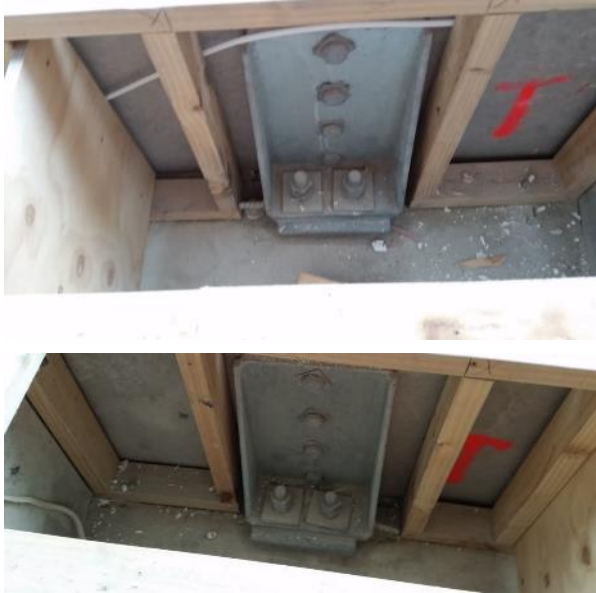
<p>346</p>	<p>Elevation 13, Grids between E-D. Precast façade panels in level 3.</p>	<p>Diagonal cracks 0.4mm wide around the bottom connections and in the panel.</p>

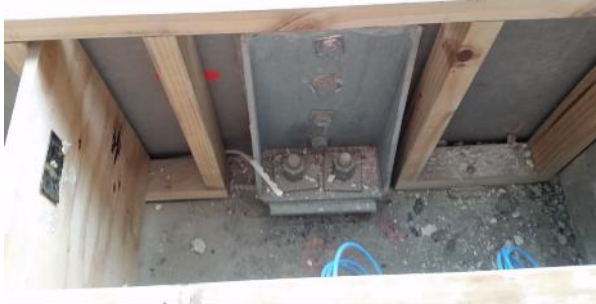
<p>347</p>	<p>Elevation 13, Grids between D-C. Precast façade panels in level 3.</p>	<p>Diagonal cracks 0.4mm wide around the bottom connections. Right side plate bent.</p>

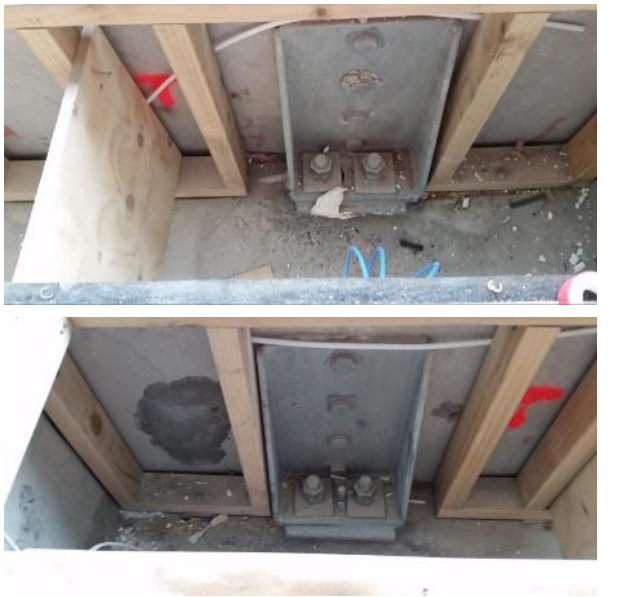
348	Elevation 13, Grids between C-B. Precast façade panels in level 3.	<p>Diagonal cracks range between 0.2mm to 0.5mm wide around the bottom connections.</p> <p>0.5 mm diagonal cracking on left of panel 0.3 mm on right side in upper connections</p> <p>Both plates bent.</p>

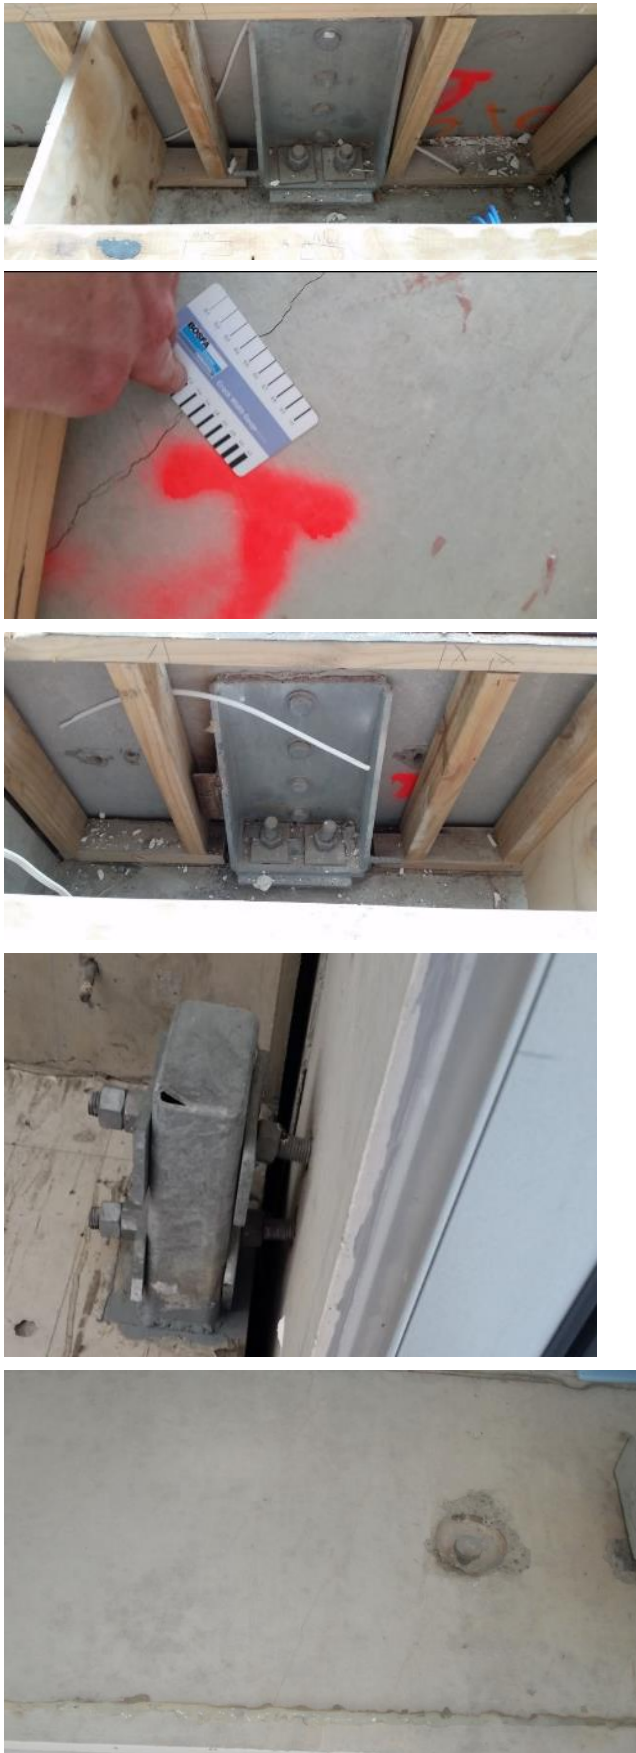
349	Elevation 13, Grids between B-A. Precast façade panels in level 3.	<p>Diagonal cracks range between 0.3mm to 0.4mm wide around the bottom connections.</p> <p>Bolts and plates in the top connections are bent.</p> <p>0.2 mm diagonal cracking on left of panel.</p> <p>0.4 mm diagonal cracking on Right of panel.</p>

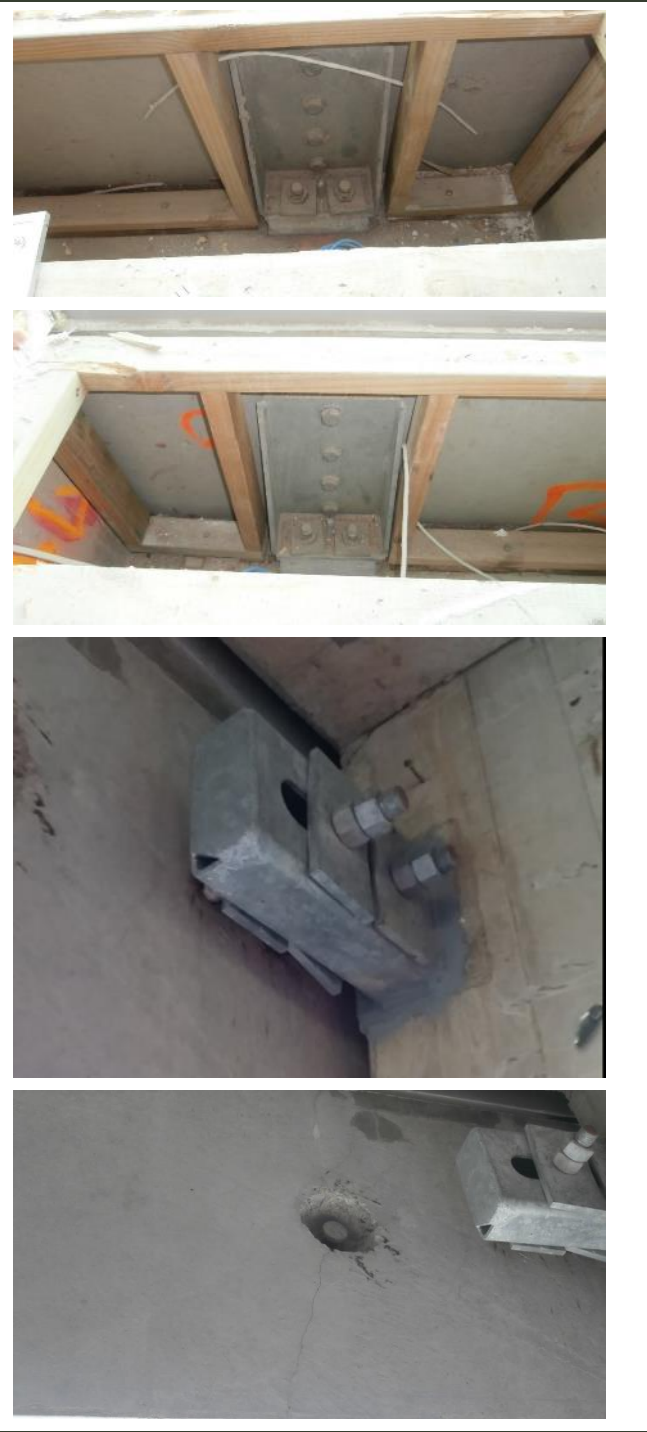
352	Elevation N, Grids between 3-4. Precast façade panels in level 3.	Diagonal cracks approximately 0.6mm wide around the bottom connections. Right side panel bent.

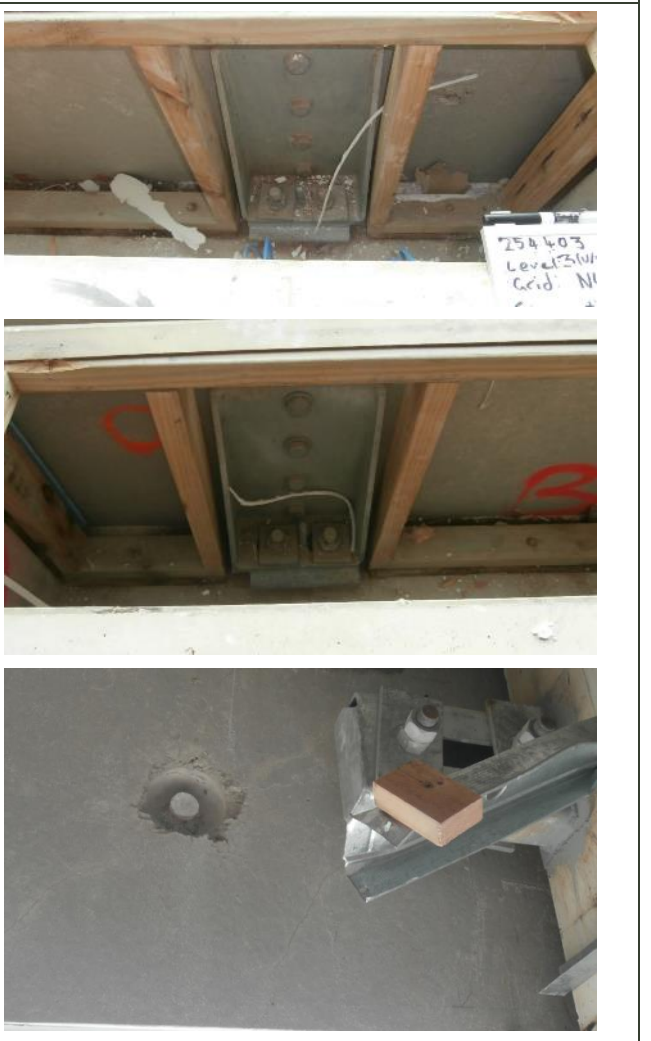
353	Elevation N, Grids between 4-5. Precast façade panels in level 3.	Diagonal cracks between 0.3mm to 0.5mm wide around the bottom connections and in the panel.

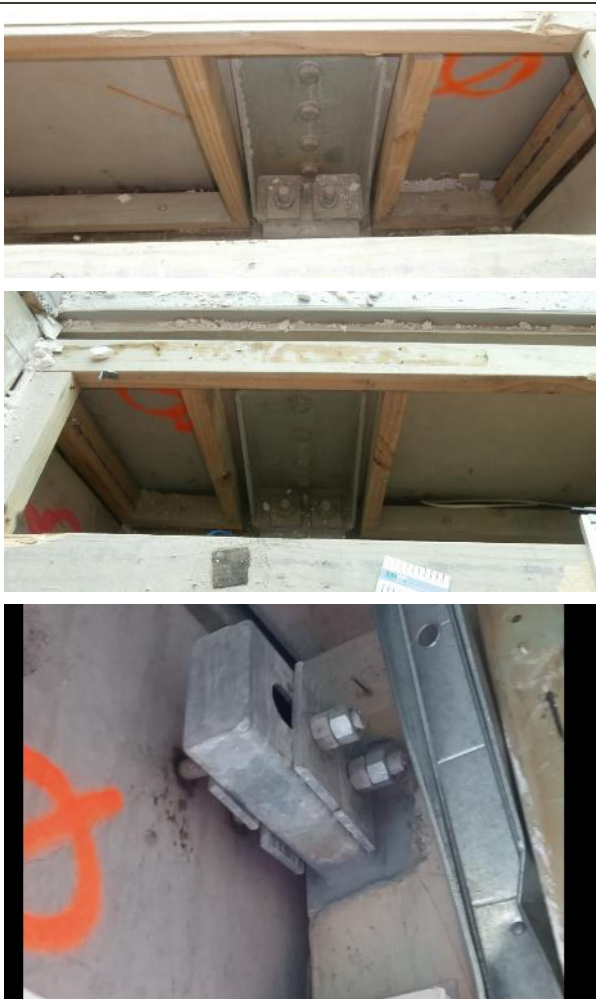
554	Elevation N, Grids between 5-6. Precast façade panels in level 3.	Diagonal cracks between 0.1mm to 0.4mm wide around the bottom connections and in the panel. Right hand plate bent.

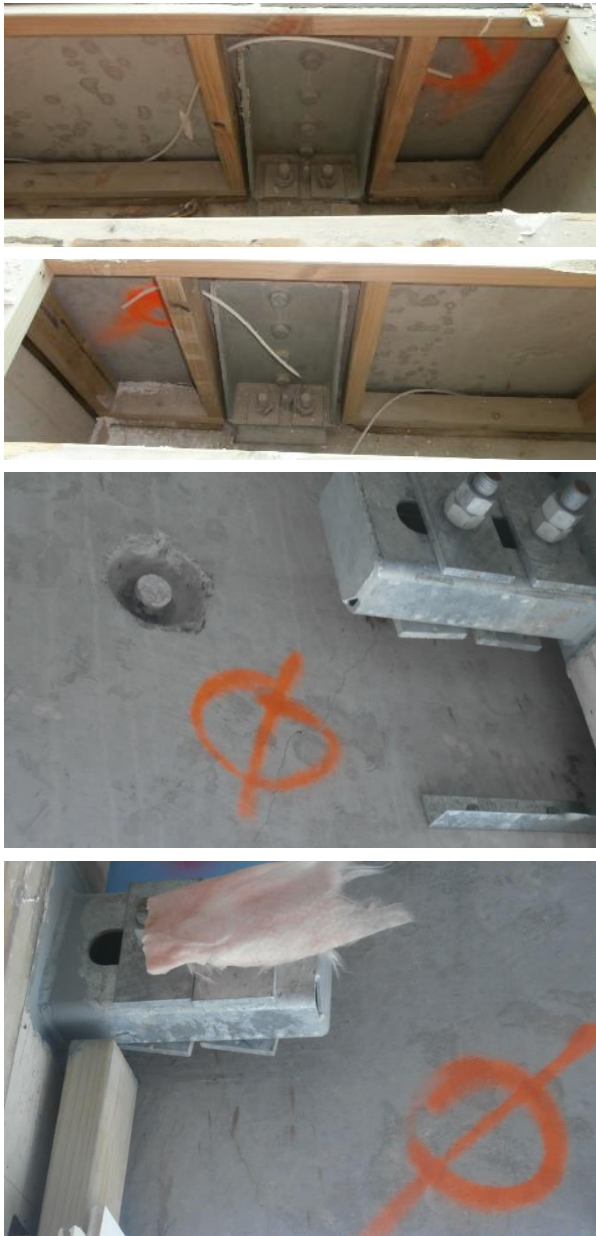
357	Elevation N, Grids between 8-9. Precast façade panels in level 3.	Diagonal cracks between 0.2mm to 0.4mm wide around the bottom connections.

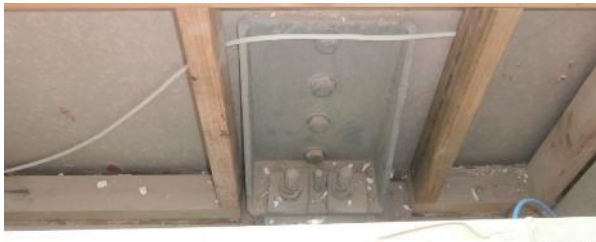
358	Elevation N, Grids between 9-10. Precast façade panels in level 3.	Diagonal cracks between 0.3mm to 0.4mm wide around the bottom connections and in the panel.

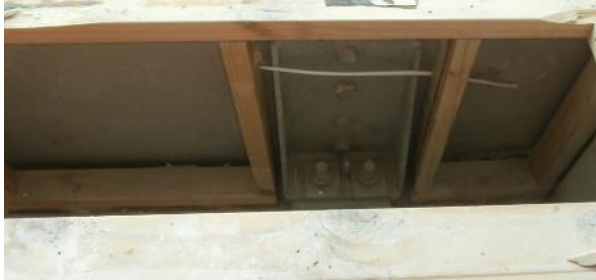
359	Elevation N, Grids between 10-11. Precast façade panels in level 3.	Diagonal cracks between 0.2mm to 0.3mm wide around the bottom connections and in the panel.

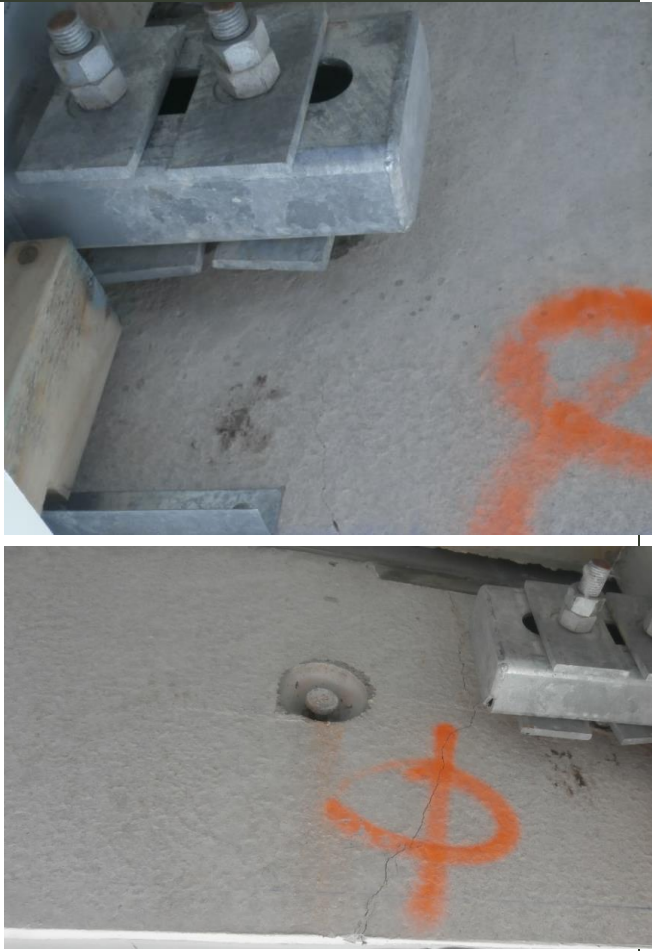
<p>360</p>	<p>Elevation N, Grids between 11-12. Precast façade panels in level 3.</p>	<p>Diagonal cracks 0.2mm wide around the bottom connections.</p>	 
------------	--	--	---

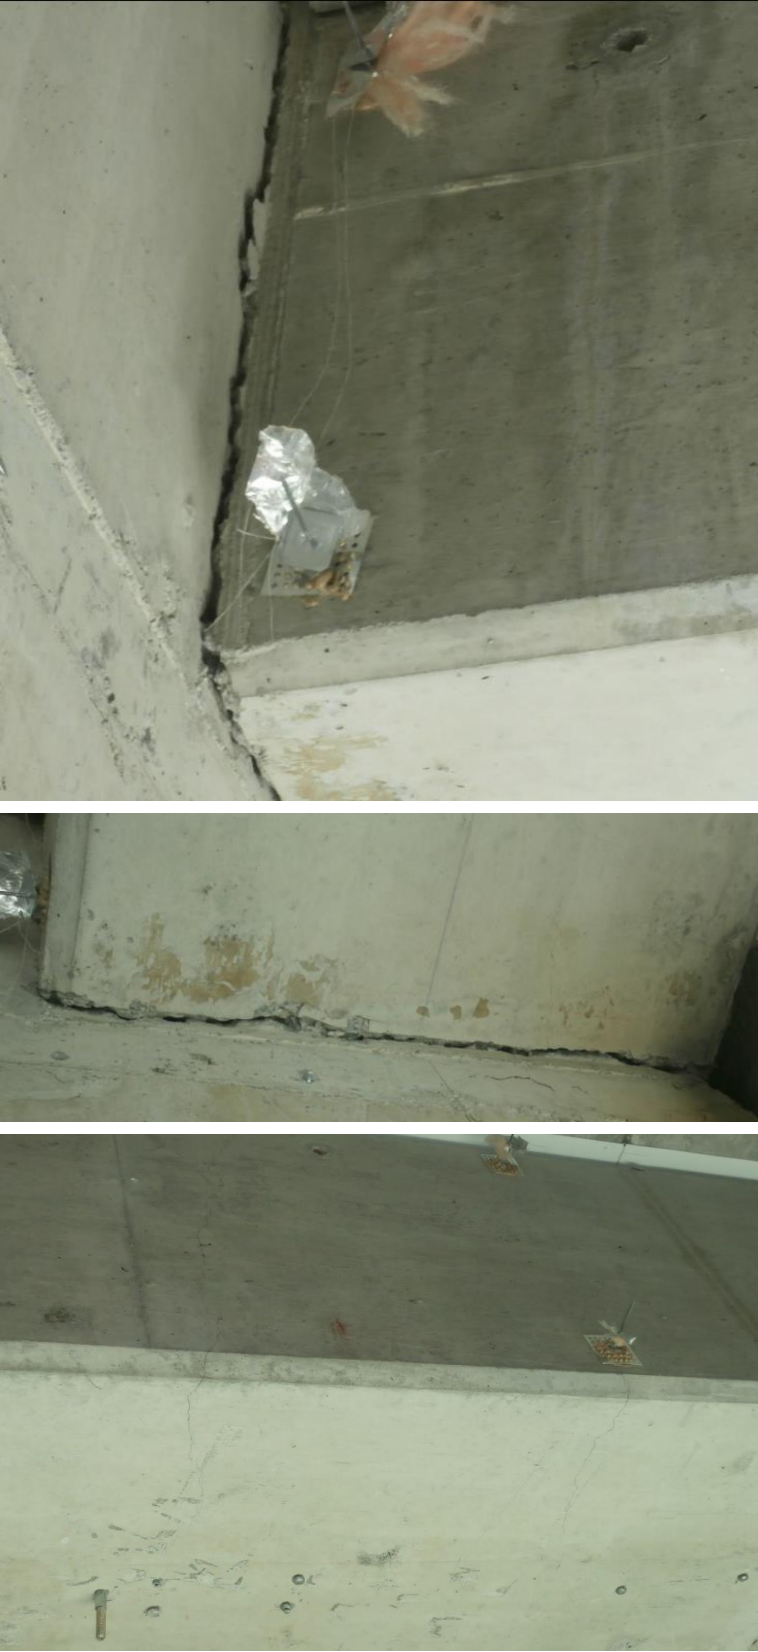
ID.	Location	Comment	Photographs
362	Elevation 8A-Grid A. Beam column joint underside of level 5 DS 1 2.0%	8 mm crack at face of column. 6 vertical cracks along beam approx. 0.2 mm.

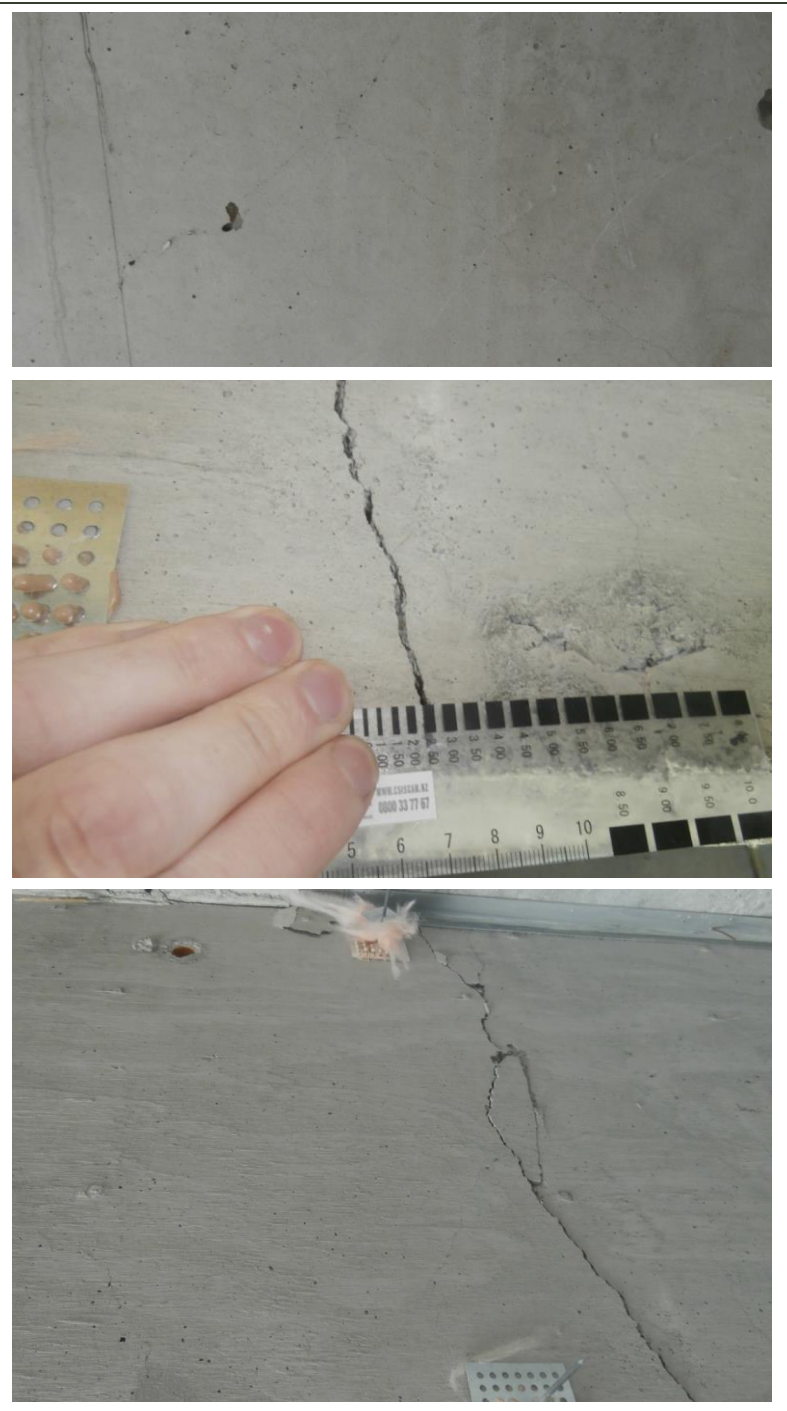
<p>363/3 64</p>	<p>Elevation 8A-Grid B. Beam column joint underside of level 5</p> <p>DS 1 2.0%</p>	<p>Diagonal hairline cracks in column. Crack on LHS of beam column joint approx. 2 mm. Crack on RHS of beam column joint approx. 2.5 mm. 2 hairline cracks along beam span.</p>

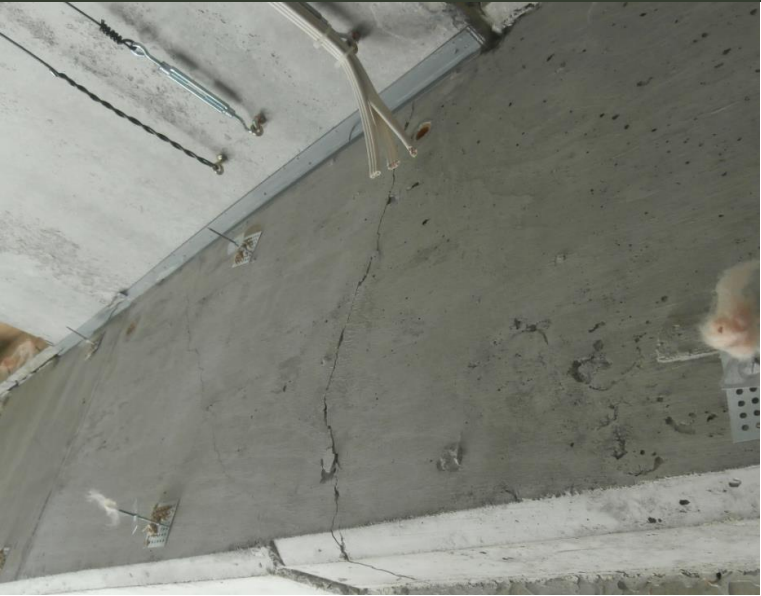
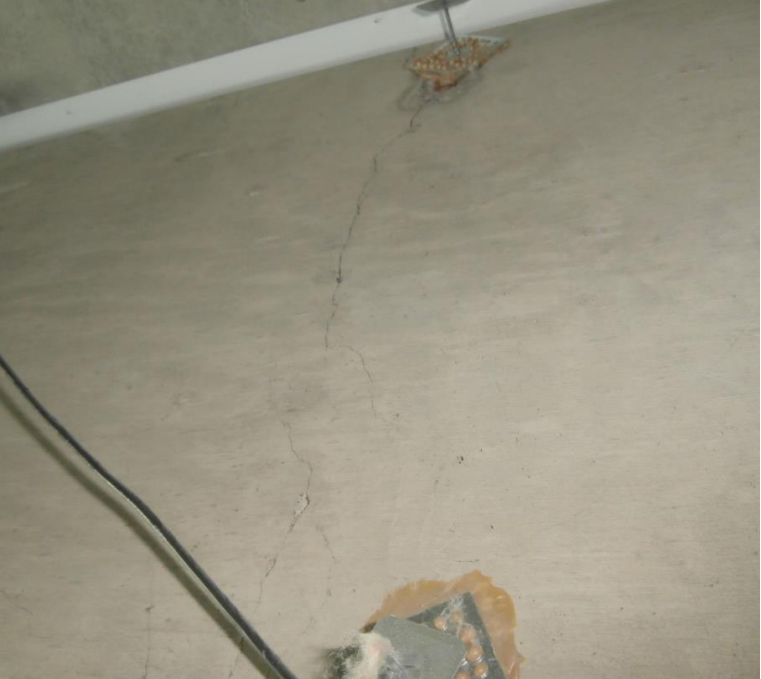
365/3 66	Elevation 8A-Grid C. Beam column joint underside of level 5 DS 1 2.0%	Diagonal hairline cracking in column. Cracks on either side of beam column joint approx. 2.5 mm.

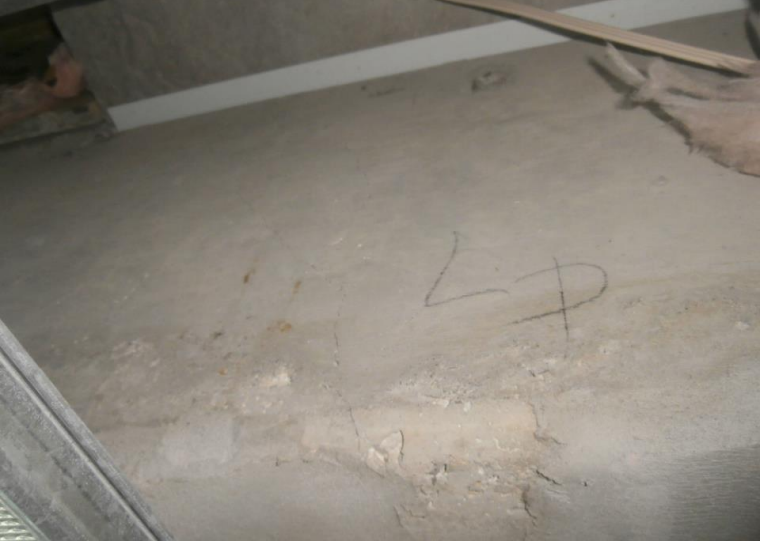
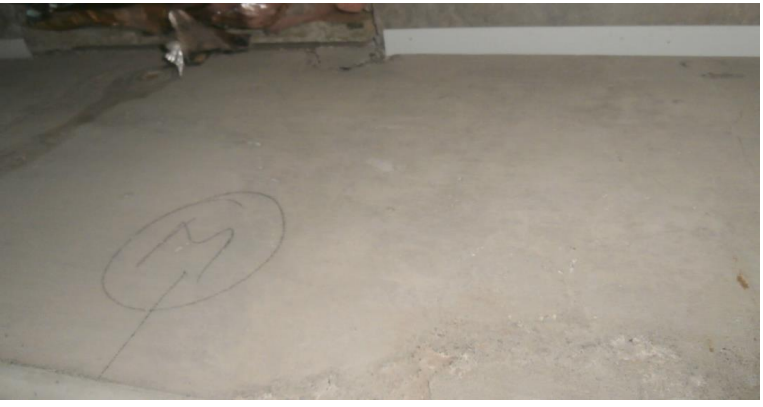
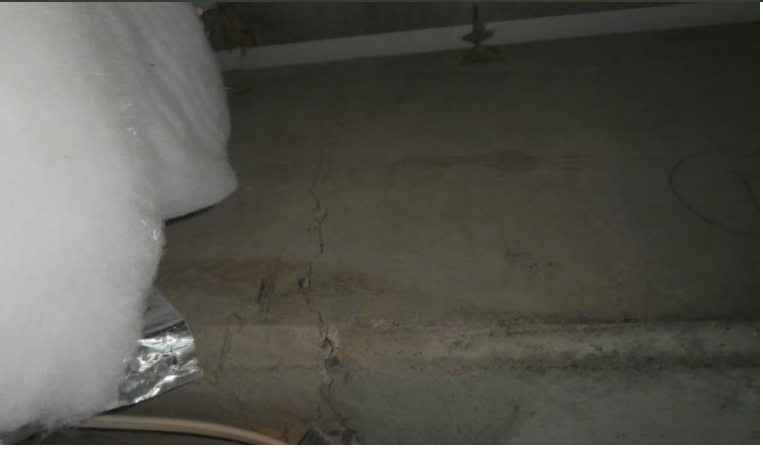
367/3 68	Elevation 8A-Grid D. Beam column joint underside of level 5 DS 0 1 %	Column not accessible, only beam column joint. Crack on LHS of beam column joint approx. 0.3 mm Crack on RHS of beam column joint approx. 1.5 mm.
