Resilient Repair Guide Source Report: Case Study Annex

APPLIED TECHNOLOGY COUNCIL
201 Redwood Shores Parkway, Suite 240
Redwood City, California 94065
www.ATCouncil.org

FEDERAL EMERGENCY MANAGEMENT AGENCY
Michael Mahoney, Project Officer
William T. Holmes, Technical Monitor
Washington, D.C.

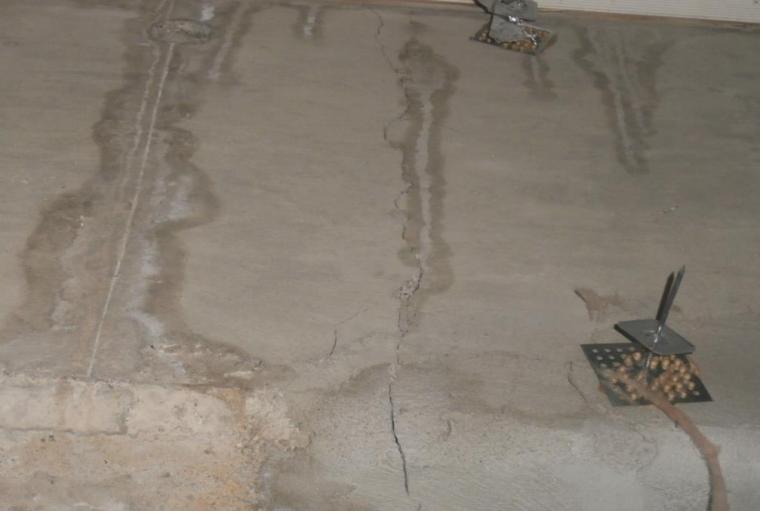
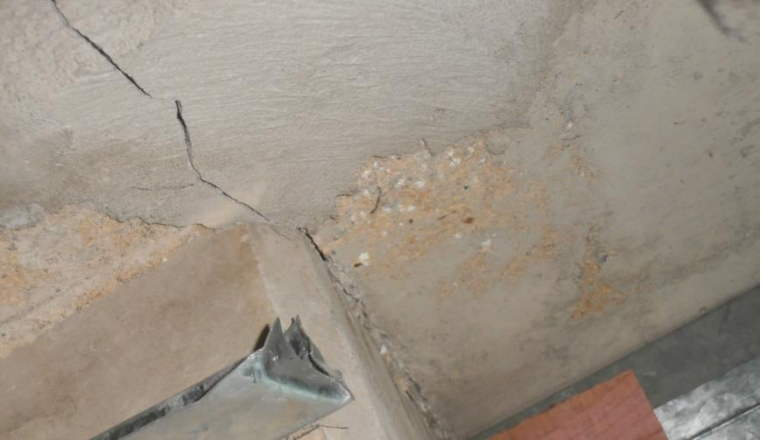
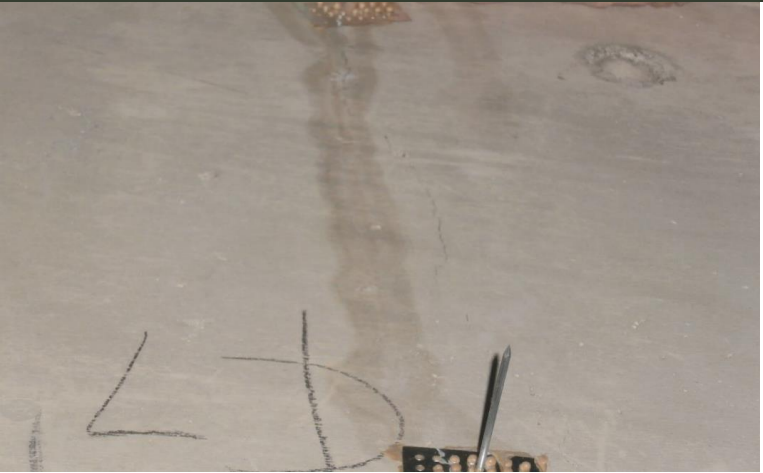
369/3 70	Elevation 8A-Grid E. Beam column joint underside of level 5 DS 1 2.0%	Diagonal hairline cracking in column. Cracking on either side of the beam column joint 1-2 mm.

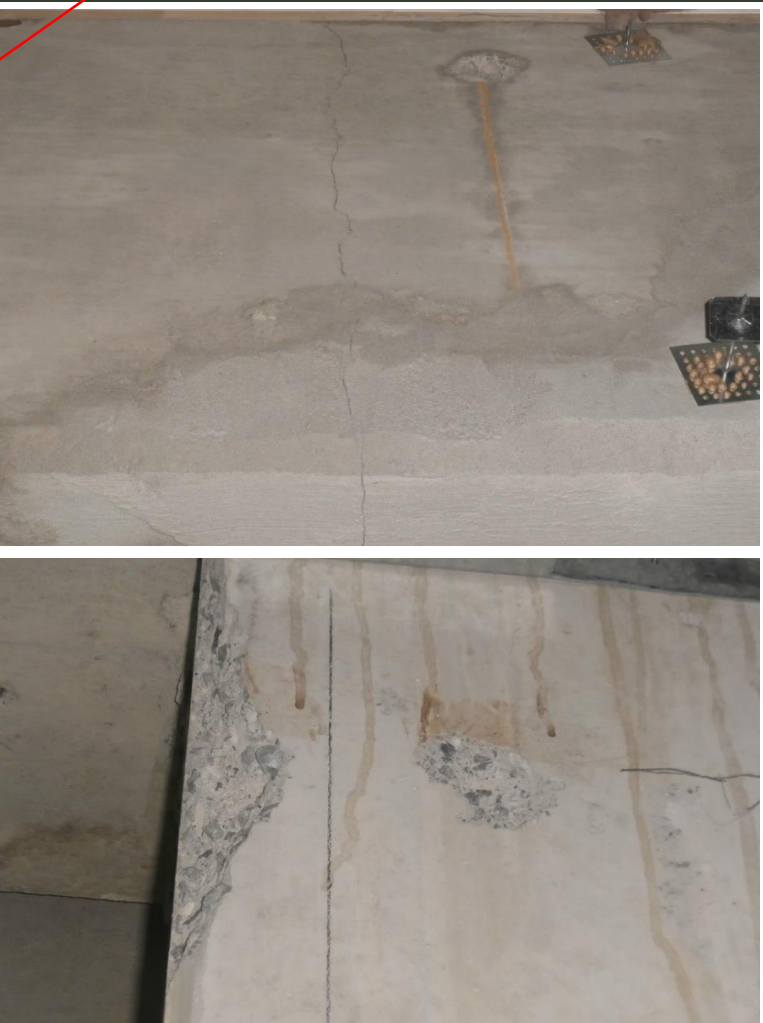
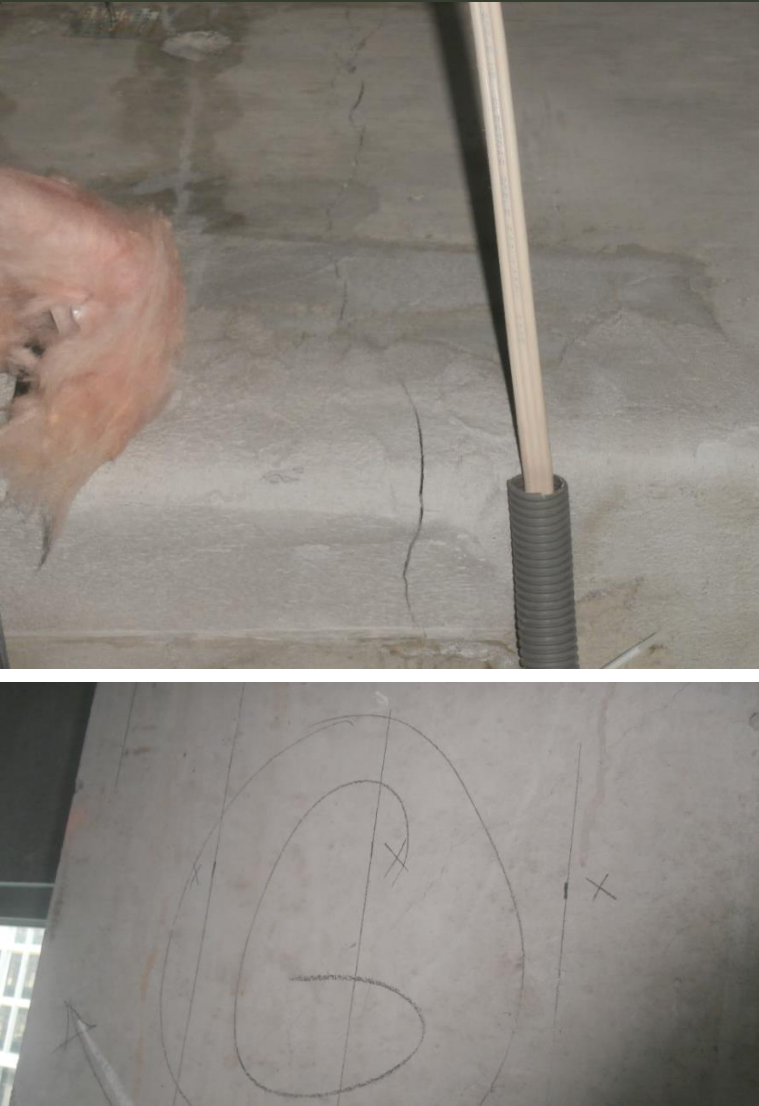
<p>371/3 72</p>	<p>Elevation 8A-Grid F. Beam column joint underside of level 5</p>	<p>No access not exposed</p>	<p>looks relatively minor</p>
<p>373/3 74</p>	<p>Elevation 8A-Grid G. Beam column joint underside of level 5 DS 0 1 %</p>	<p>Diagonal hairline cracking in column. Spalling of concrete from column. Cracking either side of beam column joint approx. 1-1.5 mm wide.</p>

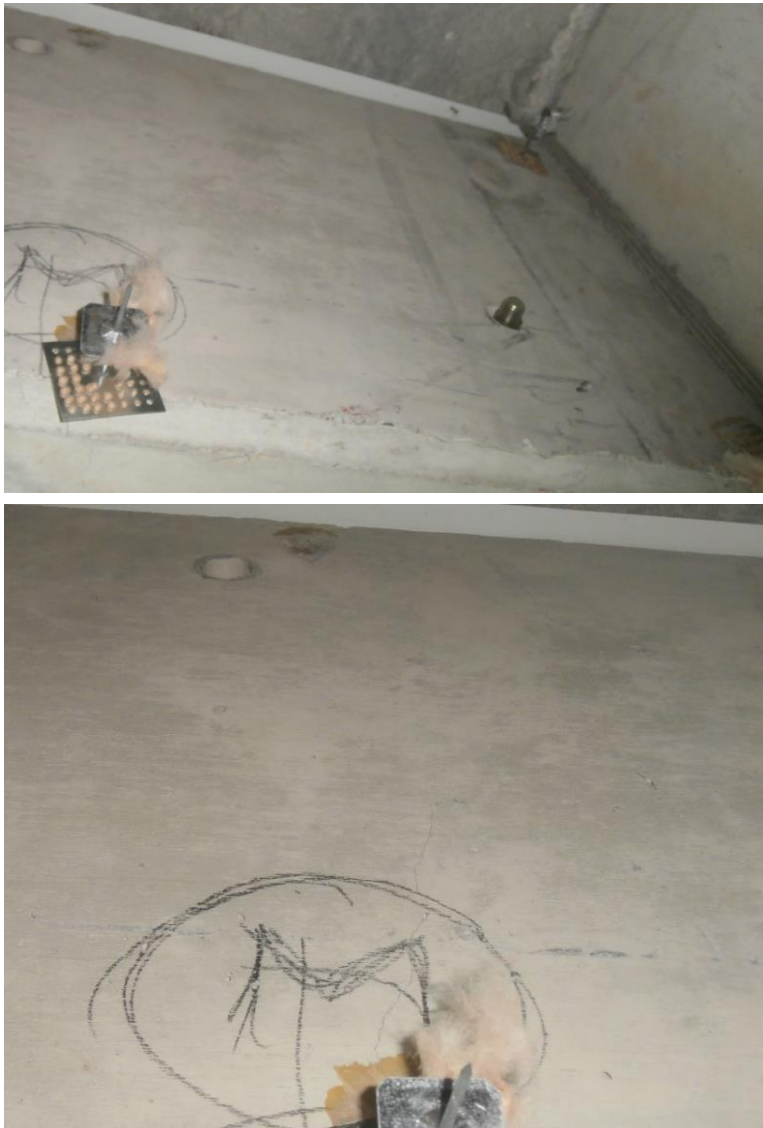
378	Elevation 8A-Grid HA. Beam column joint underside of level 5 DS 1 2.0%	Hairline diagonal cracking in beam. Vertical crack at column face approx. 2 mm.

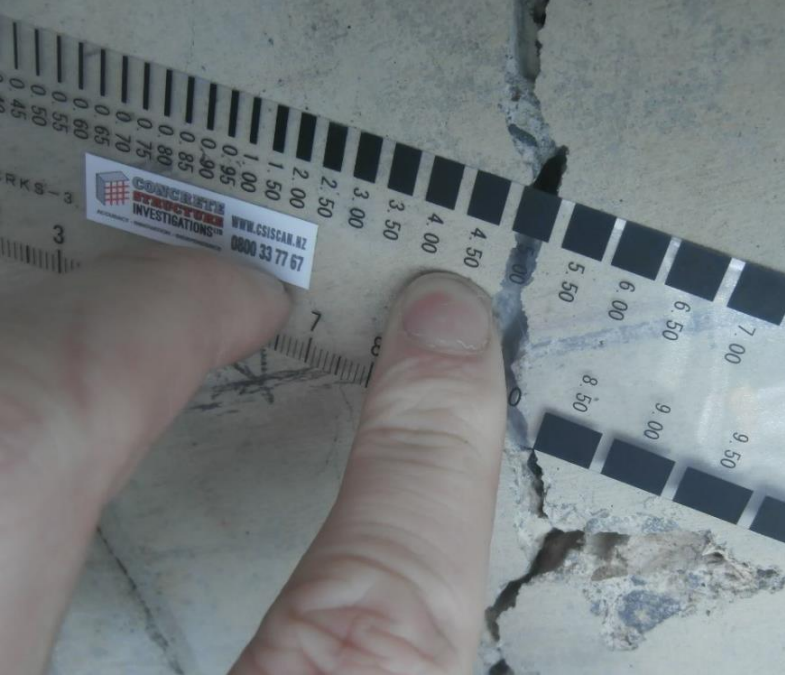
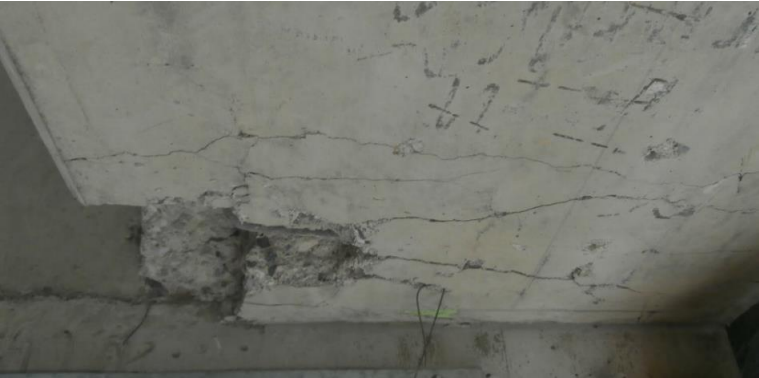
379	Elevation 1-Grid HA. Beam column joint underside of level 3 DS 1 2.0%	Vertical crack at column face approx. 5 mm wide. Diagonal cracking spreading from column face 0.3 mm wide. Transverse crack on underside of beam 5 mm wide. 6 cracks along span 0.2-0.3 mm. Loss of concrete to beam and column.

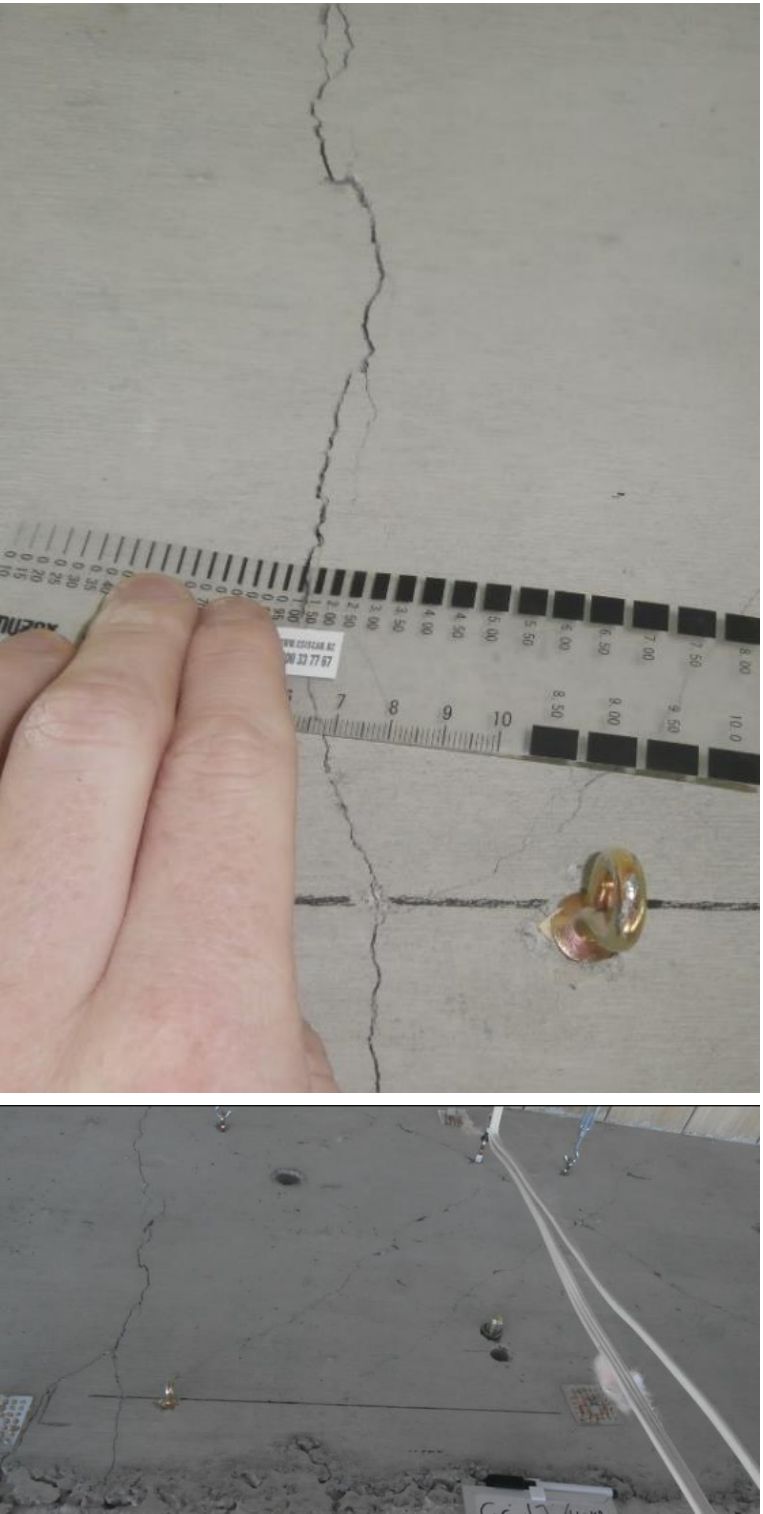
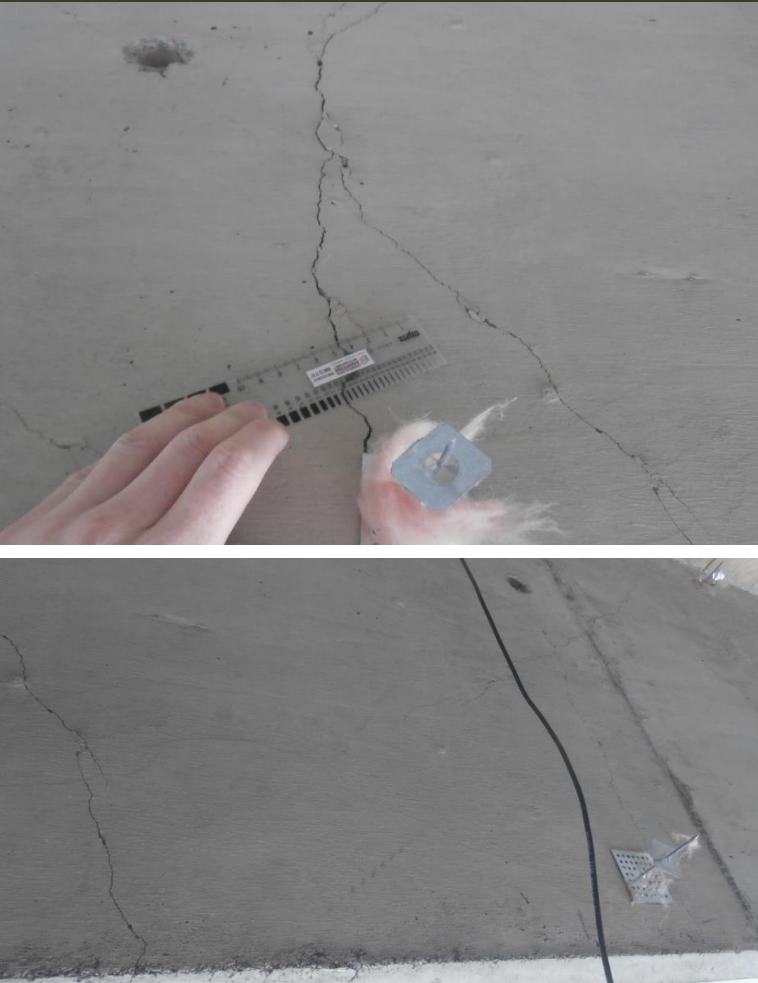
380/3 81	Elevation 1-Grid HA/KA. Beam column joint underside of level 3 DS 0 1 %	Diagonal cracking to beam column joint and column approx. 0.2 mm. Vertical cracking either side of beam column joint 0.3-1 mm. 5 hairline cracks along beam span.

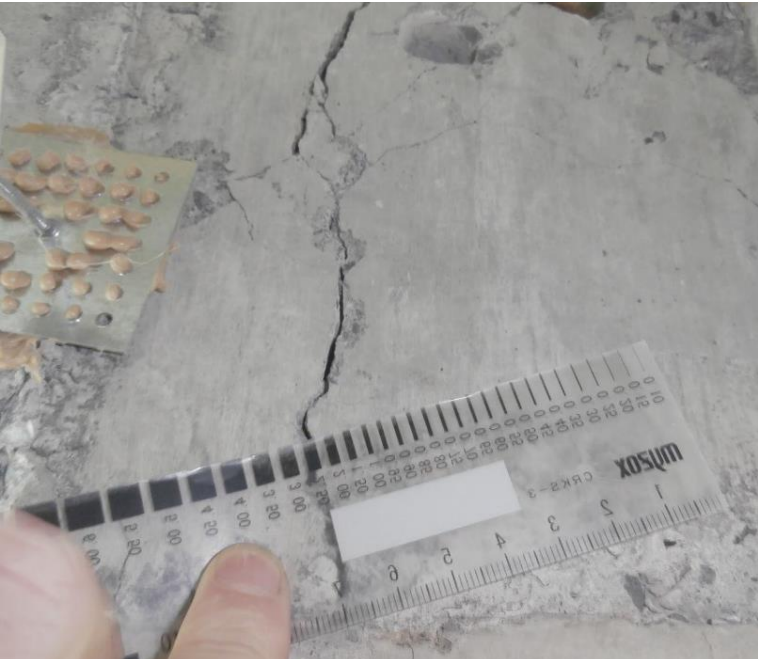
<p>382/3 83</p>	<p>Elevation 1-Grid KA. Beam column joint underside of level 3</p> <p>DS 1 2.0%</p>	<p>Diagonal cracking in column 0.2 mm. Vertical cracking either side of beam column joint 2.5 mm wide. Diagonal cracking spreading from beam column joint continuing to underside of beam 0.2-0.5 mm. 7 hairline cracks along beam.</p>

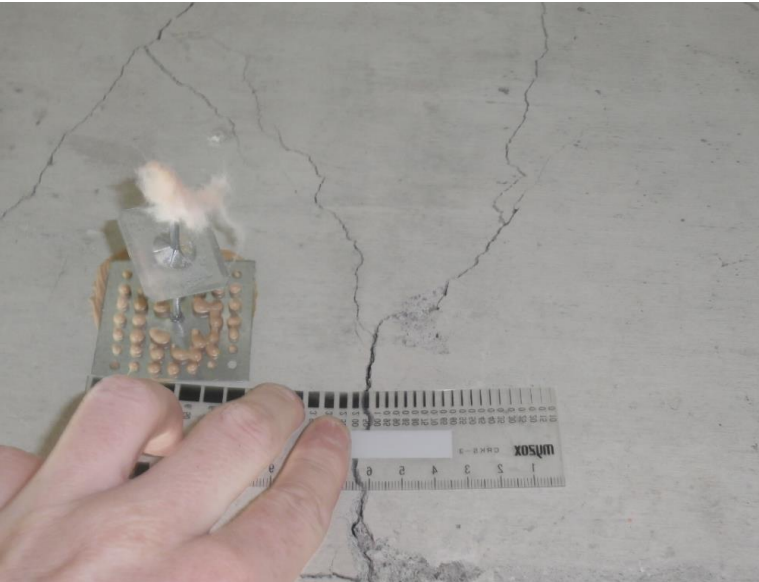
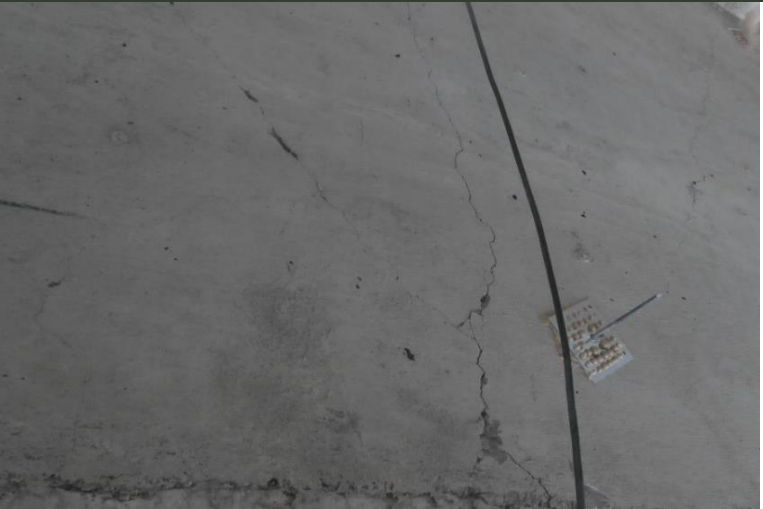
<p>384/3 85</p>	<p>Elevation 1-Grid KA/N. Beam column joint underside of level 3</p> <p>DS 0 1 %</p>	<p>Diagonal hairline cracking in column.</p> <p>Diagonal cracking in each side of beam column joint spreading out into beam 0.2-1.5 mm wide.</p> <p>6 hairline cracks along beam span.</p>

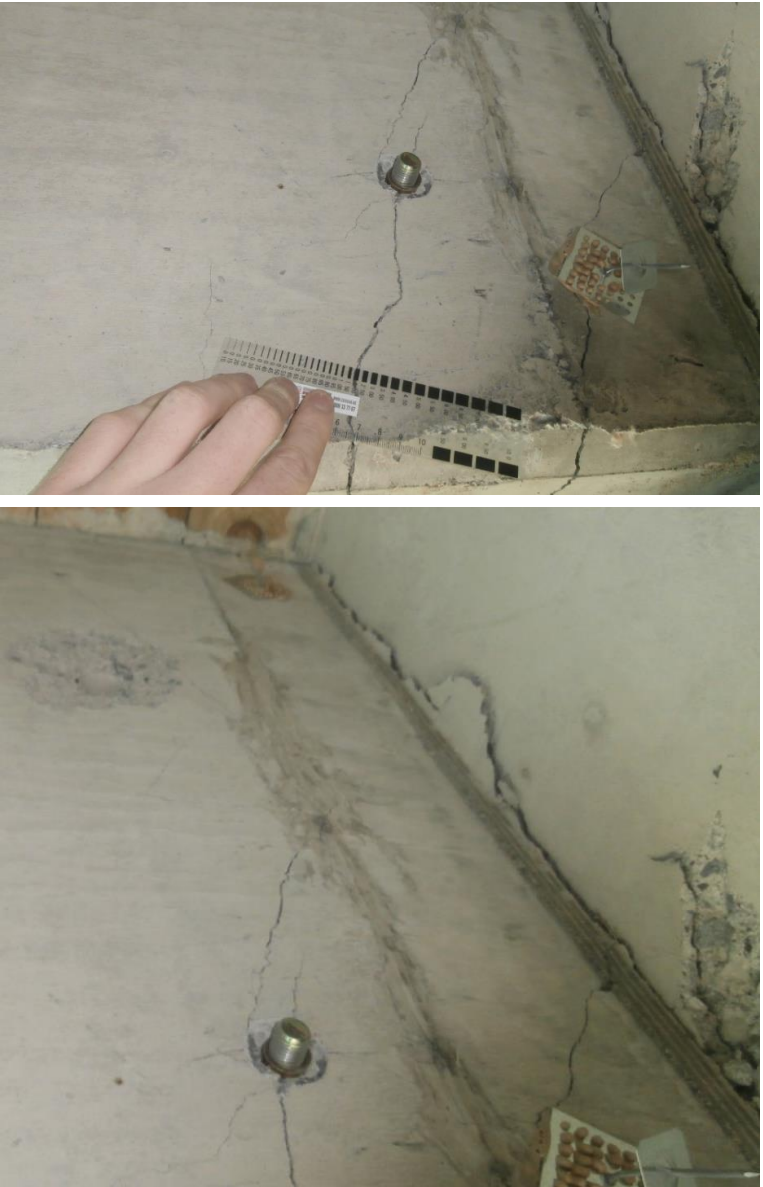
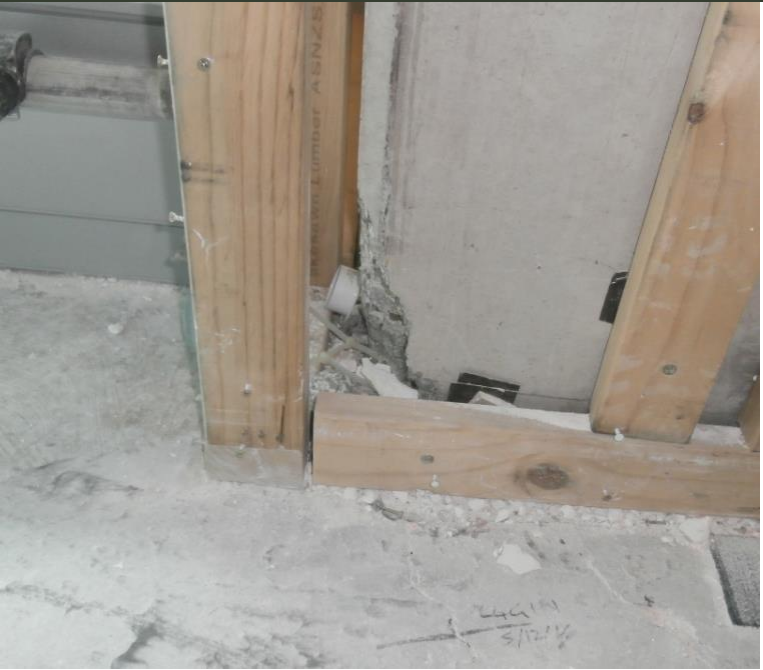
386	Elevation 1-Grid N. Beam column joint underside of level 3 DS 1 2.0%	Vertical crack in beam at column face. Diagonal cracks in beam continuing to underside of beam approx. 2 mm. Spalling of column concrete. Crushing on concrete at column toe.

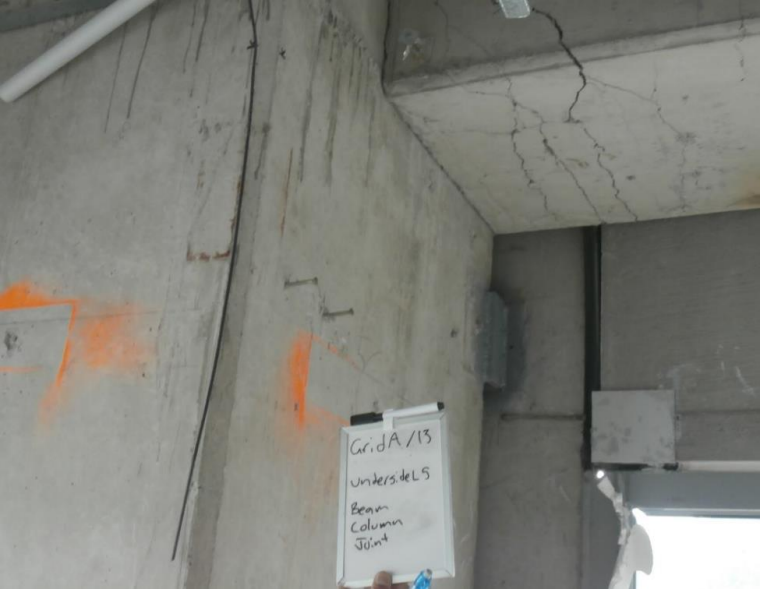
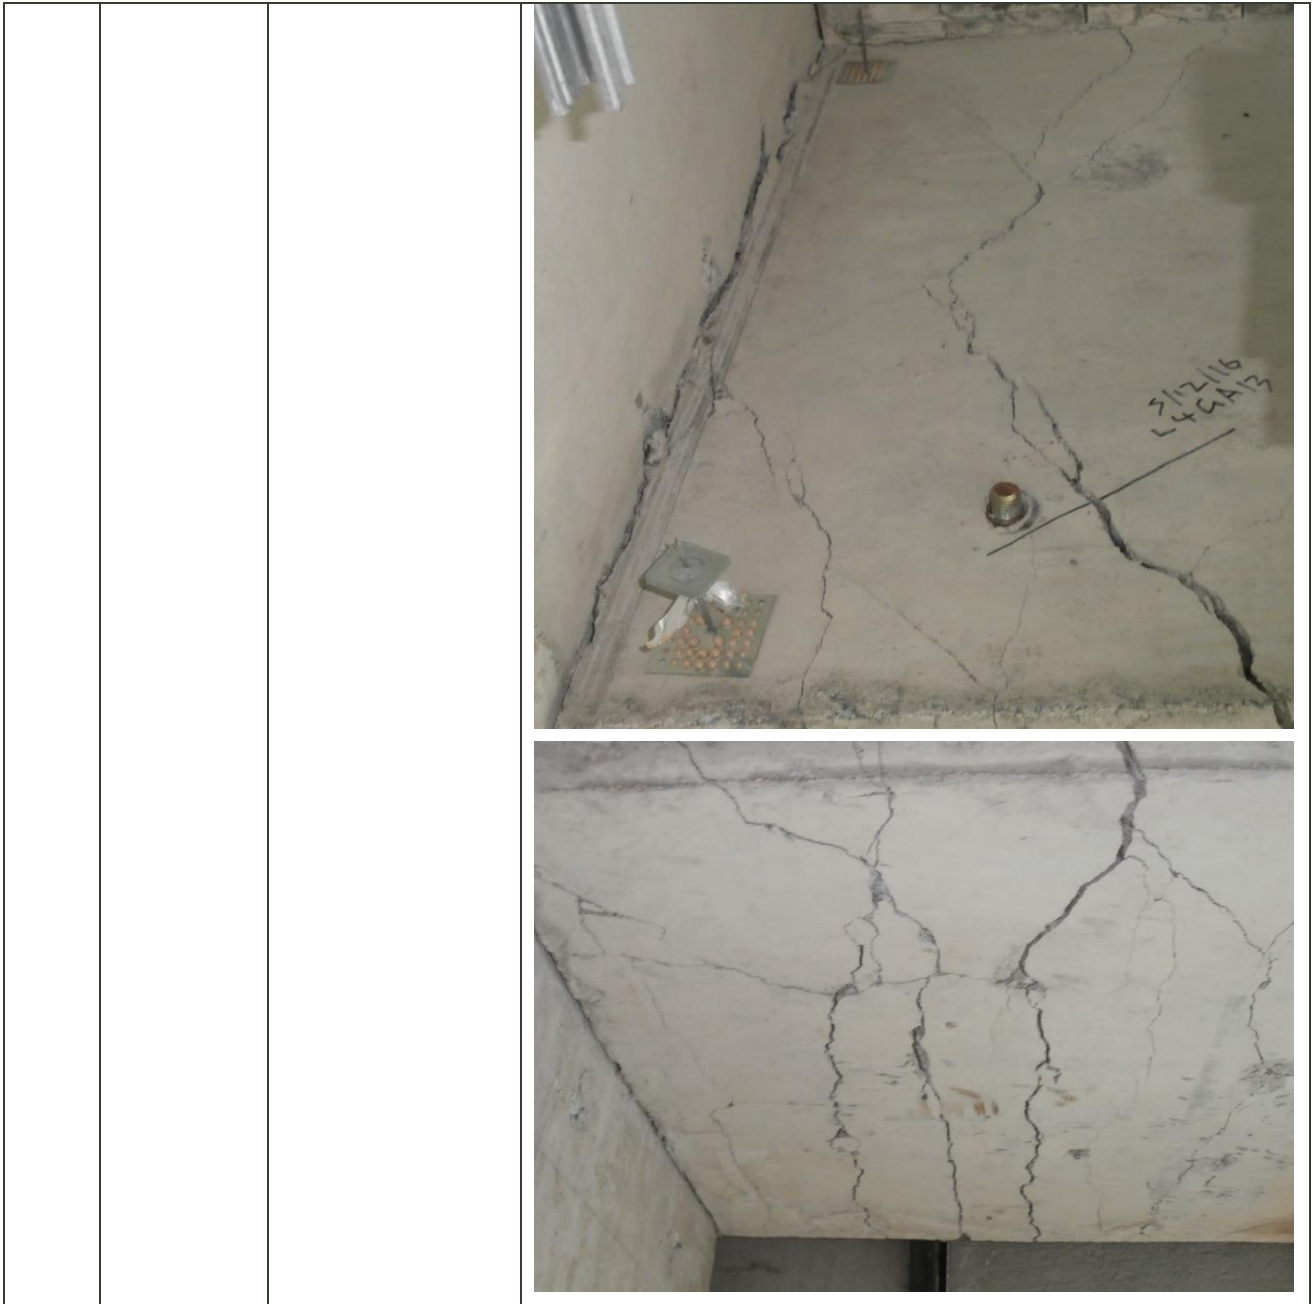
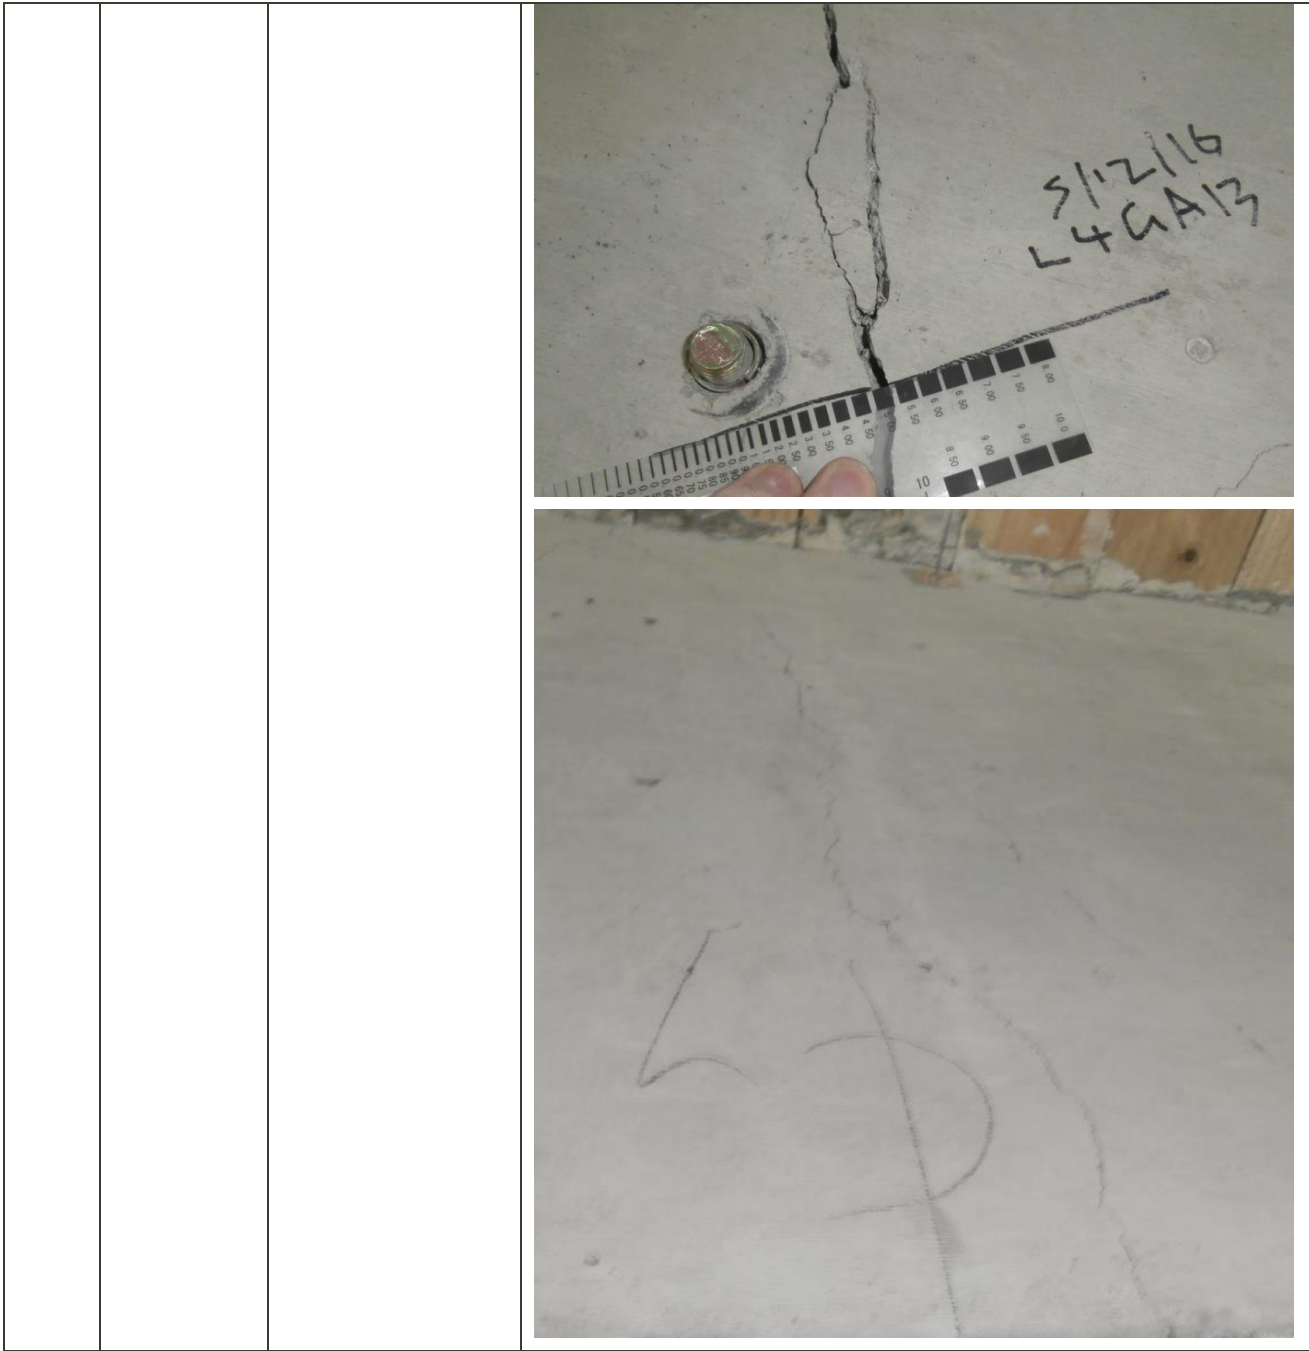
387	Elevation A-Grid 13. Beam column joint underside of level 5 DS 1 2.0%	Vertical crack at column face approx. 5 mm. Cracking 5 mm wide. Cracking to underside of beam. Diagonal cracks spread along the span of the beam.

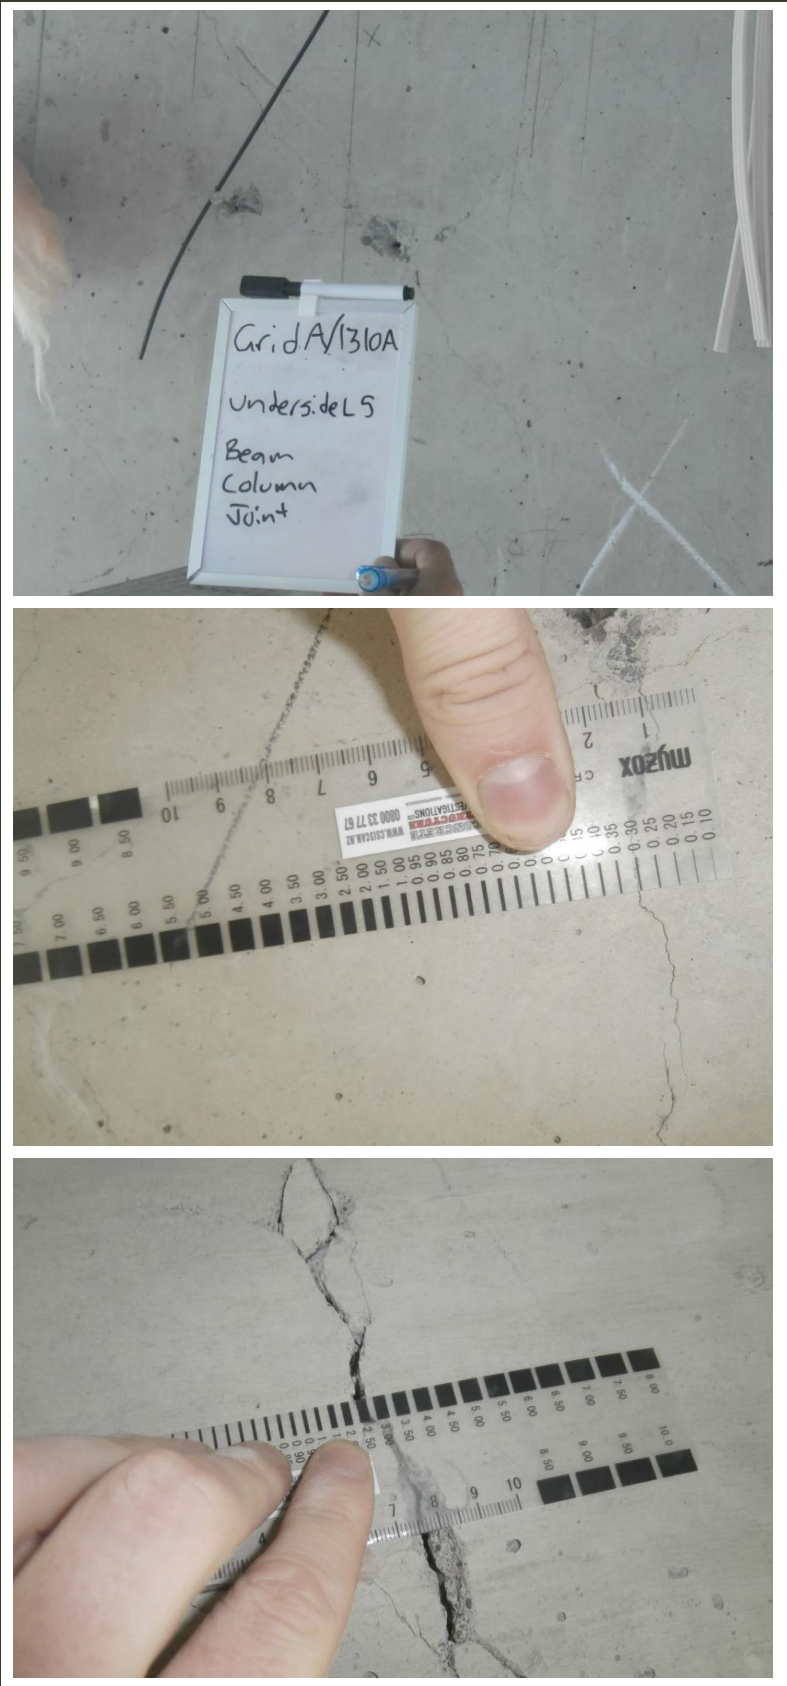
<p>288/3 89</p>	<p>Elevation A-Grid 13/10A. Beam column joint underside of level 5</p> <p>DS 1 2.0%</p>	<p>Diagonal cracking in column 0.3 mm. Diagonal cracking in beam column joint 1 mm wide. Vertical crack on RHS of beam column joint 2.5- 8 mm. Vertical crack on LHS of beam column joint 2 mm.</p>

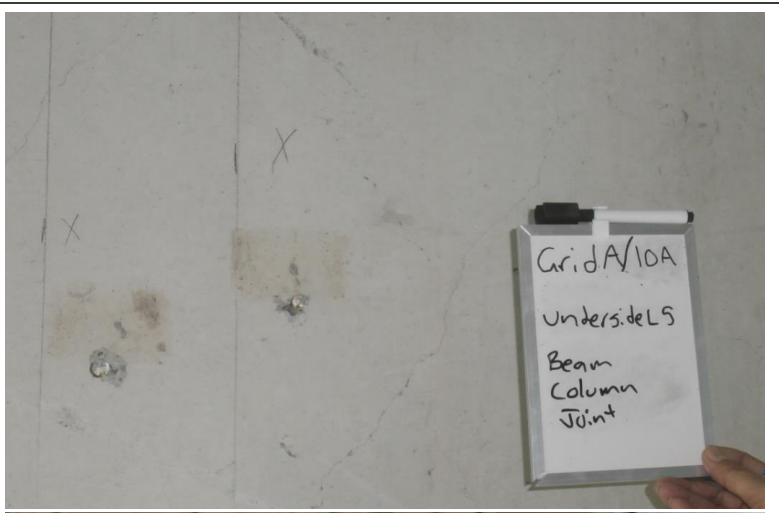
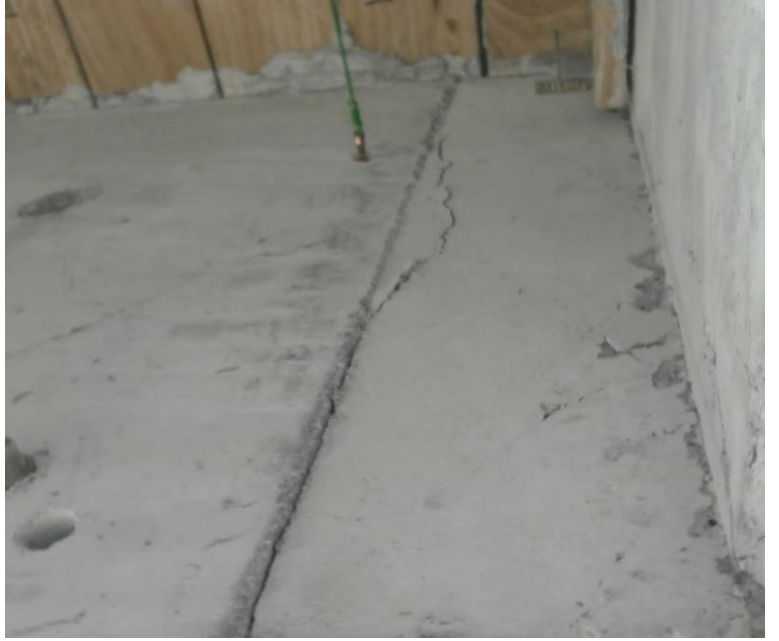
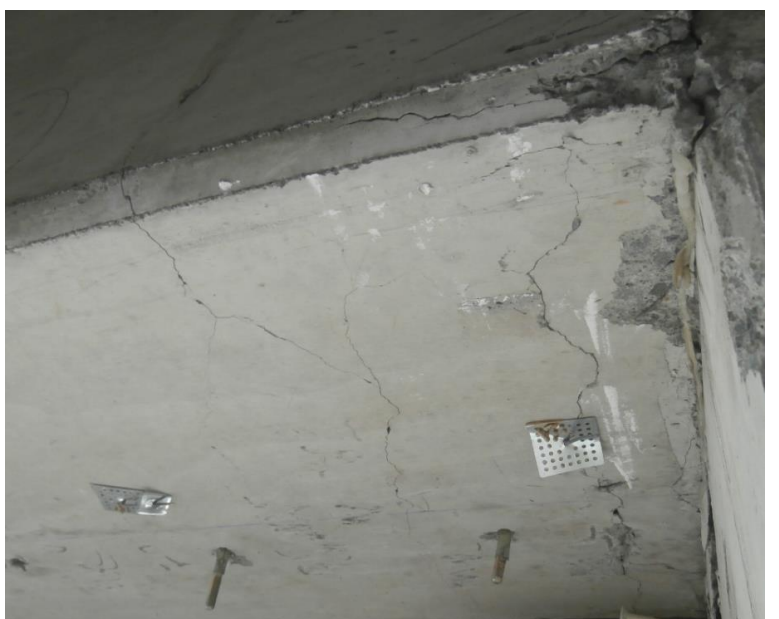
390/3 91	Elevation A-Grid 10A. Beam column joint underside of level 5 DS 1 2.0%	Diagonal cracking in column 0.3 mm wide. Vertical cracking either side of the beam column joint 2.5 mm wide. Diagonal cracking in beams either side of beam column joint 0.6 mm wide. Some spalling of concrete on underside of beam.
-------------	--	--

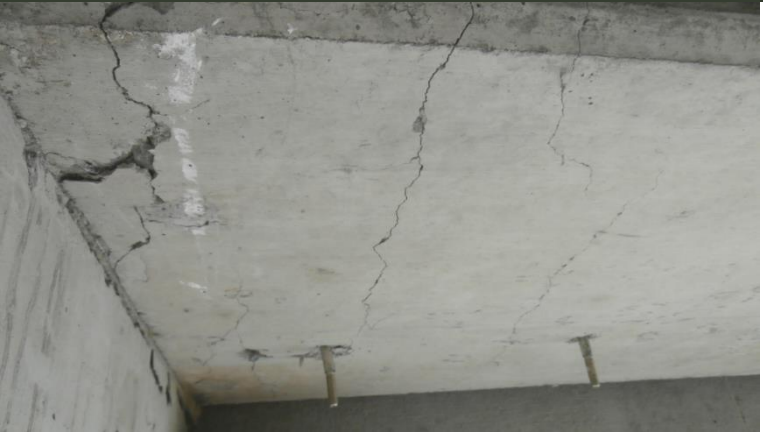
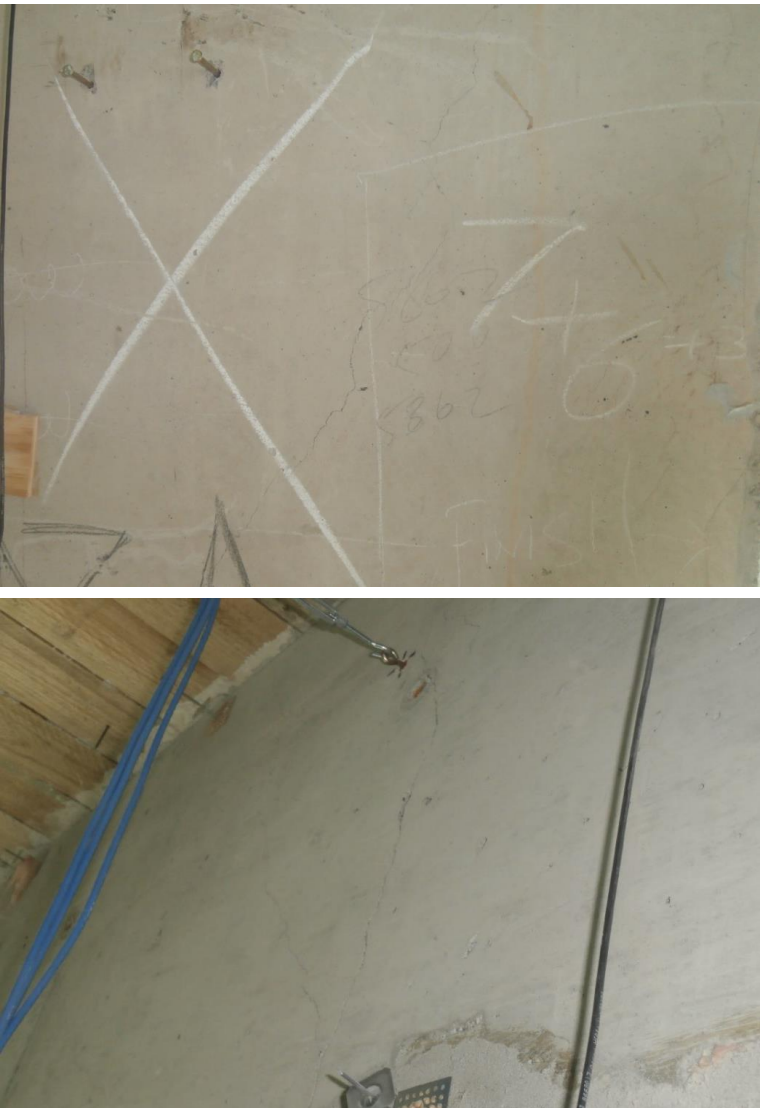
<p>392/3 93</p>	<p>Elevation A-Grid 10A/8A. Beam column joint underside of level 5</p> <p>DS 1 2.0%</p>	<p>Diagonal hairline cracking in column. Diagonal cracking in beam column joint 0.6 mm wide. Vertical cracks either side of beam column joint 2 mm wide.</p>

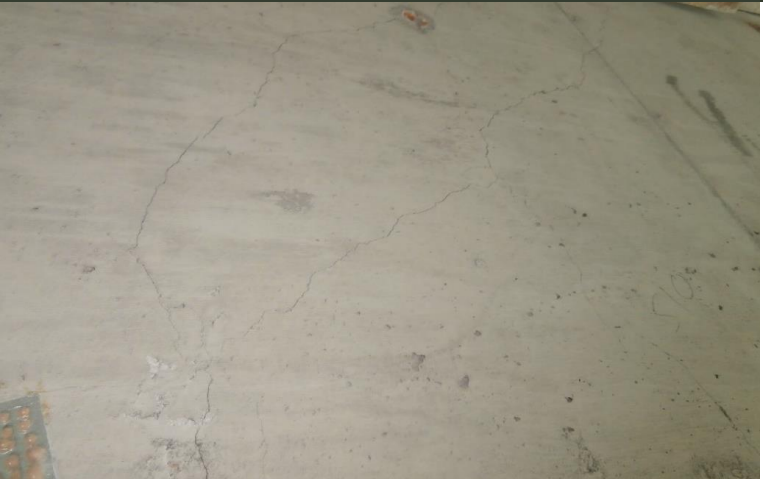
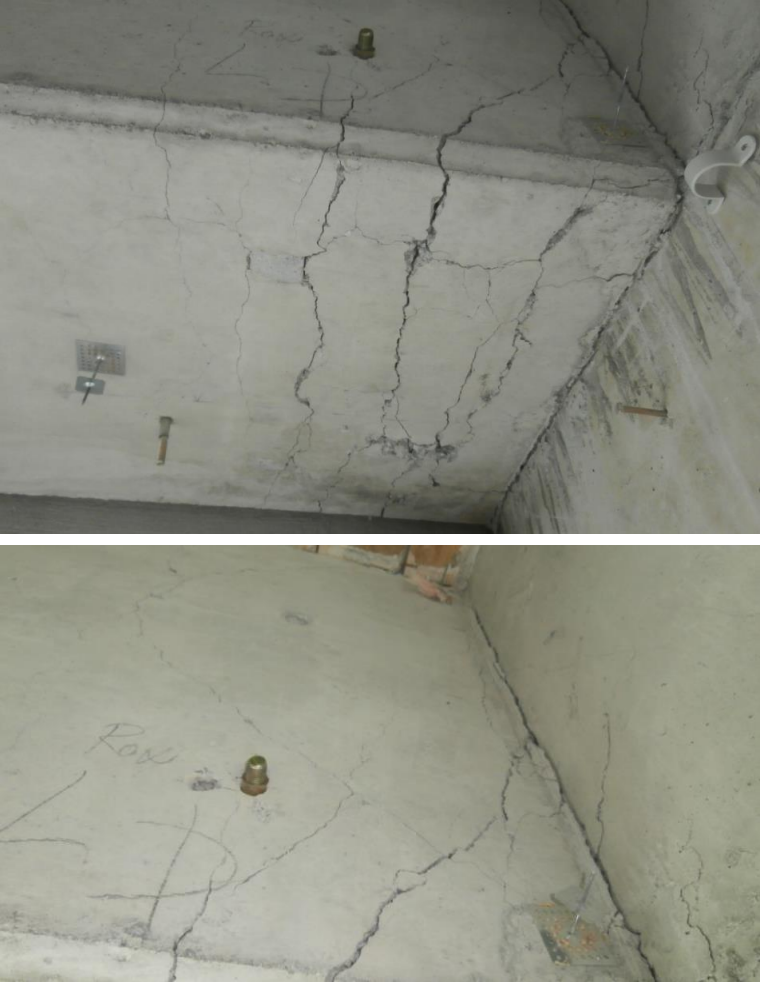
394	Elevation A-Grid 8A. Beam column joint underside of level 5 DS 2 2.75%	Vertical crack at column face, continues under the beam. Approx. 5 mm separation. Diagonal cracking spreading from beam column joint 1-5 mm. Spalling of concrete in column.

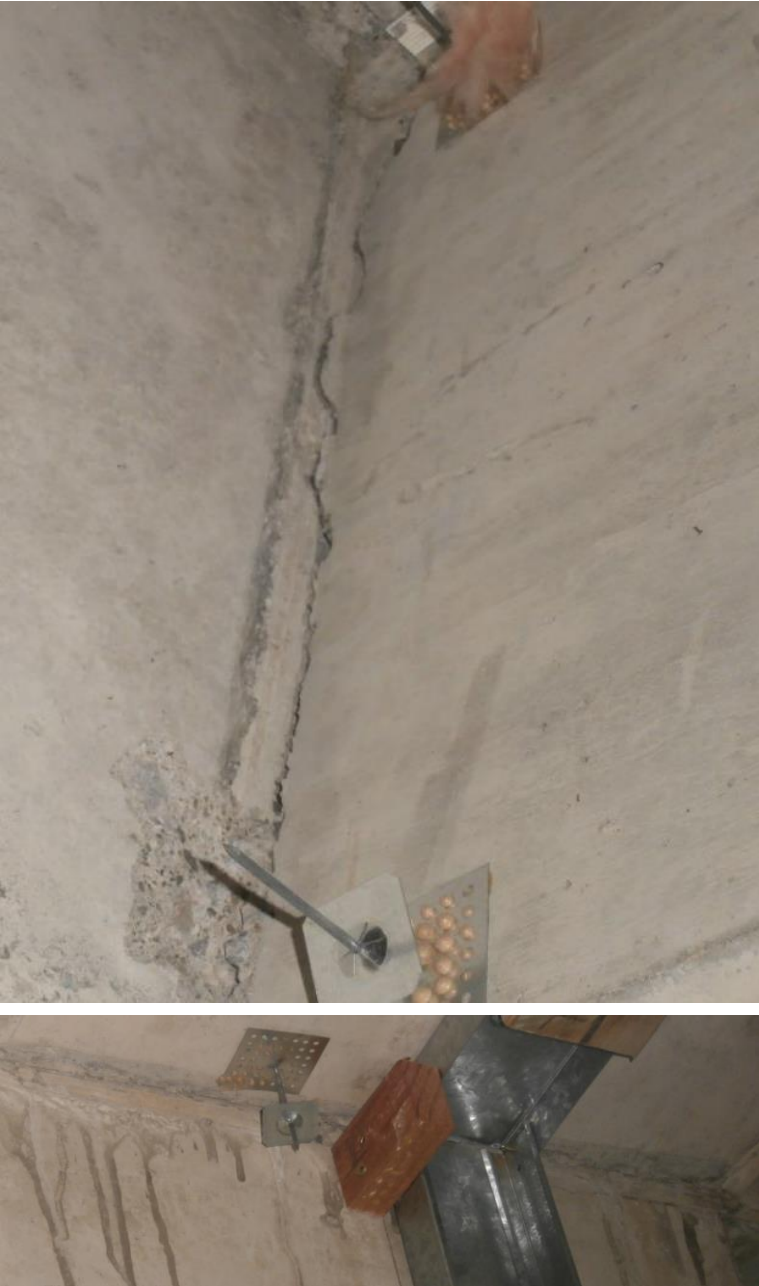
<p>395</p>	<p>Elevation HA-Grid 8A. Beam column joint underside of level 5 DS 1 2.0%</p>	<p>Vertical crack at column face approx. 2 mm.</p>

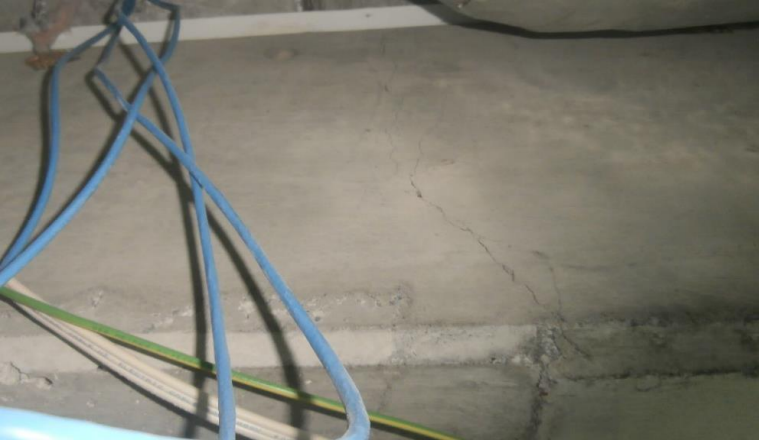
underside of level 5		
400/401	Elevation HA-Grid 6. Beam column joint underside of level 5 DS 0 1%	Diagonal hairline cracking in column. Vertical cracking either side of beam column joint 1 mm wide.

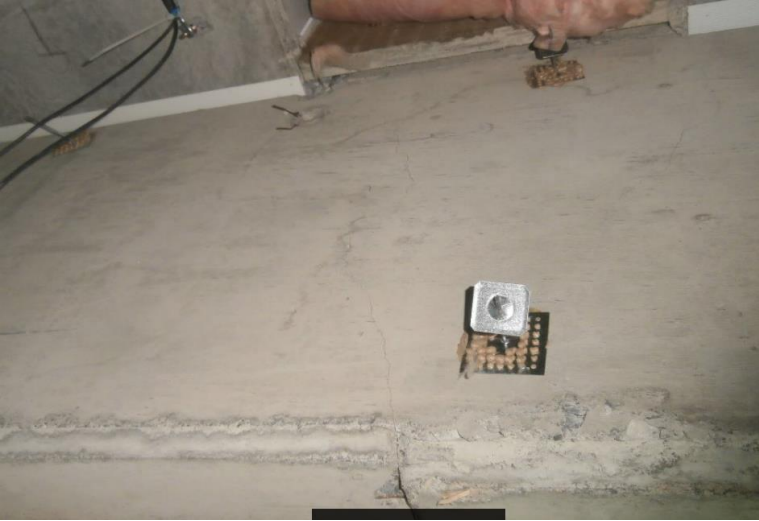
402/403	Elevation HA-Grid 5. Beam column joint underside of level 5	Vertical cracking either side of beam column joint approx. 0.5 mm wide.

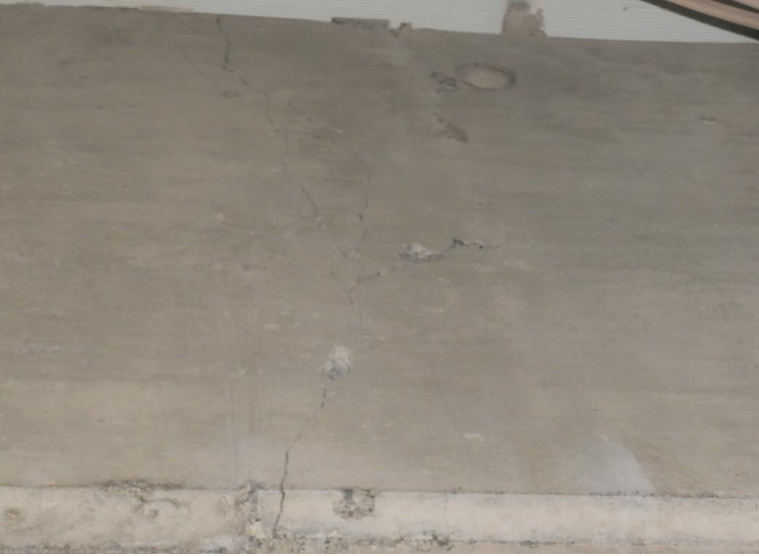
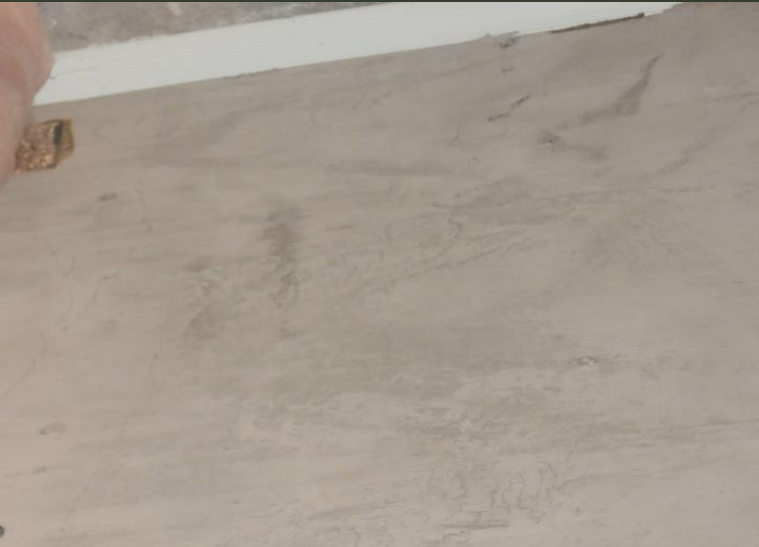
404/405	Elevation HA-Grid 4. Beam column joint underside of level 5 DS 1 2.0%	Vertical crack LHS of beam column joint 2 mm wide. Vertical crack RHS of beam column joint 0.5 mm.

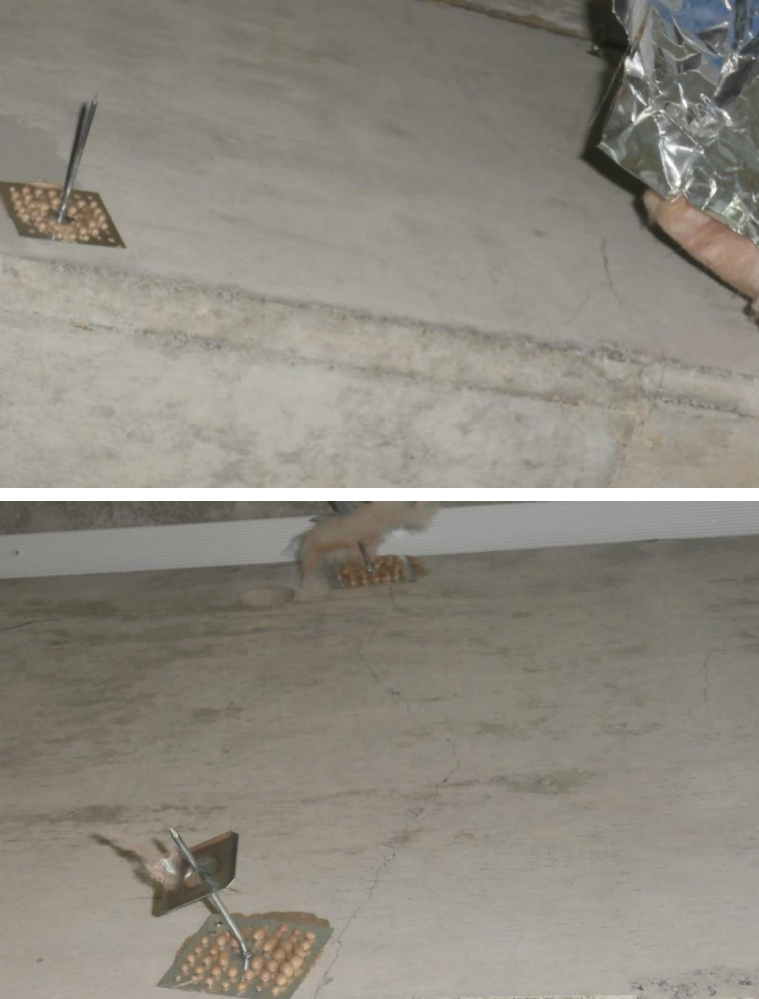
406/4 07	Elevation HA-Grid 3. Beam column joint underside of level 5 DS 0 1 %	Vertical cracks either side of beam column joint 0.5-1 mm. Hairline diagonal cracks present in beam span.
