Resilient Repair Guide Source Report: Case Study Annex

APPLIED TECHNOLOGY COUNCIL
201 Redwood Shores Parkway, Suite 240
Redwood City, California 94065
www.ATCouncil.org

FEDERAL EMERGENCY MANAGEMENT AGENCY
Michael Mahoney, Project Officer
William T. Holmes, Technical Monitor
Washington, D.C.

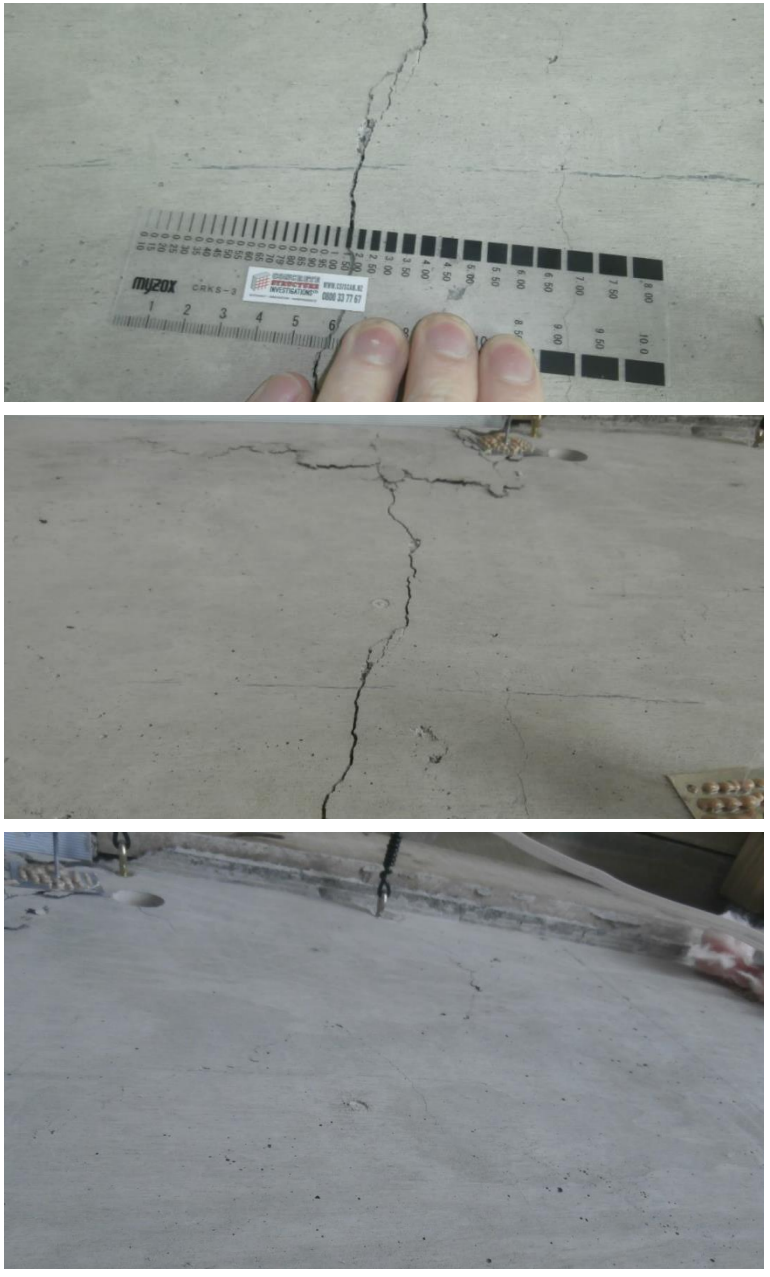
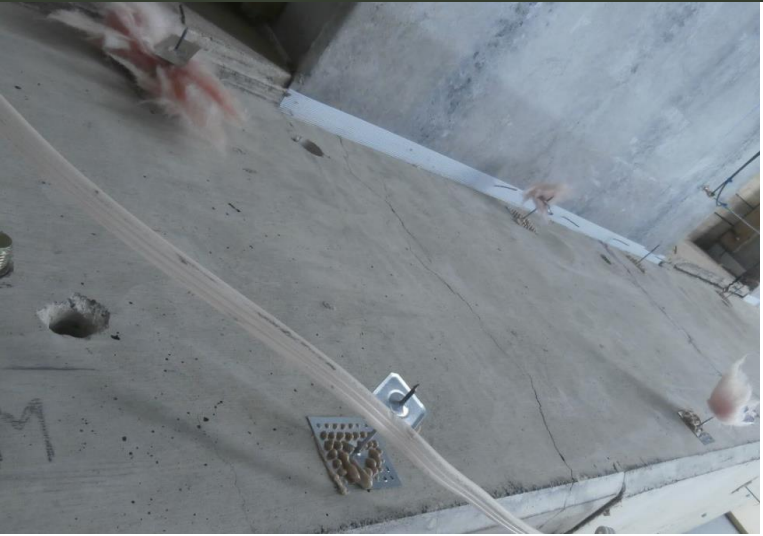
408/4 09	Elevation HA-Grid 2. Beam column joint underside of level 5 DS 1 2.0%	1.5 mm wide vertical crack LHS of beam column joint. Spalling of concrete at top of beam. 1 mm wide vertical crack RHS of beam column joint.

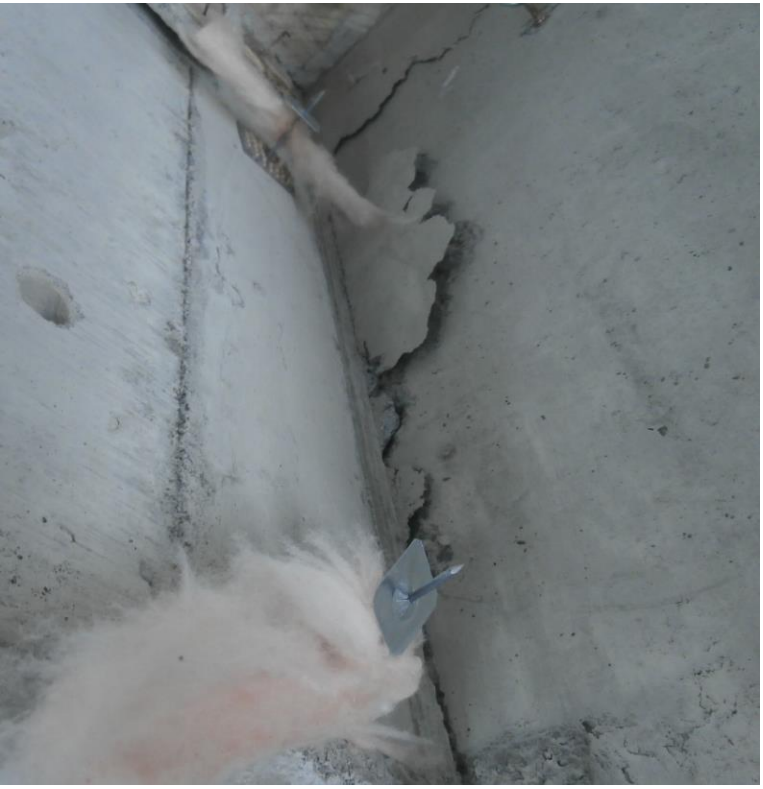
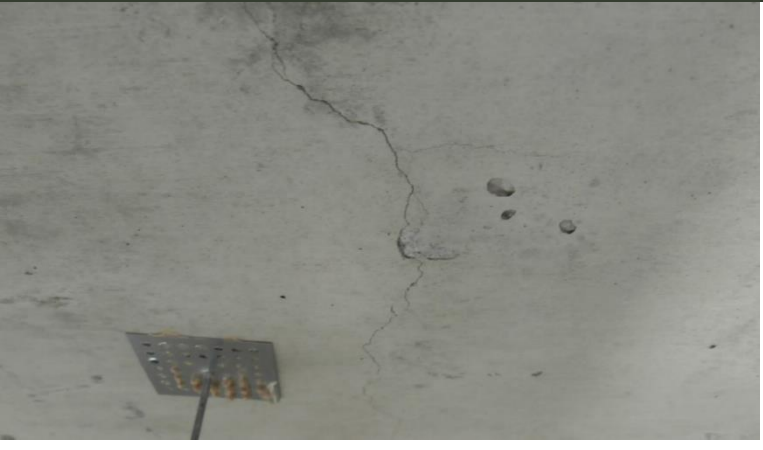
410	Elevation HA-Grid 1. Beam column joint underside of level 5 DS 1 2.0%	Vertical crack at column face continuing to underside of beam approx. 5 mm. Spalling of concrete in column.

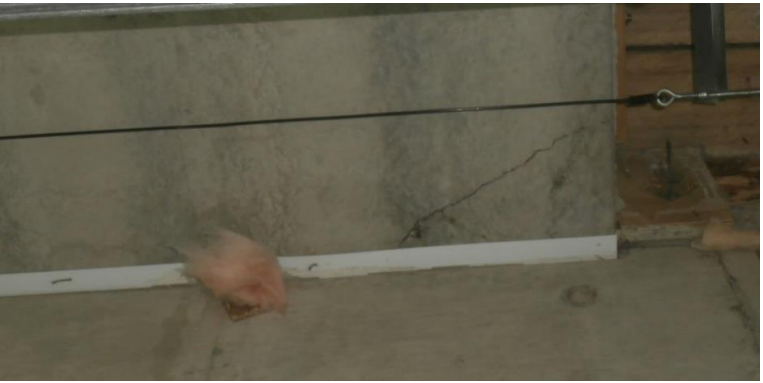
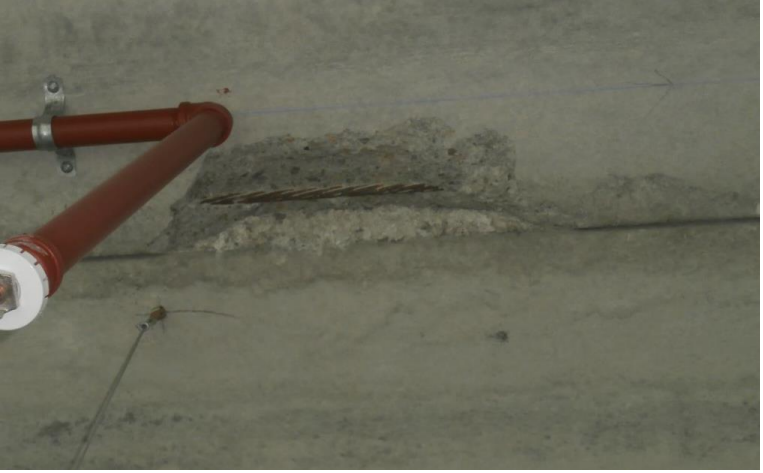
411-489	Frames on grid lines 13,10A,KA and N	Frames along these grid lines were not assessed.	
490	Dycore units Underside of level 5. Grid numbers between 1-2 and HA-KA.	Diagonal cracking in corner HA approx. 2 mm. Concrete loss in middle of slab exposing tendon.

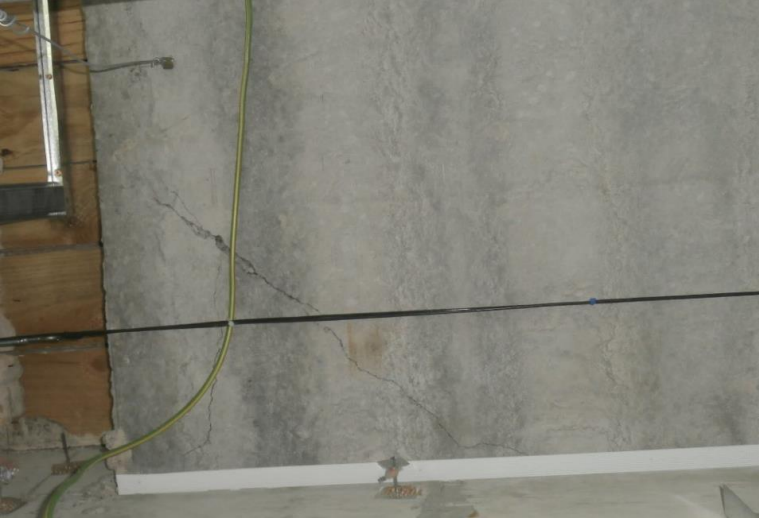
491	Dycore units Underside of level 5. Grid numbers between 1-2 and KA-N.	Diagonal cracking in corner 1/N approx. 2 mm.

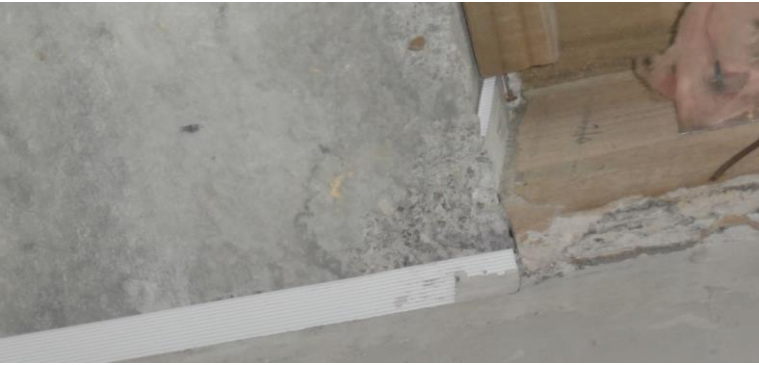
492	Dycore units Underside of level 5. Grid numbers between 2-3 and HA-KA.	Concrete spalled at end on grid HA/2-3.

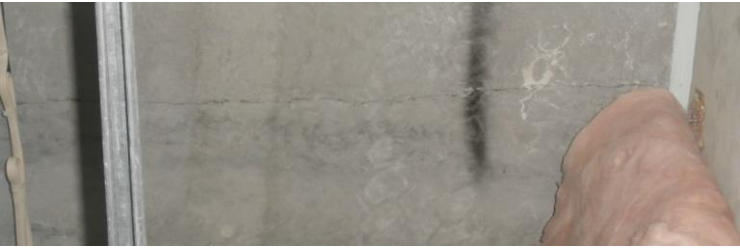
493	Dycore units Underside of level 5. Grid numbers between 2-3 and KA-N.	No access at time of inspection.	
494	Dycore units Underside of level 5. Grid numbers between 3-8 and HA-KA.	Longitudinal crack from Grid point HA/4 along half span of slab.

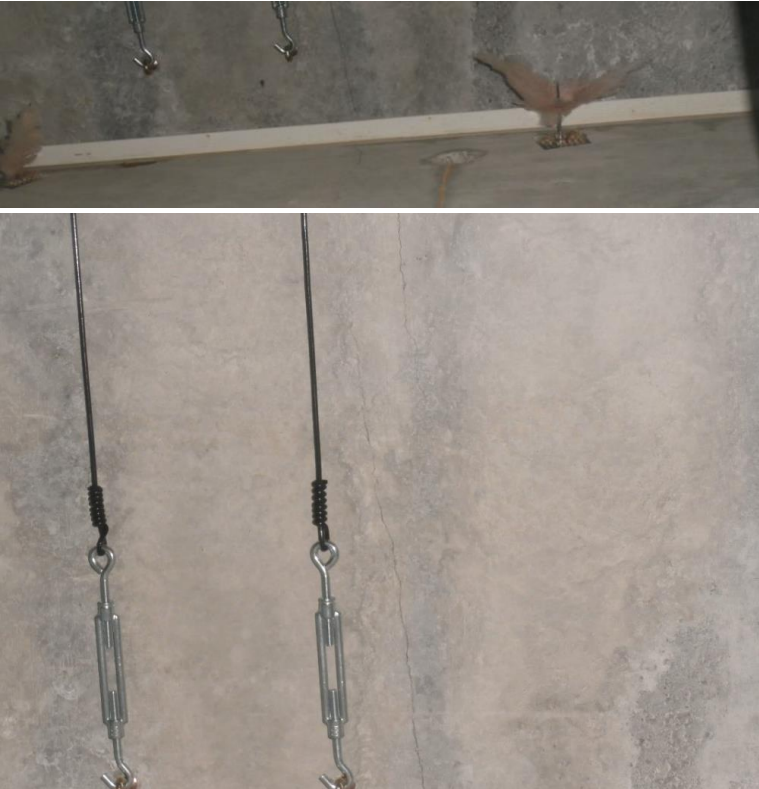
<p>500</p>	<p>Dycore units Underside of level 5. Grid numbers between 8A-10A and C-H.</p>	<p>Longitudinal cracks between Grids F-G approx. 1.5 mm run as far as exposed.</p>

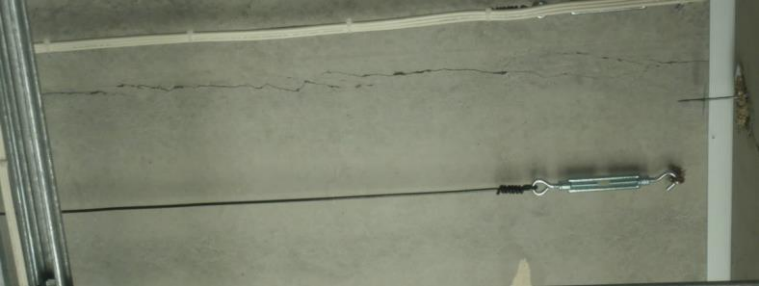
<p>502</p>	<p>Dycore units Underside of level 5. Grid numbers between 8A-10A and B-C.</p>	<p>Longitudinal crack from point 8A/C spanning approx. half the slab approx. 1.5 mm.</p>

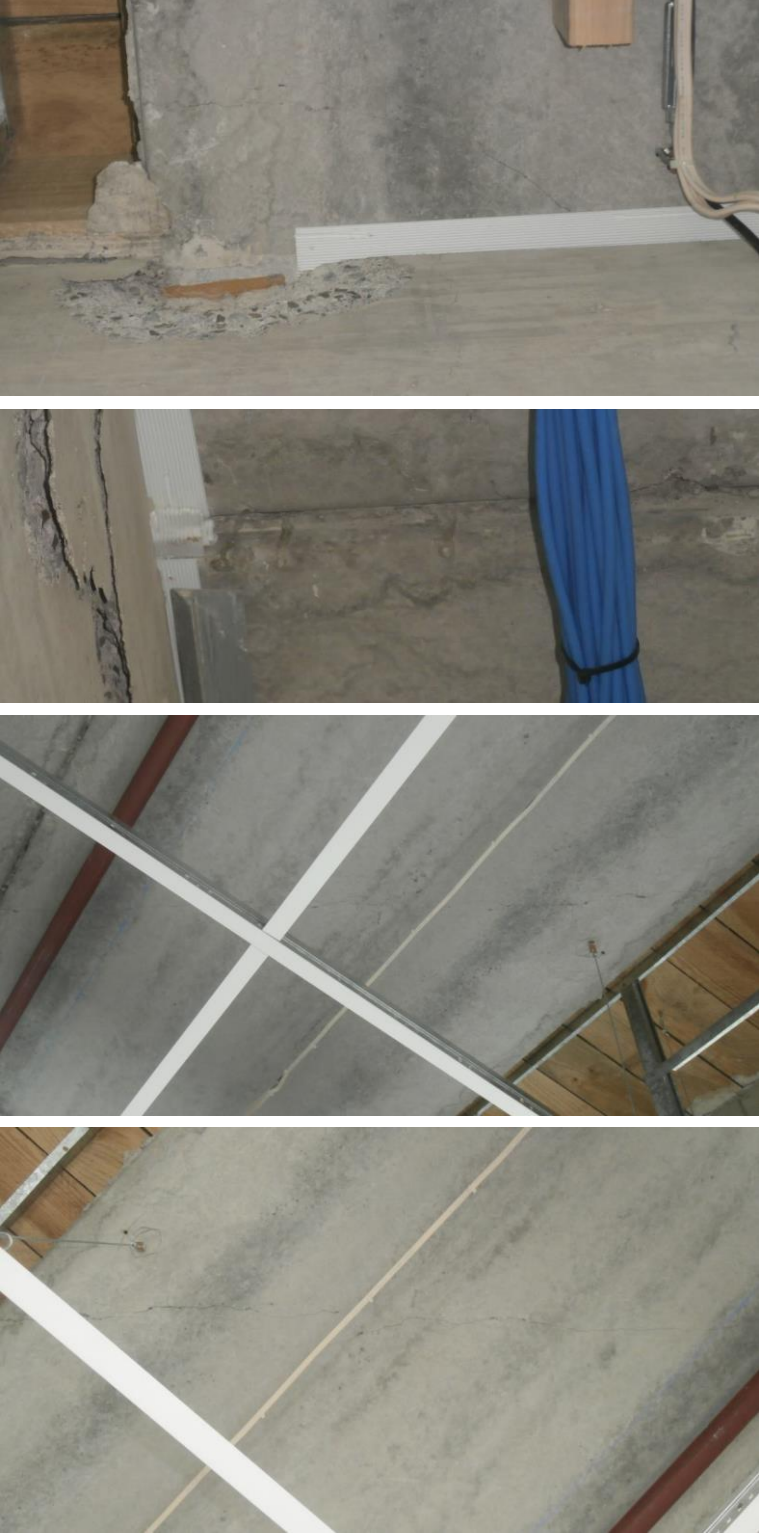
503	Dycore units Underside of level 5. Grid numbers between 10A-13 and A-B.	Diagonal cracking in corner A13 loss of concrete in beam. Beam damage in beam spanning grid line 10A, decrease in slab seating. Diagonal crack along mid span of slab.

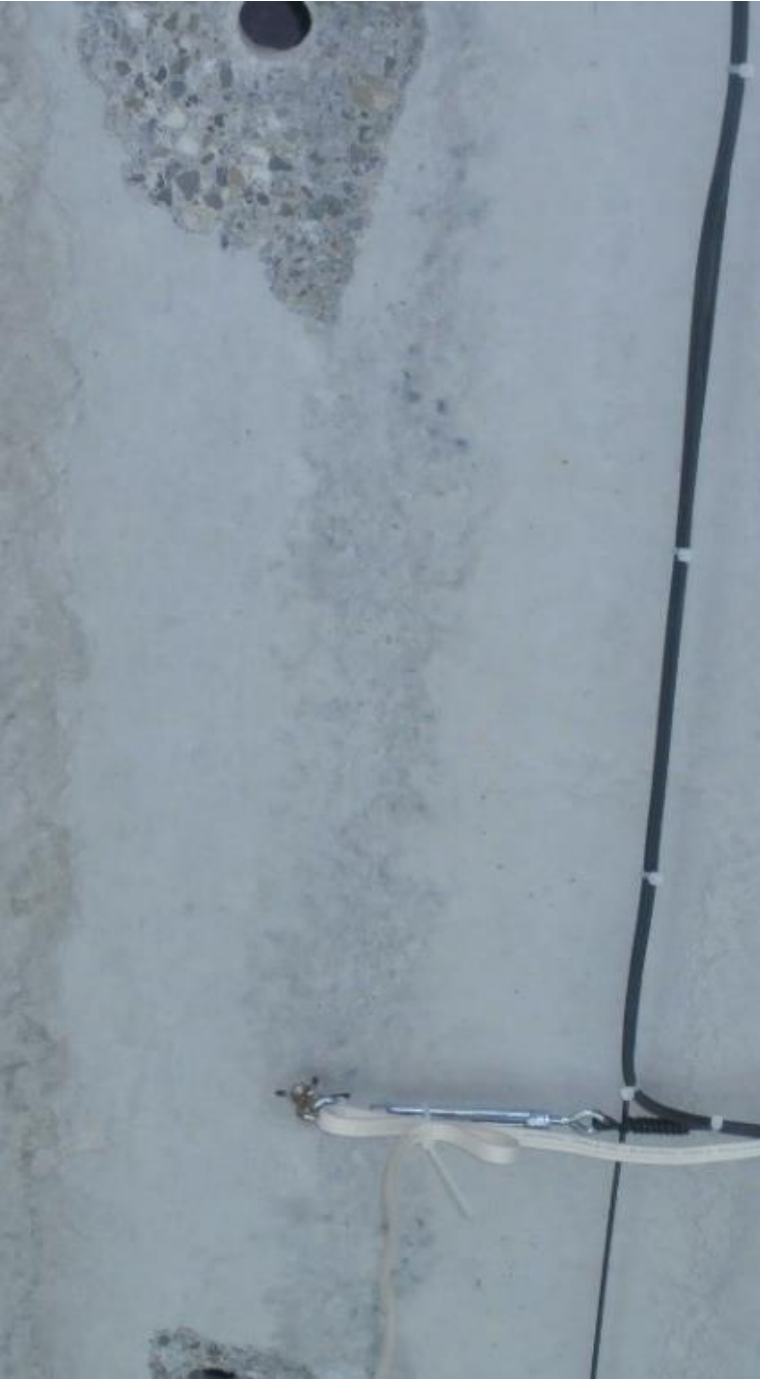
504	Dycore units Underside of level 5. Grid numbers between 8A-10A and A-B.	Loss of concrete at hole in underside of Dycore. Suspected during installation. Diagonal cracking at corner A/8A.

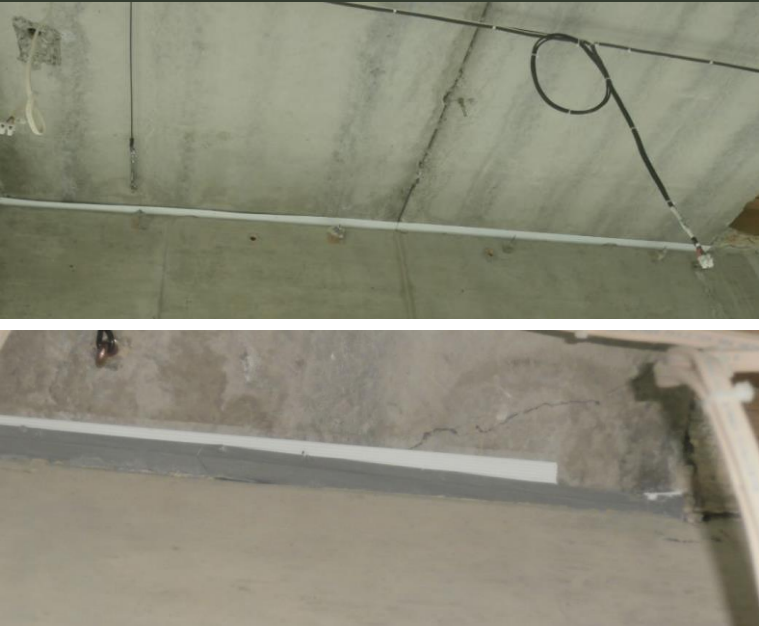
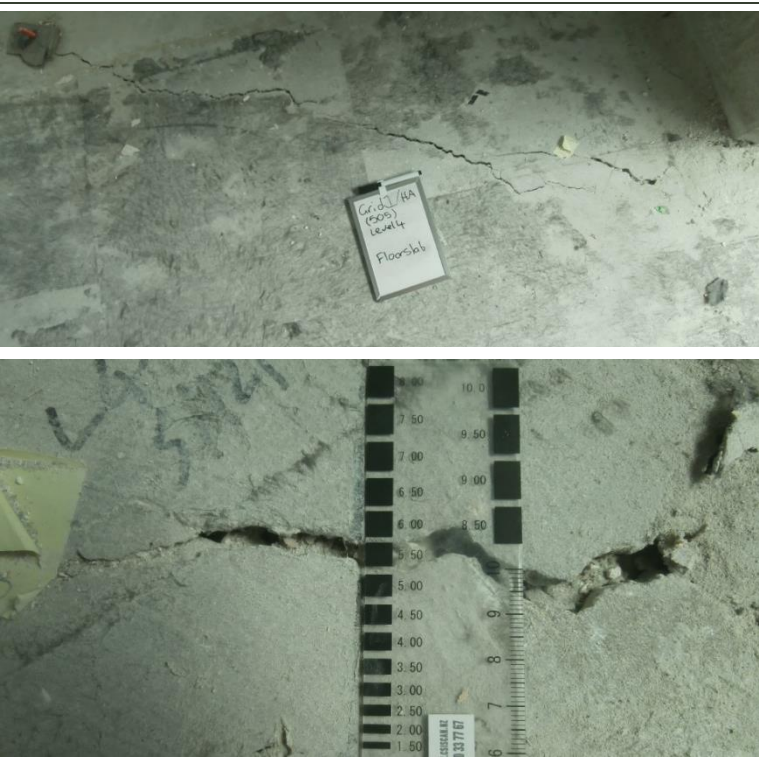
505	<p>Floor slab level 4. Grid numbers between HA-KA and 1-2.</p>	<p>Diagonal cracking spreading from corner column 1/HA 1-5.5 mm wide.</p> <p>9 mm transverse crack running along frame KA.</p> <p>Longitudinal crack running close to frame 2 approx. 1.5 mm.</p>

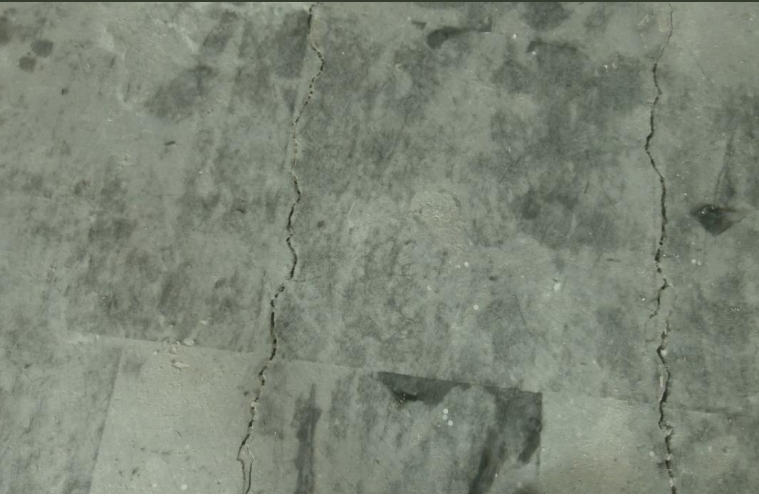
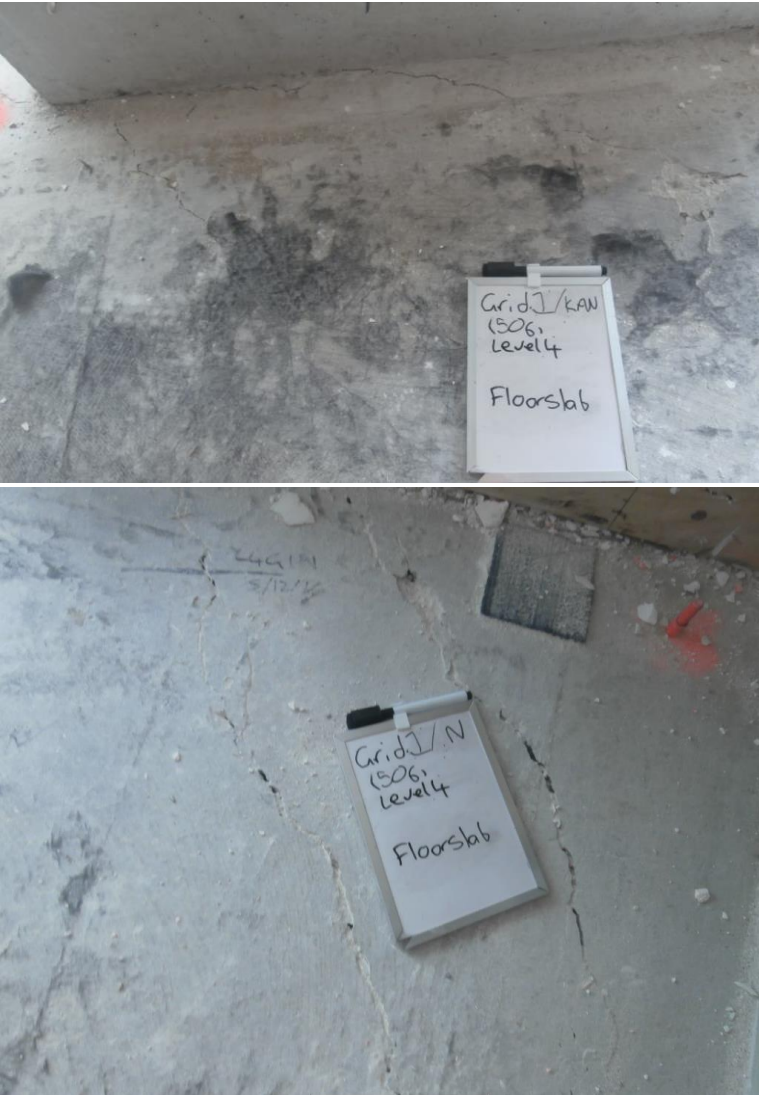
506	<p>Floor slab level 4. Grid numbers between KA-N and 1-2.</p>	<p>9 mm Transverse crack running along frame on grid KA.</p> <p>Diagonal cracking spreading from corner column 1/N 1.5-5 mm wide.</p> <p>Transverse cracking along outer frame on grid N approx. 1.5 mm wide.</p> <p>Diagonal cracking spreading from column 1/KA/N approx. 2 mm.</p>

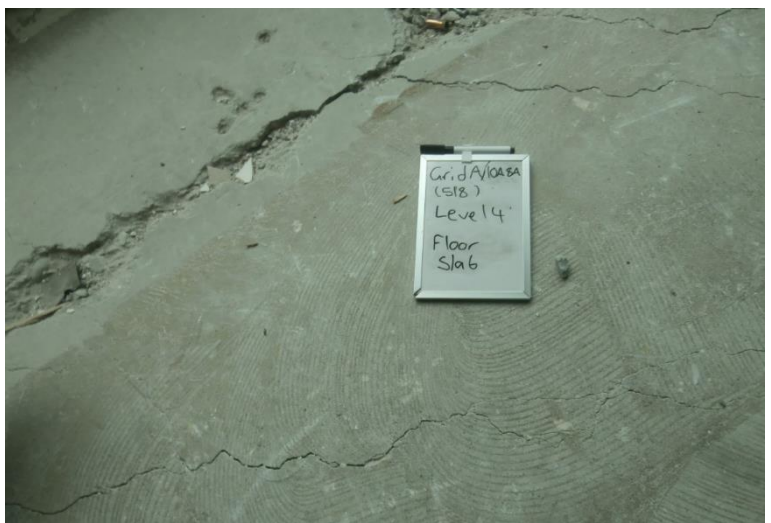
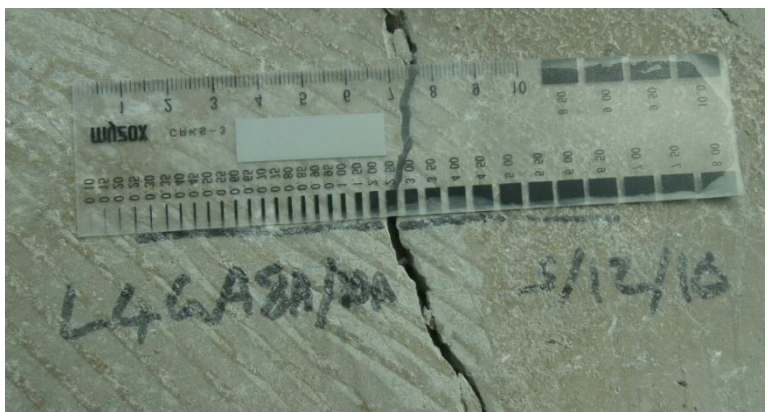
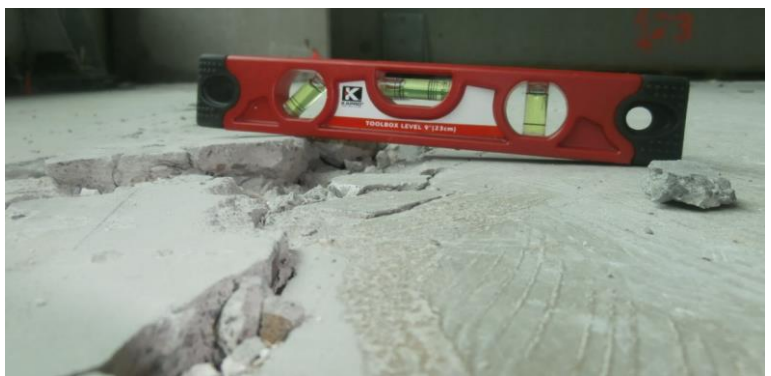
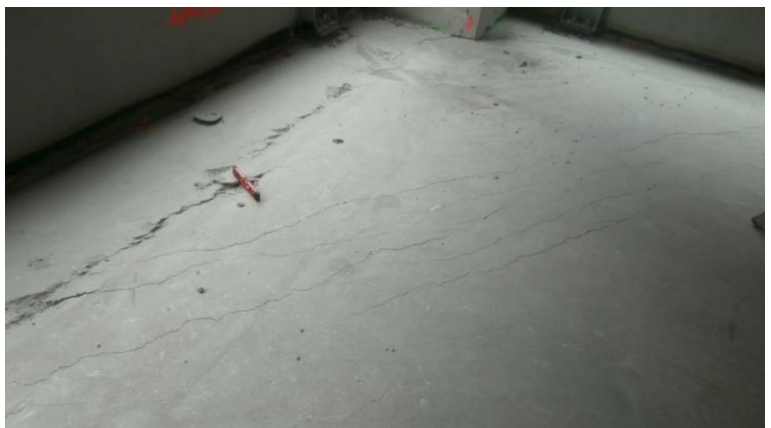
<p>518</p>	<p>Floor slab level 4. Grid numbers between A-B and 8A-10A.</p>	<p>Longitudinal crack running along outer frame on grid A, 2.5 mm wide. Loss of cover concrete, reinforcement exposed. Vertical dislocation present. Longitudinal crack running along Grid B approx. 2 mm wide. Diagonal cracking spreading from corner column A/8A, largest crack 7.5 mm wide. Transverse crack running along internal frame at Grid 10A 4 mm wide.</p>
------------	--	--

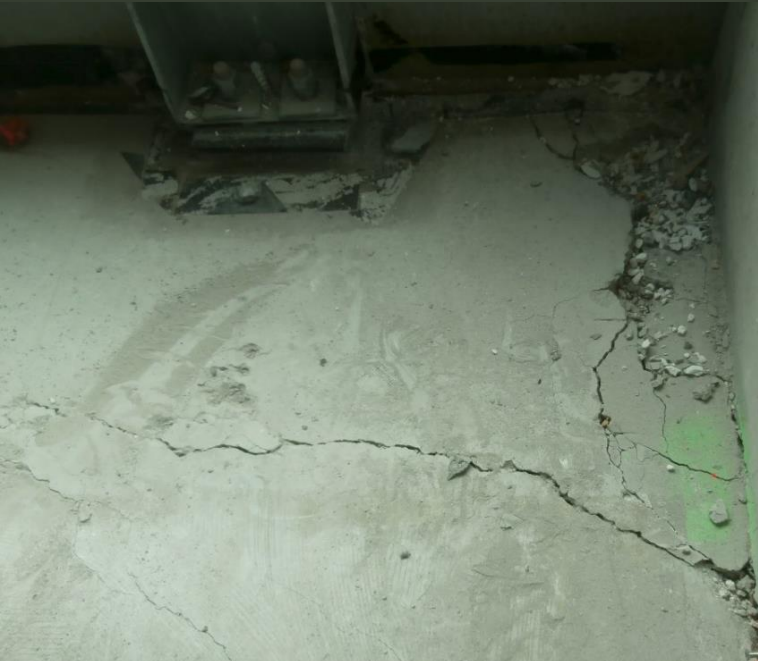
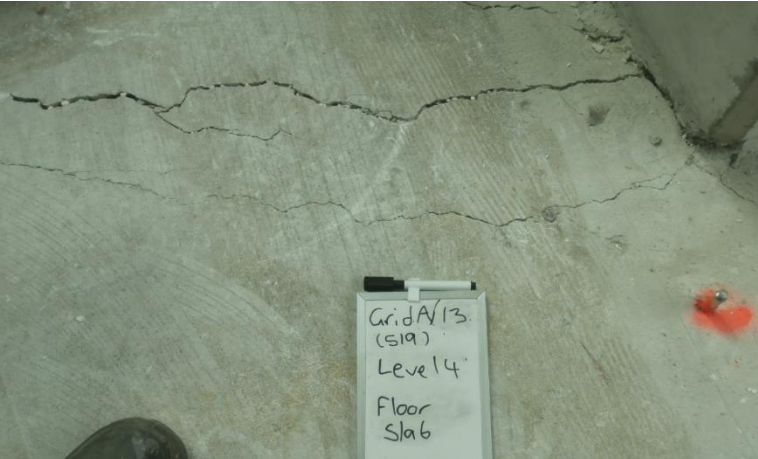
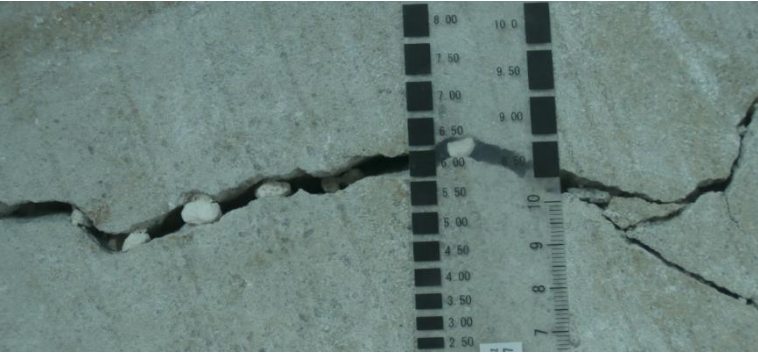
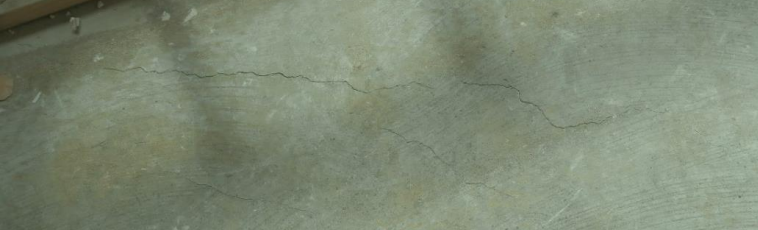
519	<p>Floor slab level 4. Grid numbers between A-B and 10A-13 .</p>	<p>Diagonal cracking spreading from corner column A/13 0.9-6 mm wide.</p> <p>Diagonal crack starting at column A/13/10A 1-9 mm wide with vertical dislocation.</p> <p>Longitudinal crack running along Grid B approx. 1.5 mm wide.</p> <p>Transverse crack along inner frame on Grid 10A 2 mm wide.</p>
